Manhole Inspection Form

M2-32-P1-32N-P2-15E-3-1N

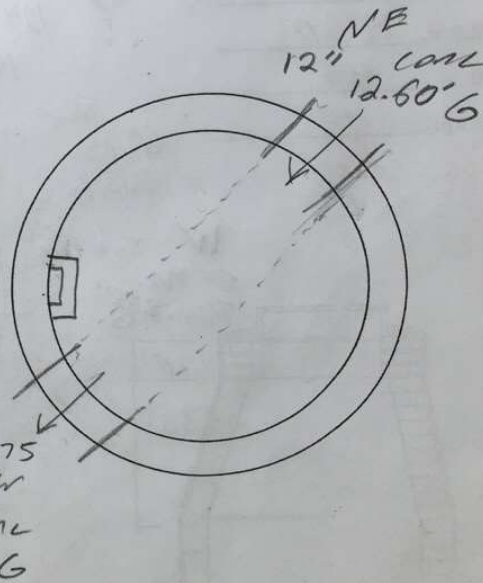
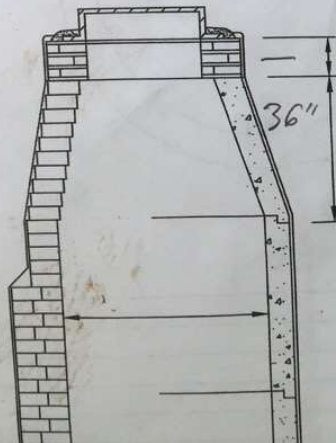
R.T. = 12.75

D = 48"

16.25	16.25
-3.50	-3.65
12.75	12.60
