# Manhole Inspection Form

M2-32-P1-32N-P2-15E-3-6S

Manhole Number: M2-32-P1-32N-P2-15E-3-6S  
Community: Chesterfield  
Inspector Initials: KMD / BRS

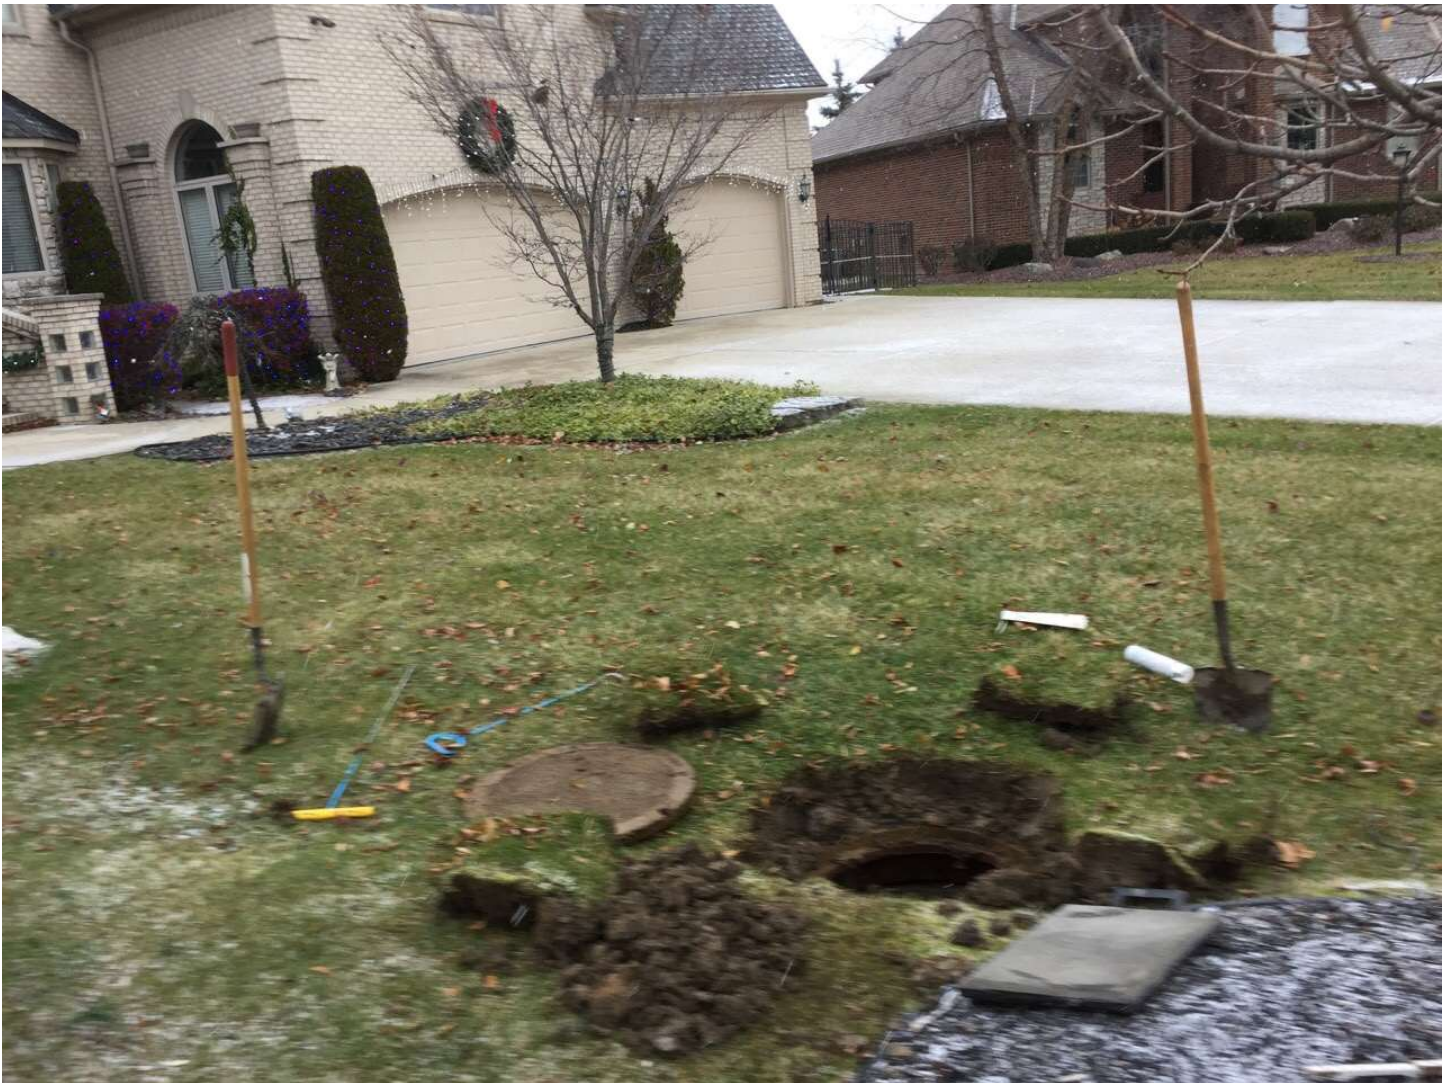
M2-32-P1-32N-P2-15E-3-6S

Recommendation 7	<null>	Recommendation 8	<null>
Manhole Rating	2 – Failure unlikely in 20 years (Good)	Comments	Buried 6"
