Manhole Inspection Form

M1-3-3-6

Manhole Number	M1-3-3-6	Historic Manhole Number	Rosebriar 6
Year Installed	1992	Structure Type	Sanitary Manhole
Street	Rosebriar	Address	26175
Elevation	592.107	Weather	Sunny
Temperature	20°	Ground Condition	Dry
Status	At Surface Grade	Location	Yard Front
Pavment Condition	<null>	Traffic	No Traffic at Location
Inspector 1	Brs	Inspector 2	Kmd
Cover Type	Ej1040a	Number of Cover Holes	Solid Cover
Catch Basin Cover	<null>	Cover Insert	No
Cover Gasket	Yes	Cover Grade	Cover is Below Grade
Grade Dist	6	Cover Fit	Good Fit
Cover Condition	Good	Frame Condition	Fair
Frame Offset	5	Frame Seal Condition	Poor
Frame Seal Inflow	Low	Frame Riser	No
Frame Riser Height	<null>	Frame Riser Material	N/A
Manhole Diameter	48	Manhole Depth	9.75
Chimney Depth	1.2	Chimney Construction	Precast
Chimney Condition	Fair	Chimney Inflow	Low
Cone Shape	Eccentric	Cone Depth	28
Cone Construction	Precast	Cone Condition	Good
Cone Inflow	Low	Cone Defect Location	Wall/Cone Joint

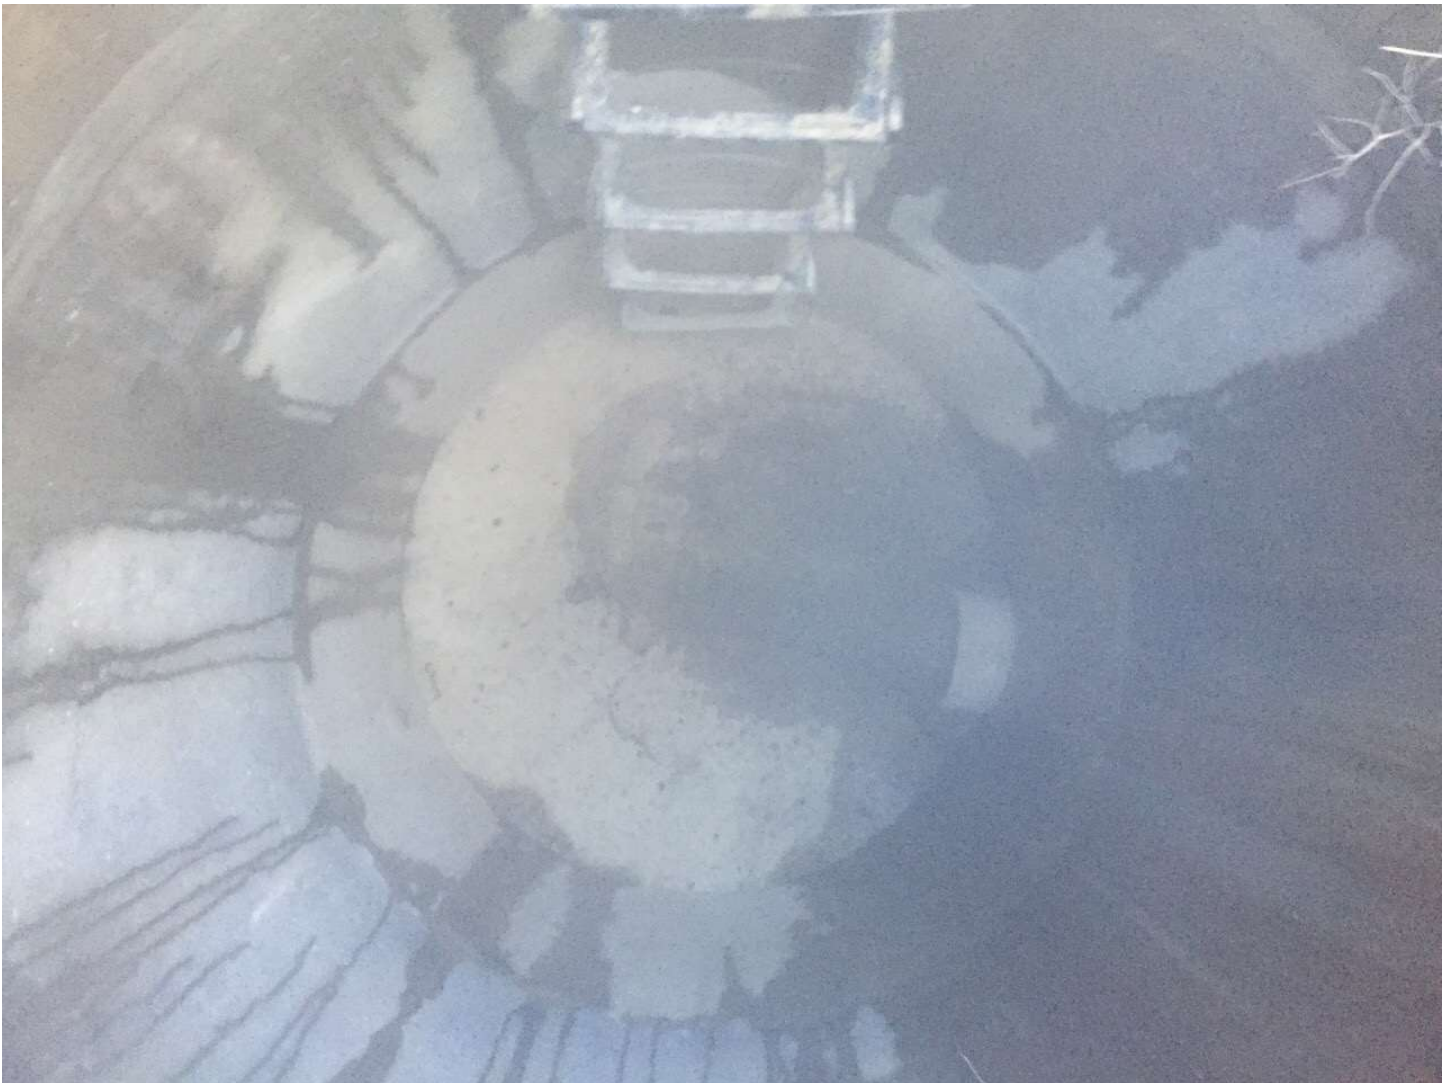
Wall Construction	Precast	Wall Condition	Fair
Wall Inflow	Low	Wall Defect Location	Wall Joint +
Wall Defect Location 2	<null>	Wall Defect Location 3	<null>
Wall Defect Location 4	<null>	Wall Defect Location 5	<null>
Bench Construction	Poured	Bench Condition	Fair
Bench Inflow	None	Channel Construction	Poured
Channel Condition	Fair	Channel Inflow	None
Channel Hydraulics	Good	Channel Exposure	Yes

Recommendation 7	<null>	Recommendation 8	<null>
Manhole Rating	3 – Failure likely in 10 to 20 years (Fair)	Comments	Buried 6"

Pipe 5 Drop	<null>	Pipe 5 Comments	<null>
Pipe 6 Flow	<null>	Pipe 6 Diameter	<null>
Pipe 6 Direction	<null>	Pipe 6 Depth	<null>
Pipe 6 Material	<null>	Pipe 6 Seal Condition	<null>
Pipe 6 Drop	<null>	Pipe 6 Comments	<null>
Recommendation 1	Internal Chimney Seal	Recommendation 2	<null>
Recommendation 3	<null>	Recommendation 4	<null>
Recommendation 5	<null>	Recommendation 6	<null>
