Manhole Inspection Form

M1-5-3-3-3-2-2-1

Manhole Number	M1-5-3-3-3-2-2-1	Historic Manhole Number	Norvell 1
Year Installed	1980	Structure Type	Sanitary Manhole
Street	Norvell	Address	25861
Elevation	591.33	Weather	Sunny
Temperature	70°	Ground Condition	Dry
Status	At Surface Grade	Location	Driveway Concrete
Pavment Condition	Good	Traffic	Driveway
Inspector 1	Pfm	Inspector 2	Kja
Cover Type	Ej 1040	Number of Cover Holes	Solid Cover
Catch Basin Cover	<null>	Cover Insert	No
Cover Gasket	Yes	Cover Grade	Cover is At Grade
Grade Dist	0	Cover Fit	Good Fit
Cover Condition	Good	Frame Condition	Good
Frame Offset	2	Frame Seal Condition	Fair
Frame Seal Inflow	Low	Frame Riser	No
Frame Riser Height	<null>	Frame Riser Material	N/A
Manhole Diameter	48	Manhole Depth	12.4
Chimney Depth	0	Chimney Construction	None
Chimney Condition	<null>	Chimney Inflow	<null>
Cone Shape	Eccentric	Cone Depth	30
Cone Construction	Precast	Cone Condition	Fair
Cone Inflow	Low	Cone Defect Location	Wall/Cone Joint

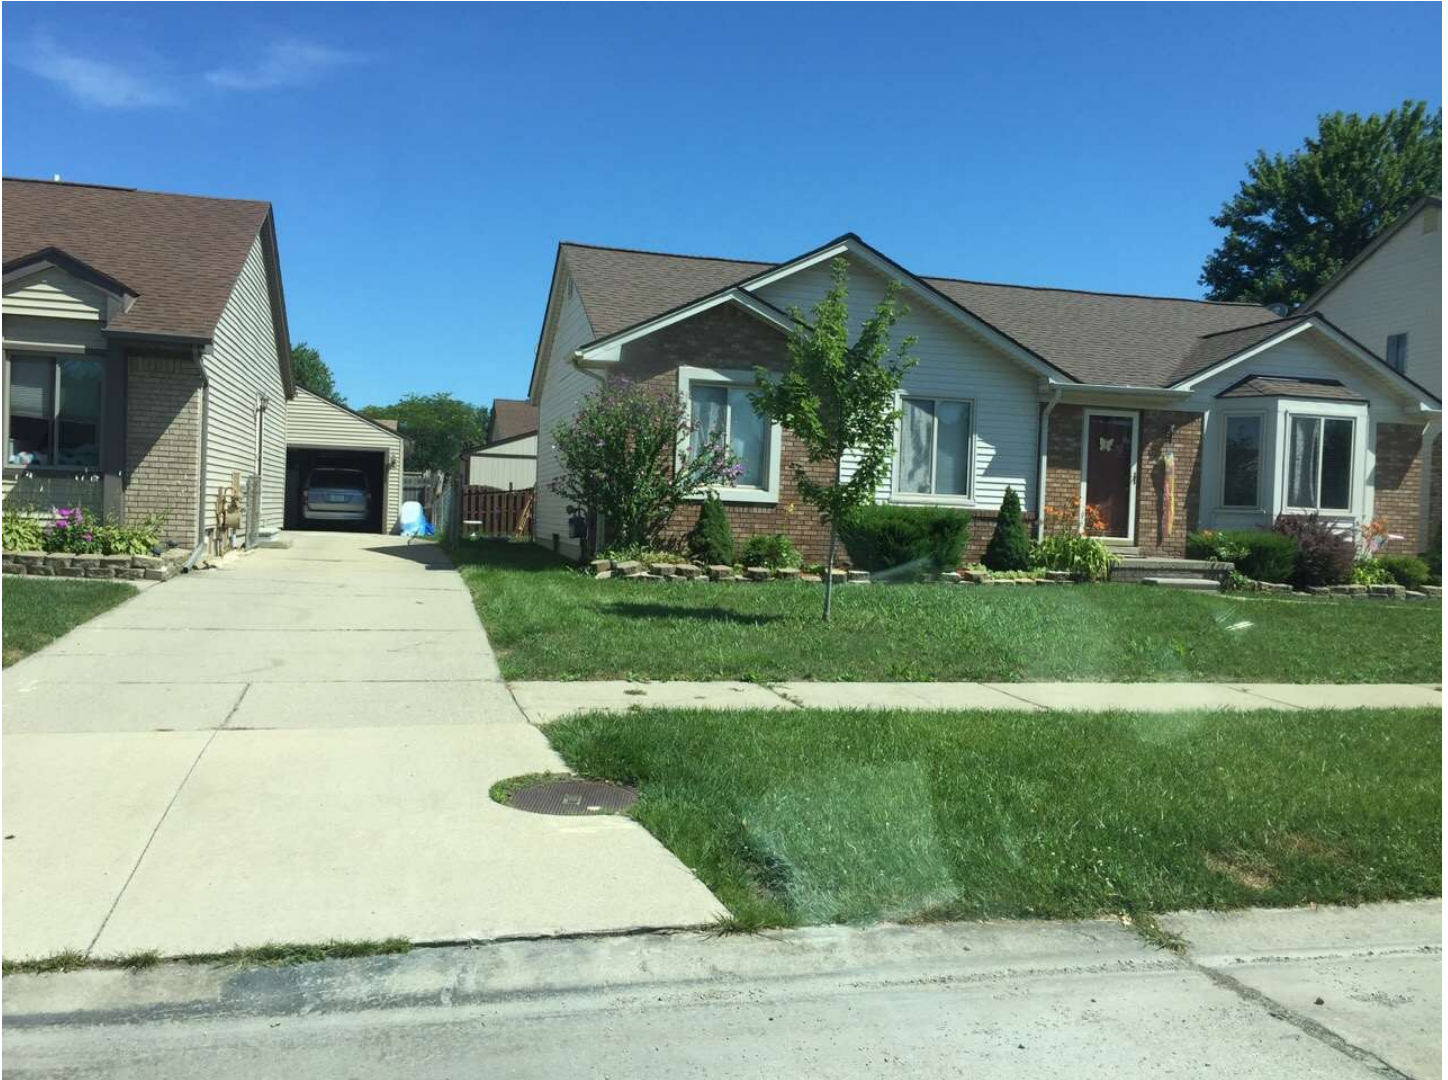
M1-5-3-3-3-2-2-1

Recommendation 7	<null>	Recommendation 8	<null>
Manhole Rating	2 – Failure unlikely in 20 years (Good)	Comments	<null>

Pipe 6 Flow	<null>	Pipe 6 Diameter	<null>
Pipe 6 Direction	<null>	Pipe 6 Depth	<null>
Pipe 6 Material	<null>	Pipe 6 Seal Condition	<null>
Pipe 6 Drop	<null>	Pipe 6 Comments	<null>
Recommendation 1	Internal Chimney Seal	Recommendation 2	<null>
Recommendation 3	<null>	Recommendation 4	<null>
Recommendation 5	<null>	Recommendation 6	<null>
