# Manhole Inspection Form

M1-5-3-3-8A

**ANDERSON, ECKSTEIN AND WESTRICK, INC.**  
51301 Schoenherr Road, Shelby Township, Michigan 48315  
Civil Engineers • Surveyors • Architects 586-726-1234

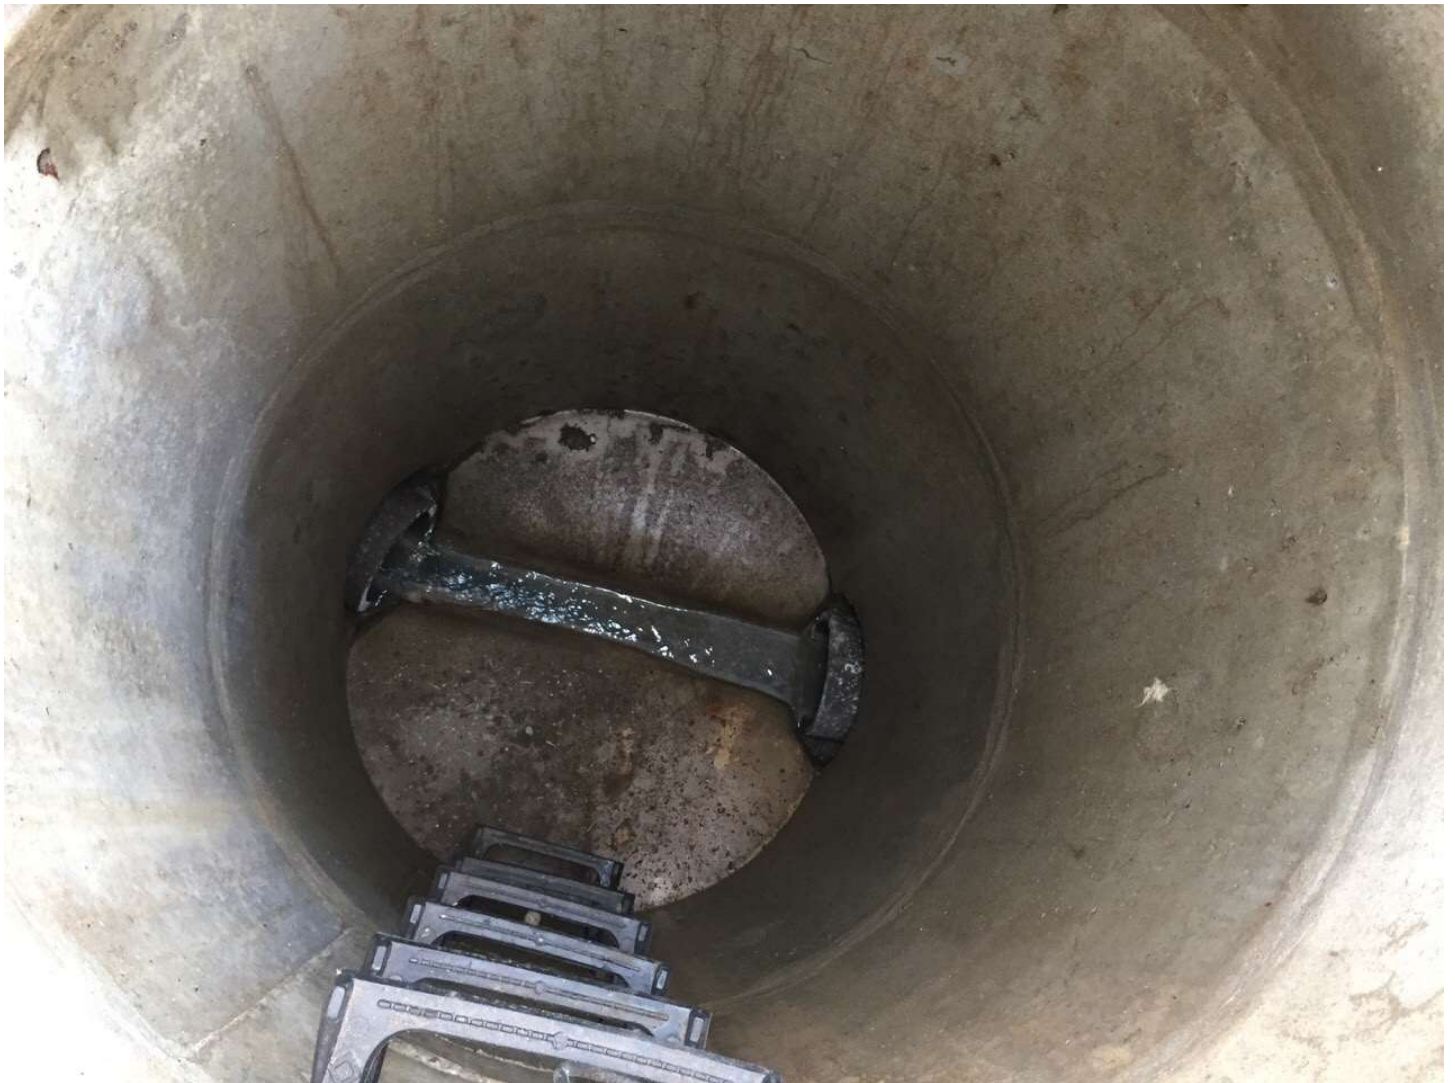
Recommendation 7	<null>	Recommendation 8	<null>
Manhole Rating	3 – Failure likely in 10 to 20 years (Fair)	Comments	<null>

Pipe 6 Flow	<null>	Pipe 6 Diameter	<null>
Pipe 6 Direction	<null>	Pipe 6 Depth	<null>
Pipe 6 Material	<null>	Pipe 6 Seal Condition	<null>
Pipe 6 Drop	<null>	Pipe 6 Comments	<null>
Recommendation 1	Vactor Clean	Recommendation 2	Internal Chimney Seal
Recommendation 3	Point Pipes	Recommendation 4	Raise
Recommendation 5	<null>	Recommendation 6	<null>
