Manhole Inspection Form

M1-5-3-3-13-4-1-2

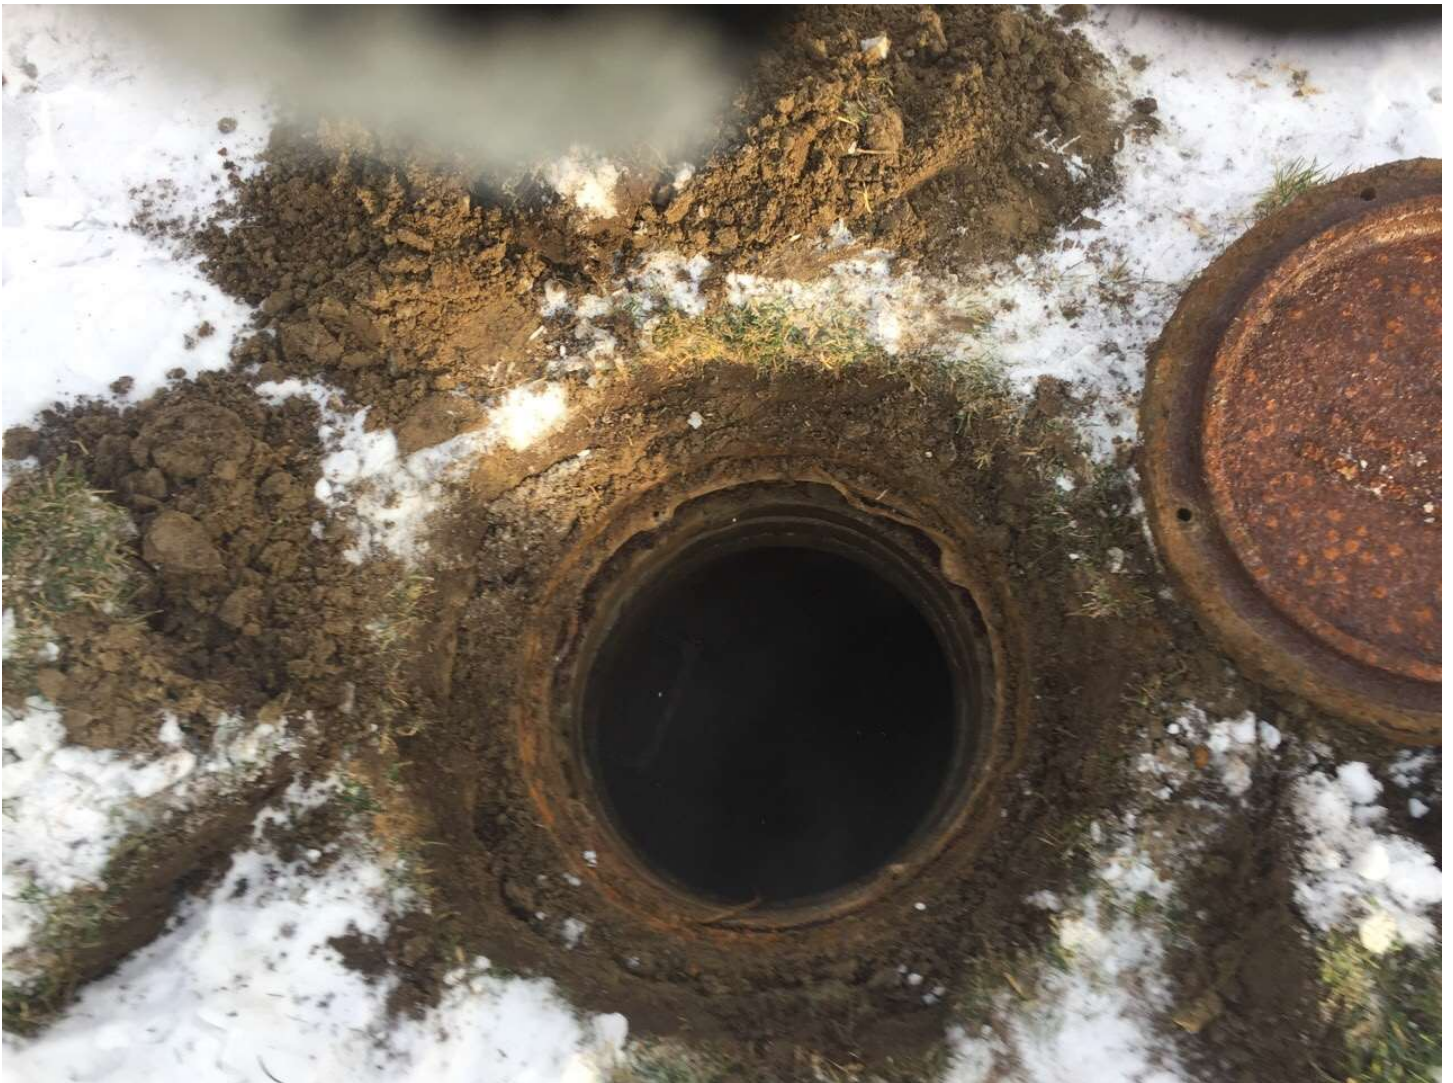
Recommendation 7	<null>	Recommendation 8	<null>
Manhole Rating	2 – Failure unlikely in 20 years (Good)	Comments	Buried 6" next to driveway
