Manhole Inspection Form

M1-5-3-3-17-1-2

Manhole Number: M1-5-3-3-17-1-2
Community: Chesterfield
Inspector Initials: BRS / KMD

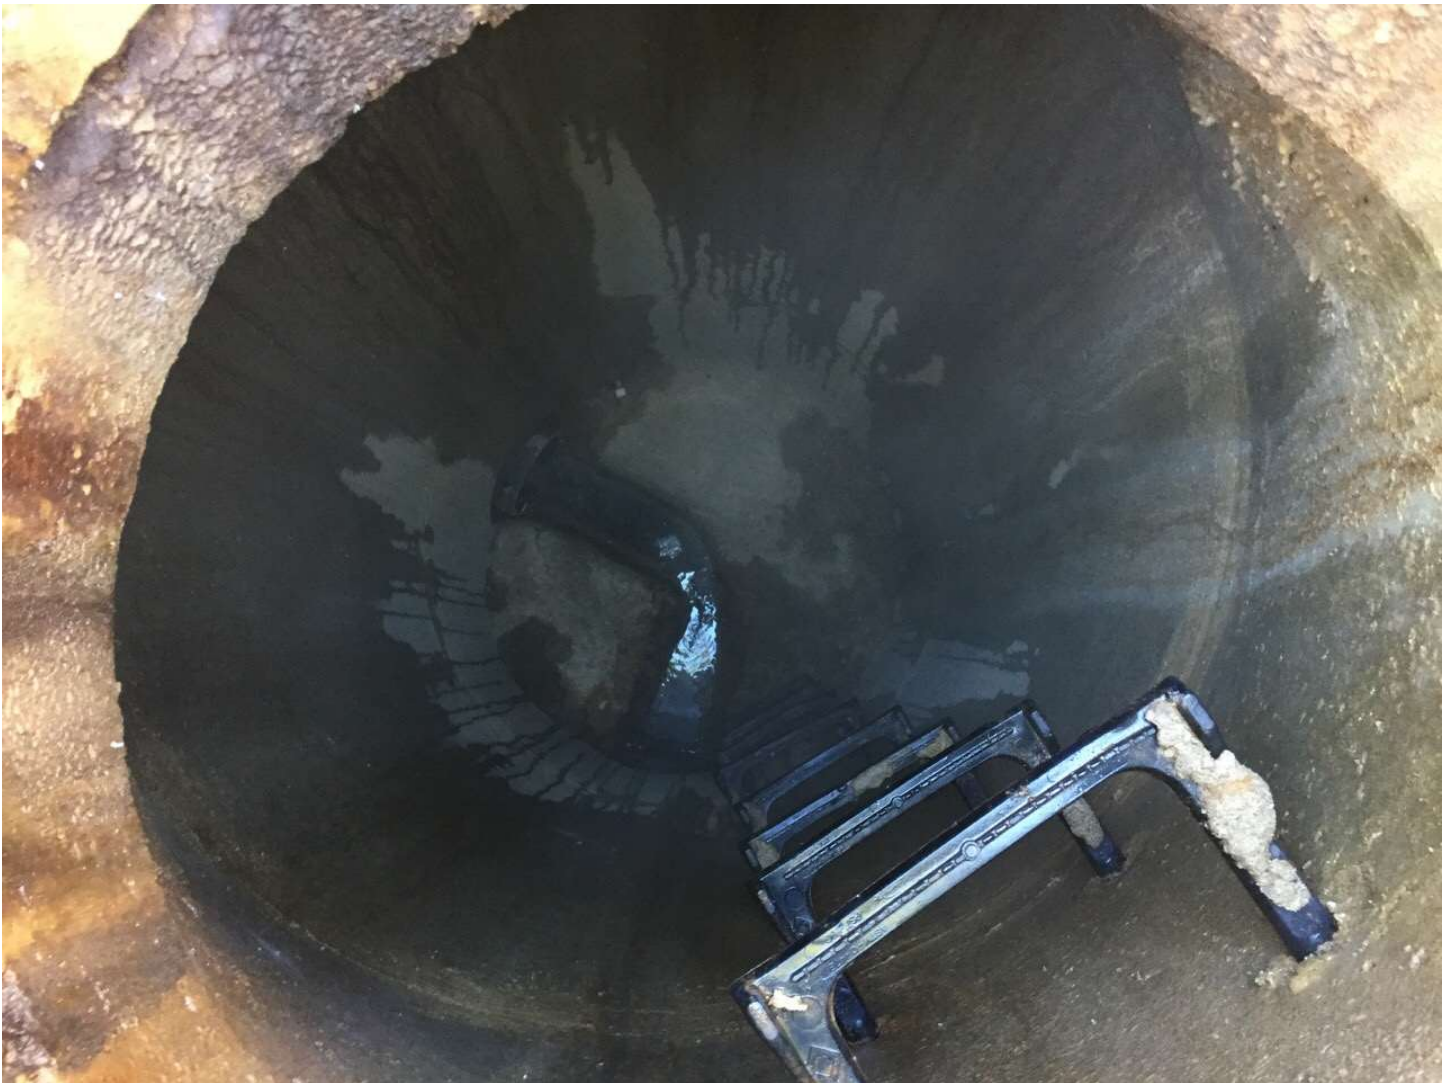
Manhole Number	M1-5-3-3-17-1-2	Historic Manhole Number	Crown 2
Year Installed	1995	Structure Type	Sanitary Manhole
Street	Crown	Address	46130
Elevation	592.554	Weather	Sunny
Temperature	20°	Ground Condition	Frozen
Status	At Surface Grade	Location	Driveway Concrete
Pavment Condition	Fair	Traffic	Driveway
Inspector 1	Kmd	Inspector 2	Brs
Cover Type	Ej1040apt	Number of Cover Holes	Solid Cover
Catch Basin Cover	<null>	Cover Insert	No
Cover Gasket	Yes	Cover Grade	Cover is At Grade
Grade Dist	0	Cover Fit	Good Fit
Cover Condition	Good	Frame Condition	Good
Frame Offset	2	Frame Seal Condition	Fair
Frame Seal Inflow	Low	Frame Riser	No
Frame Riser Height	<null>	Frame Riser Material	N/A
Manhole Diameter	48	Manhole Depth	13.15
Chimney Depth	1	Chimney Construction	Combination- S.C.
Chimney Condition	Good	Chimney Inflow	Low
Cone Shape	Eccentric	Cone Depth	36
Cone Construction	Precast	Cone Condition	Good
Cone Inflow	Low	Cone Defect Location	Wall/Cone Joint

Recommendation 7	<null>	Recommendation 8	<null>
Manhole Rating	2 – Failure unlikely in 20 years (Good)	Comments	Brick and precast chimney.

Pipe 6 Flow	<null>	Pipe 6 Diameter	<null>
Pipe 6 Direction	<null>	Pipe 6 Depth	<null>
Pipe 6 Material	<null>	Pipe 6 Seal Condition	<null>
Pipe 6 Drop	<null>	Pipe 6 Comments	<null>
Recommendation 1	Reset F&C w/Ext. Seal	Recommendation 2	Internal Chimney Seal
Recommendation 3	Seal Wall Joints	Recommendation 4	<null>
Recommendation 5	<null>	Recommendation 6	<null>
