Manhole Inspection Form

M1-5-3-3-21-1

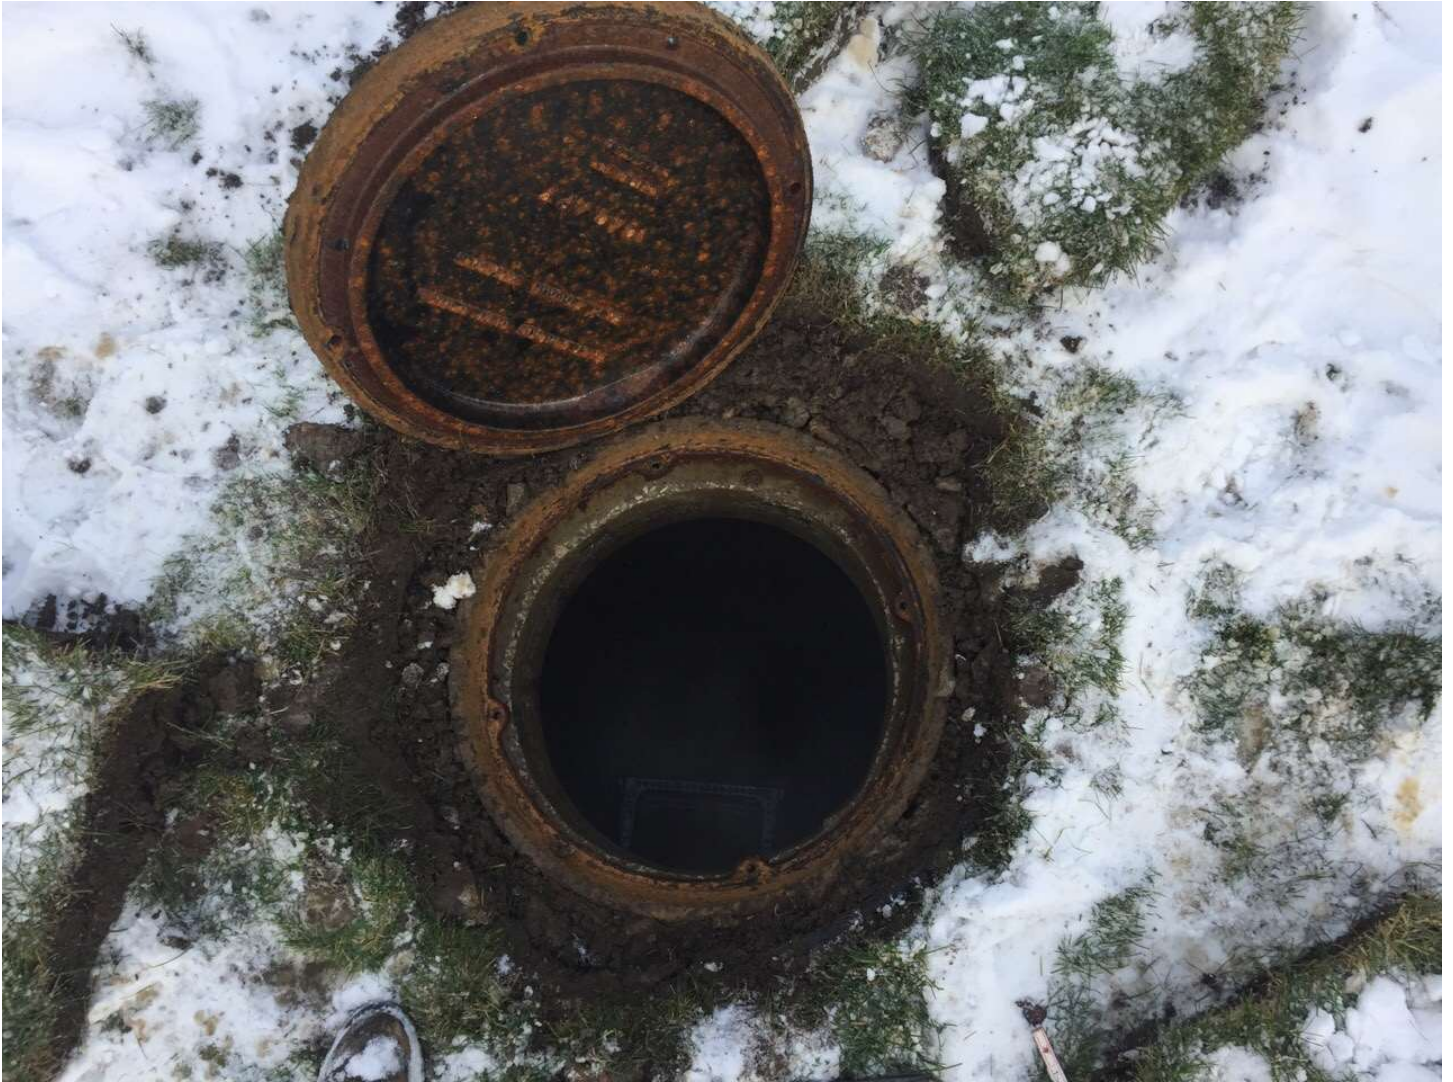
M1-5-3-3-21-1

Recommendation 7	<null>	Recommendation 8	<null>
Manhole Rating	2 – Failure unlikely in 20 years (Good)	Comments	Buried 5"
