Manhole Inspection Form

M1-5-17-10

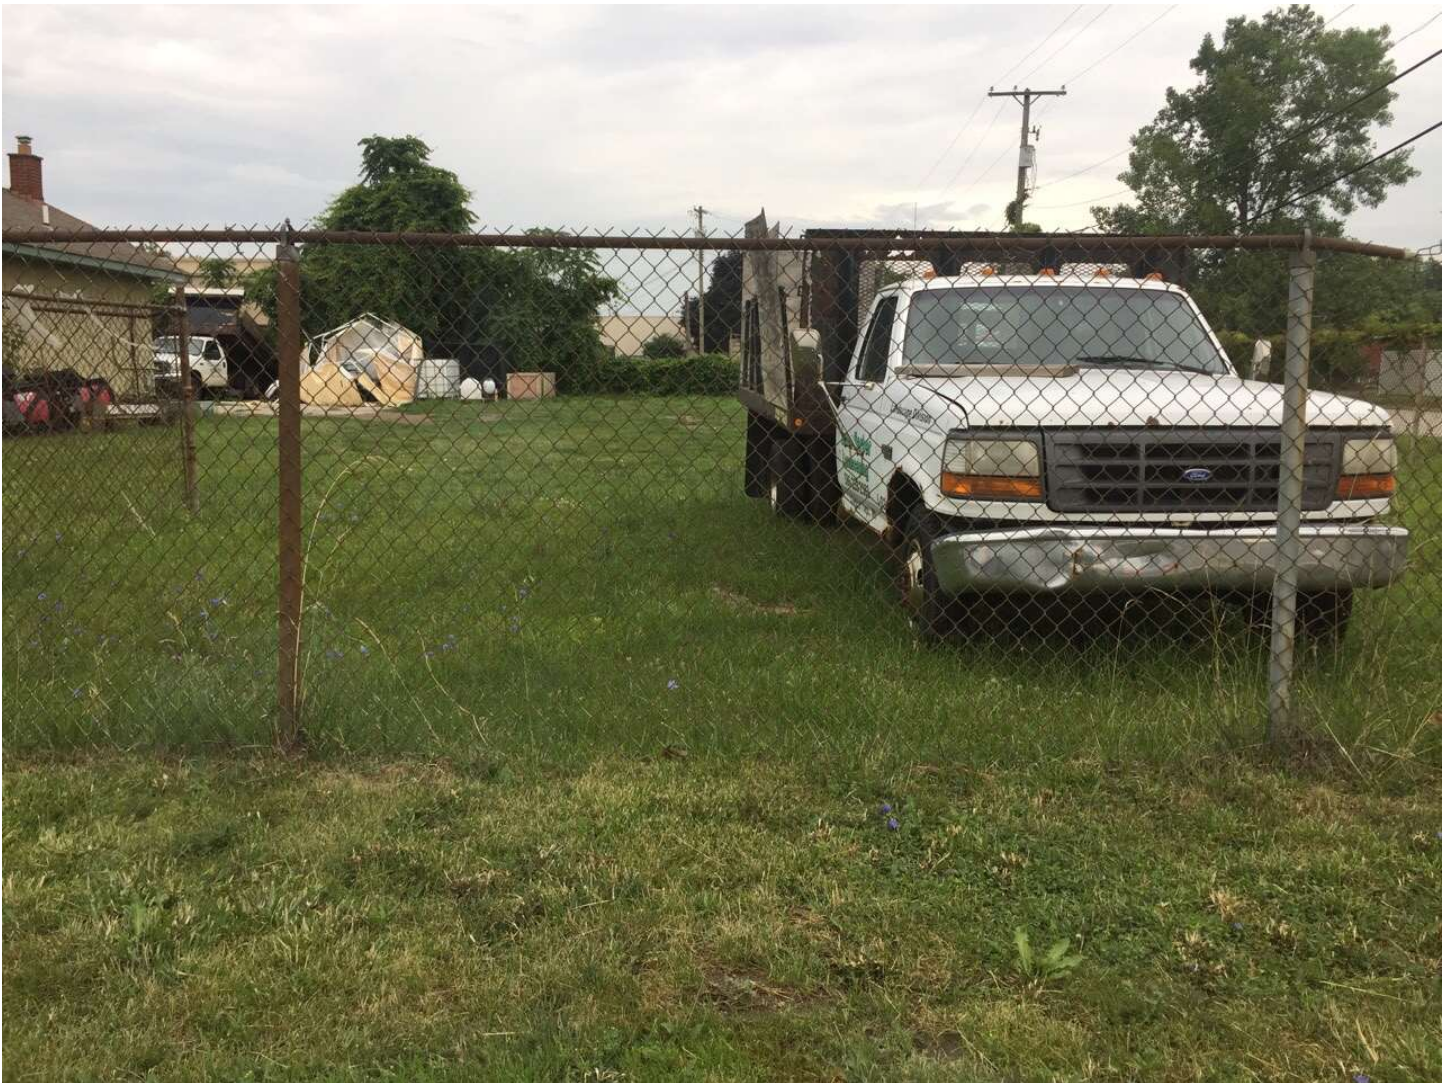
M1-5-17-10

Recommendation 5	<null>	Recommendation 6	<null>
Recommendation 7	<null>	Recommendation 8	<null>
Manhole Rating	<null>	Comments	Fenced in
