# Manhole Inspection Form

M1-7-6-4

Address: 26523 Birchcrest

Community: Chesterfield

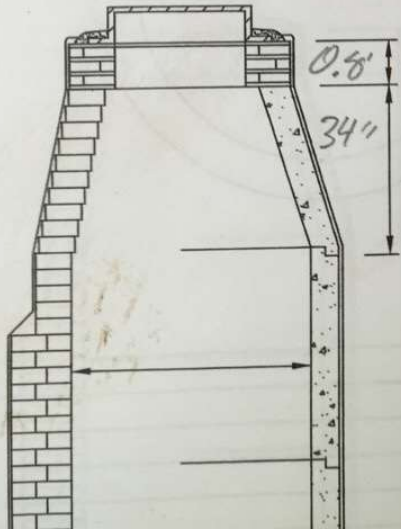
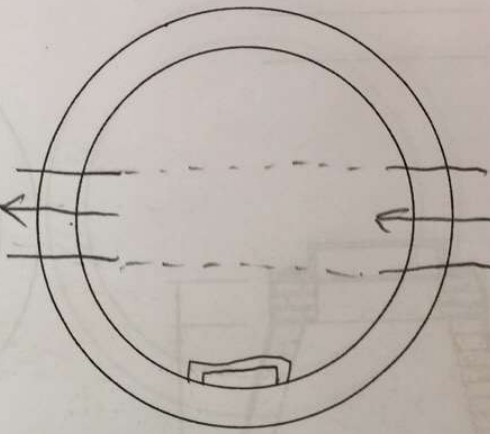
W  
Type  
? seal  
14.05'  
? dia

E  
Truss  
13.90'  
? dia
