Manhole Inspection Form

M1-16-7-1-2

| Manhole Number | M1-16-7-1-2 | Historic Manhole Number | Annagrove 1 |

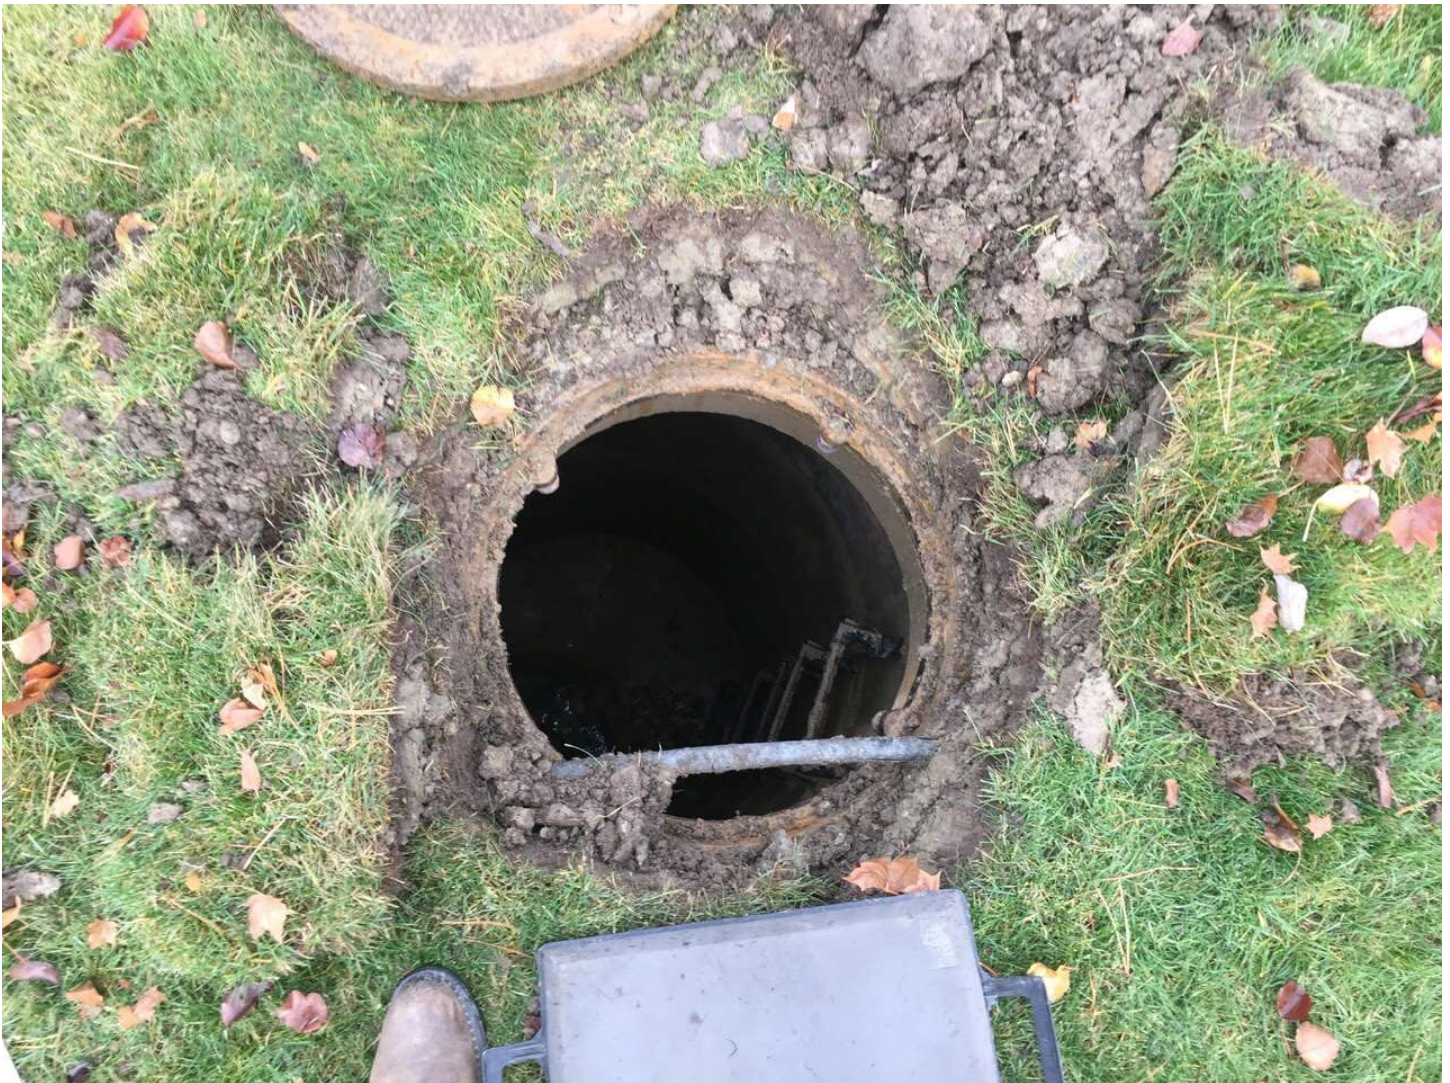
| Manhole Rating | 2 – Failure unlikely in 20 years (Good) | Comments | Buried 6" |
