Manhole Inspection Form

M1-16-7-2

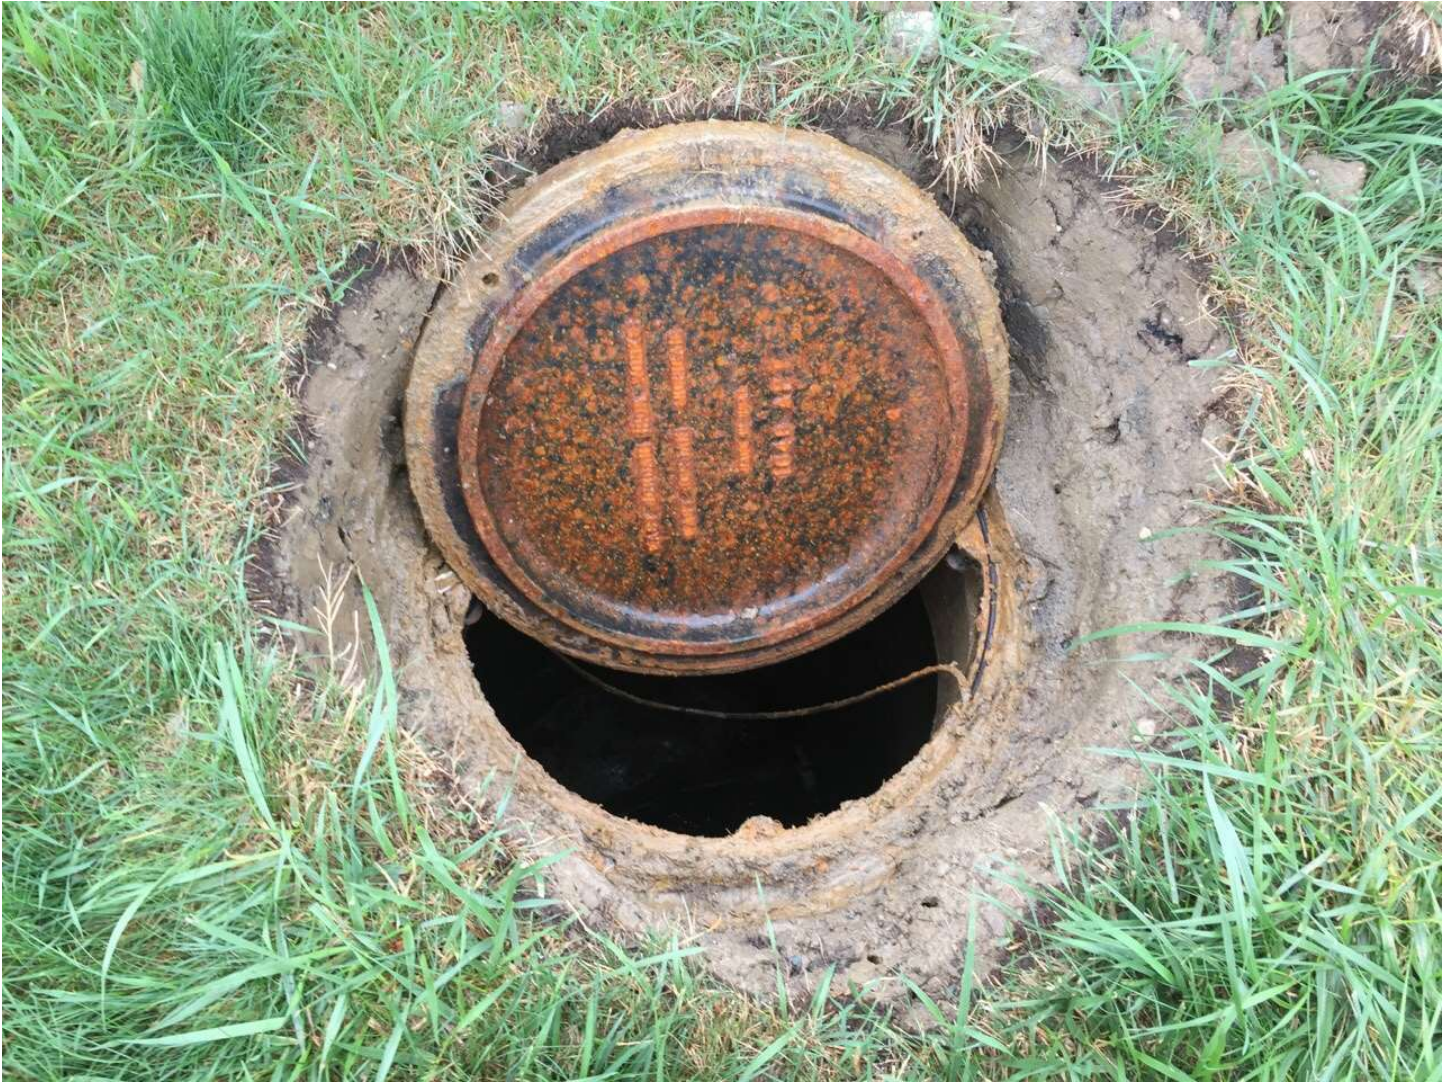
Manhole Number	M1-16-7-2	Historic Manhole Number	Jackgrove 4B
Year Installed	1991	Structure Type	Sanitary Manhole
Street	Jackgrove	Address	26225
Elevation	594.572	Weather	Overcast
Temperature	80°	Ground Condition	Damp
Status	At Surface Grade	Location	Yard Front
Pavment Condition	N/A	Traffic	No Traffic at Location
Inspector 1	Rbc	Inspector 2	AC
Cover Type	EJ 1040APT	Number of Cover Holes	3 - 5
Catch Basin Cover	N/A	Cover Insert	No
Cover Gasket	Yes	Cover Grade	Cover is Below Grade
Grade Dist	14	Cover Fit	Good Fit
Cover Condition	Good	Frame Condition	Fair
Frame Offset	<null>	Frame Seal Condition	Poor
Frame Seal Inflow	Moderate	Frame Riser	No
Frame Riser Height	<null>	Frame Riser Material	<null>
Manhole Diameter	48	Manhole Depth	11.75
Chimney Depth	0.9	Chimney Construction	Block
Chimney Condition	Fair	Chimney Inflow	Moderate
Cone Shape	<null>	Cone Depth	32
Cone Construction	Precast	Cone Condition	Fair
Cone Inflow	Low	Cone Defect Location	Wall/Cone Joint

Wall Construction	Precast	Wall Condition	Fair
Wall Inflow	None	Wall Defect Location	<null>
Wall Defect Location 2	<null>	Wall Defect Location 3	<null>
Wall Defect Location 4	<null>	Wall Defect Location 5	<null>
Bench Construction	Poured	Bench Condition	Fair
Bench Inflow	None	Channel Construction	Poured
Channel Condition	Good	Channel Inflow	None
Channel Hydraulics	Good	Channel Exposure	Fully

Recommendation 7	<null>	Recommendation 8	<null>
Manhole Rating	4 – Failure likely in 5 to 10 years (Poor)	Comments	Used Schoenstedt, could not locate

Pipe 6 Flow	<null>	Pipe 6 Diameter	<null>
Pipe 6 Direction	<null>	Pipe 6 Depth	<null>
Pipe 6 Material	<null>	Pipe 6 Seal Condition	<null>
Pipe 6 Drop	<null>	Pipe 6 Comments	<null>
Recommendation 1	Vactor Clean	Recommendation 2	Internal Chimney Seal
Recommendation 3	Seal Wall Joints	Recommendation 4	Point Pipes
Recommendation 5	Raise	Recommendation 6	<null>
