# Manhole Inspection Form

M1-16-10-3

Manhole Number	M1-16-10-3	Historic Manhole Number	Knollwood 3
Year Installed	1991	Structure Type	Sanitary Manhole
Street	Knollwood	Address	26181
Elevation	597.162	Weather	Overcast
Temperature	65°	Ground Condition	Wet
Status	At Surface Grade	Location	Yard Front
Pavment Condition	N/A	Traffic	No Traffic at Location
Inspector 1	Rbc	Inspector 2	Cad
Cover Type	EJ 1040APT	Number of Cover Holes	3 - 5
Catch Basin Cover	N/A	Cover Insert	No
Cover Gasket	Yes	Cover Grade	Cover is Below Grade
Grade Dist	24	Cover Fit	Good Fit
Cover Condition	Good	Frame Condition	Good
Frame Offset	<null>	Frame Seal Condition	Fair
Frame Seal Inflow	Low	Frame Riser	Yes
Frame Riser Height	15	Frame Riser Material	Concrete
Manhole Diameter	48	Manhole Depth	12.75
Chimney Depth	1.5	Chimney Construction	Poured
Chimney Condition	Fair	Chimney Inflow	None
Cone Shape	<null>	Cone Depth	30
Cone Construction	Precast	Cone Condition	Good
Cone Inflow	None	Cone Defect Location	Wall/Cone Joint

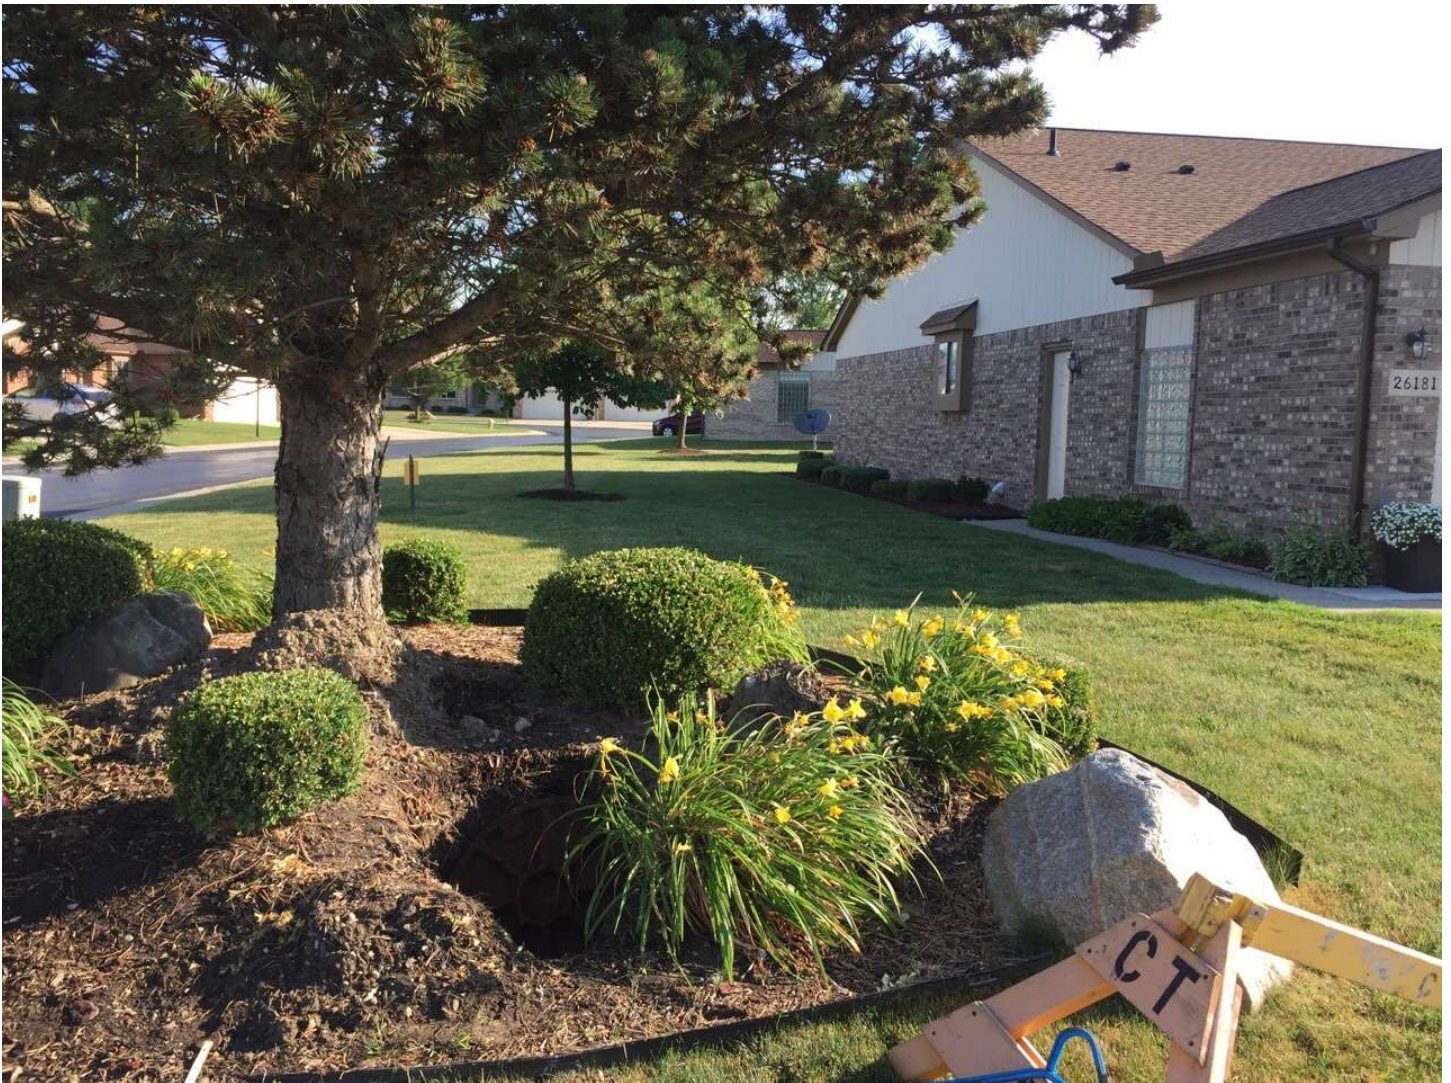
Recommendation 7	<null>	Recommendation 8	<null>
Manhole Rating	4 – Failure likely in 5 to 10 years (Poor)	Comments	Very deep in landscaping area.

Pipe 6 Flow	<null>	Pipe 6 Diameter	<null>
Pipe 6 Direction	<null>	Pipe 6 Depth	<null>
Pipe 6 Material	<null>	Pipe 6 Seal Condition	<null>
Pipe 6 Drop	<null>	Pipe 6 Comments	<null>
Recommendation 1	Vactor Clean	Recommendation 2	Internal Chimney Seal
Recommendation 3	Point Pipes	Recommendation 4	Seal Wall Joints
Recommendation 5	Raise	Recommendation 6	<null>
