Manhole Inspection Form

M1-16-31

ANDERSON, ECKSTEIN AND WESTRICK, INC.
51301 Schoenherr Road, Shelby Township, Michigan 48315
Civil Engineers • Surveyors • Architects 586-726-1234

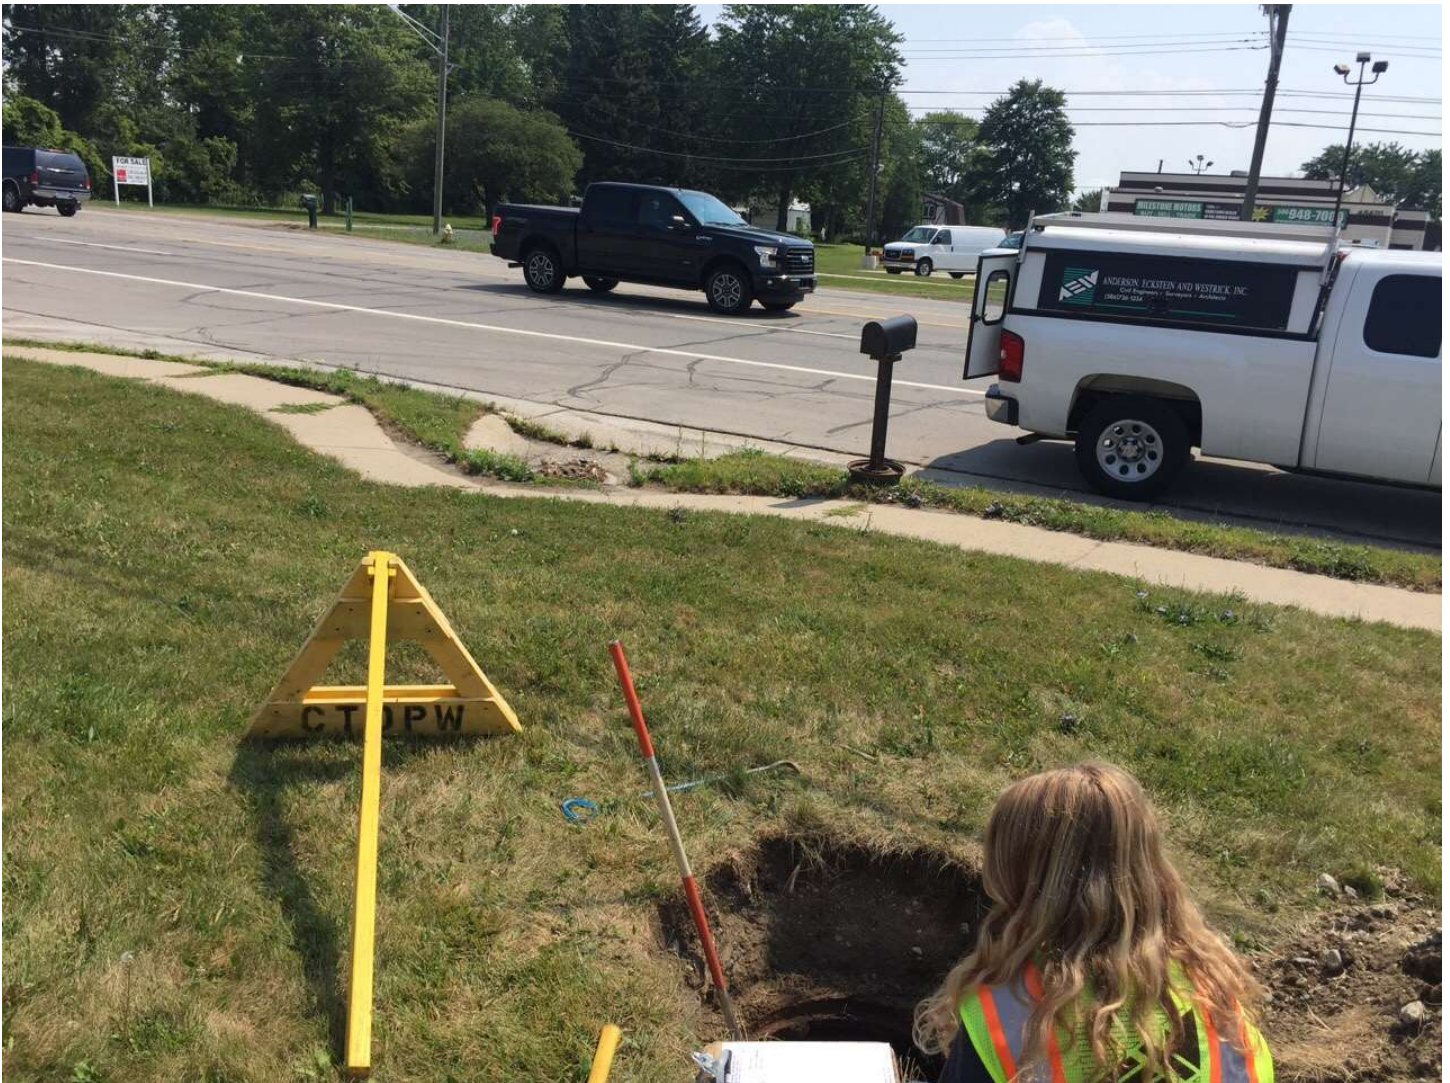
M1-16-31

Wall Construction	Precast	Wall Condition	Fair
Wall Inflow	Moderate	Wall Defect Location	Wall Joint
Wall Defect Location 2	<null>	Wall Defect Location 3	<null>
Wall Defect Location 4	<null>	Wall Defect Location 5	<null>
Bench Construction	Poured	Bench Condition	Fair
Bench Inflow	Low	Channel Construction	Poured
Channel Condition	Fair	Channel Inflow	None
Channel Hydraulics	Poor	Channel Exposure	Fully

Recommendation 7	<null>	Recommendation 8	<null>
Manhole Rating	4 – Failure likely in 5 to 10 years (Poor)	Comments	<null>

Pipe 6 Flow	<null>	Pipe 6 Diameter	<null>
Pipe 6 Direction	<null>	Pipe 6 Depth	<null>
Pipe 6 Material	<null>	Pipe 6 Seal Condition	<null>
Pipe 6 Drop	<null>	Pipe 6 Comments	<null>
Recommendation 1	Vactor Clean	Recommendation 2	Reset F&C w/Ext. Seal
Recommendation 3	Seal Wall Joints	Recommendation 4	Point Pipes
Recommendation 5	Raise	Recommendation 6	<null>
