# Manhole Inspection Form

M1-16-36-P5-10E-P6-3-0

Manhole Number	M1-16-36-P5-10E-P6-3-0	Historic Manhole Number	Callens 10
Year Installed	1977	Structure Type	Sanitary Manhole
Street	Oak brooke	Address	49961
Elevation	581.278	Weather	Overcast
Temperature	40°	Ground Condition	Wet
Status	At Surface Grade	Location	Paved Concrete
Pavment Condition	Fair	Traffic	Two Lane Road
Inspector 1	Kmd	Inspector 2	Brs
Cover Type	EJ1040apt	Number of Cover Holes	Solid Cover
Catch Basin Cover	N/A	Cover Insert	No
Cover Gasket	Yes	Cover Grade	Cover is At Grade
Grade Dist	0	Cover Fit	Good Fit
Cover Condition	Good	Frame Condition	Good
Frame Offset	<null>	Frame Seal Condition	Good
Frame Seal Inflow	None	Frame Riser	No
Frame Riser Height	<null>	Frame Riser Material	N/A
Manhole Diameter	60	Manhole Depth	22.05
Chimney Depth	2	Chimney Construction	Combination- S.C.
Chimney Condition	Good	Chimney Inflow	None
Cone Shape	Eccentric	Cone Depth	20
Cone Construction	Precast	Cone Condition	Good

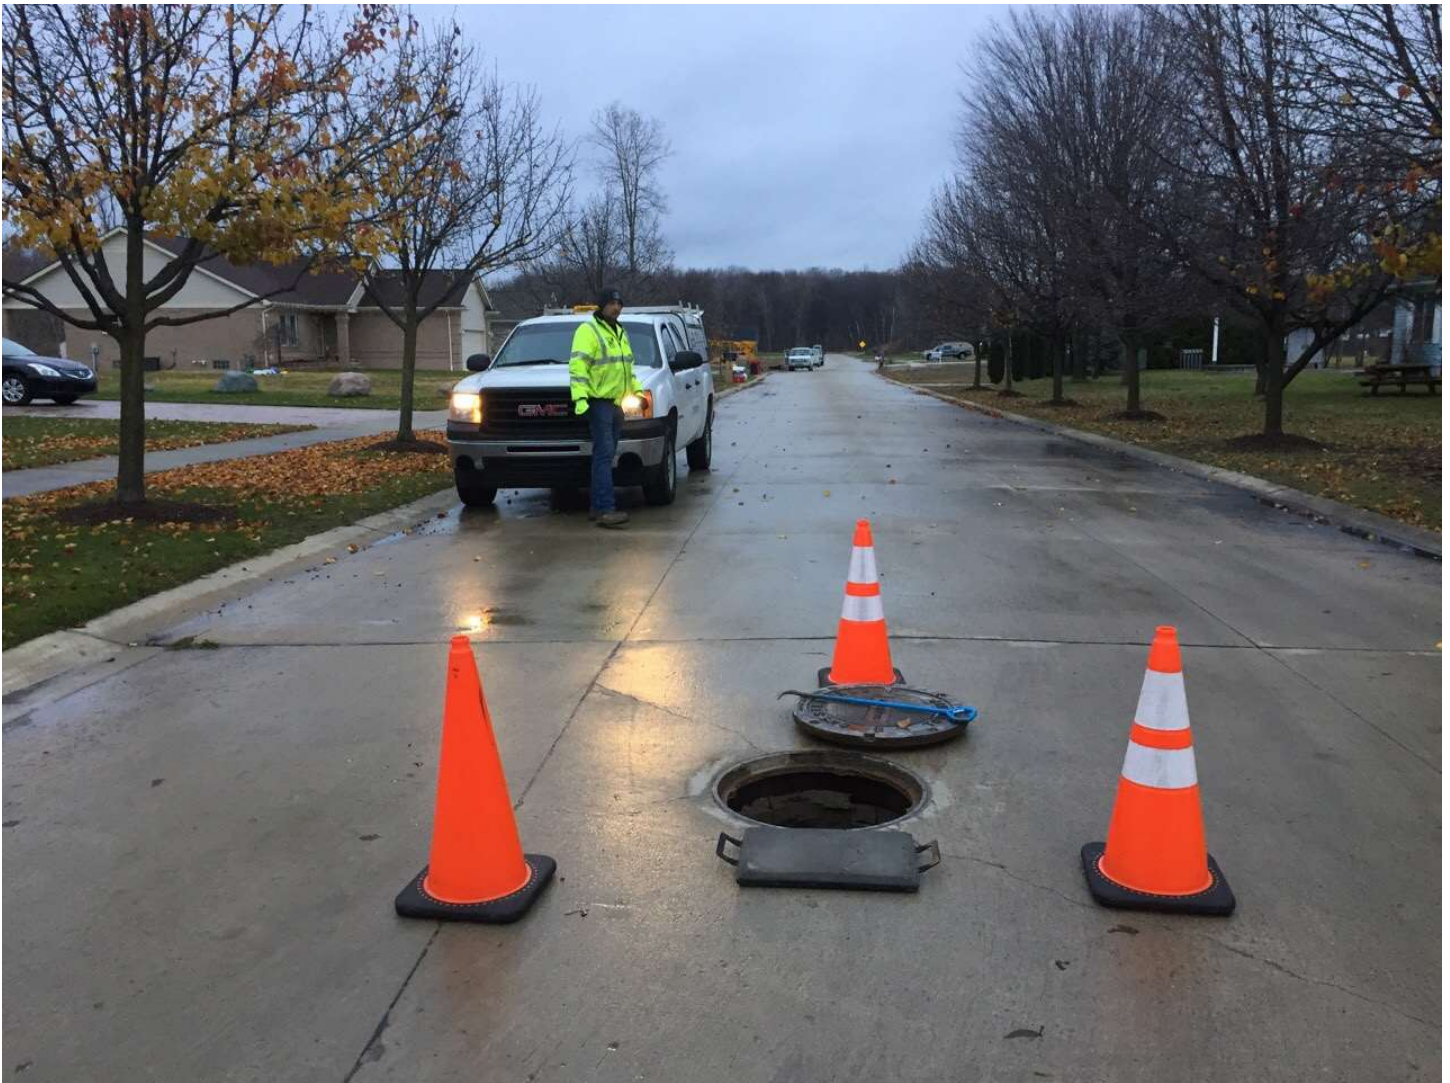
Recommendation 5	<null>	Recommendation 6	<null>
Recommendation 7	<null>	Recommendation 8	<null>
Manhole Rating	2 – Failure unlikely in 20 years (Good)	Comments	Gasket missing. Brick and block chimney. 2 cones first is 20" opens to 48" diameter second opens to 60" diameter.
