# Manhole Inspection Form

M1-30-51-3-2

Manhole Number	M1-30-51-3-2	Historic Manhole Number	Colette 2
Year Installed	1995	Structure Type	Sanitary Manhole
Street	Colette	Address	53824
Elevation	627.684	Weather	Sunny
Temperature	35°	Ground Condition	Dry
Status	At Surface Grade	Location	Yard Front
Pavment Condition	<null>	Traffic	<null>
Inspector 1	Brs	Inspector 2	Kmd
Cover Type	Ej1040apt	Number of Cover Holes	Solid Cover
Catch Basin Cover	<null>	Cover Insert	No
Cover Gasket	Yes	Cover Grade	Cover is At Grade
Grade Dist	0	Cover Fit	Good Fit
Cover Condition	Good	Frame Condition	Good
Frame Offset	<null>	Frame Seal Condition	Good
Frame Seal Inflow	None	Frame Riser	No
Frame Riser Height	<null>	Frame Riser Material	N/A
Manhole Diameter	48	Manhole Depth	8.3
Chimney Depth	0.5	Chimney Construction	Precast
Chimney Condition	Good	Chimney Inflow	None
Cone Shape	Eccentric	Cone Depth	38
Cone Construction	Precast	Cone Condition	Good
Cone Inflow	None	Cone Defect Location	<null>

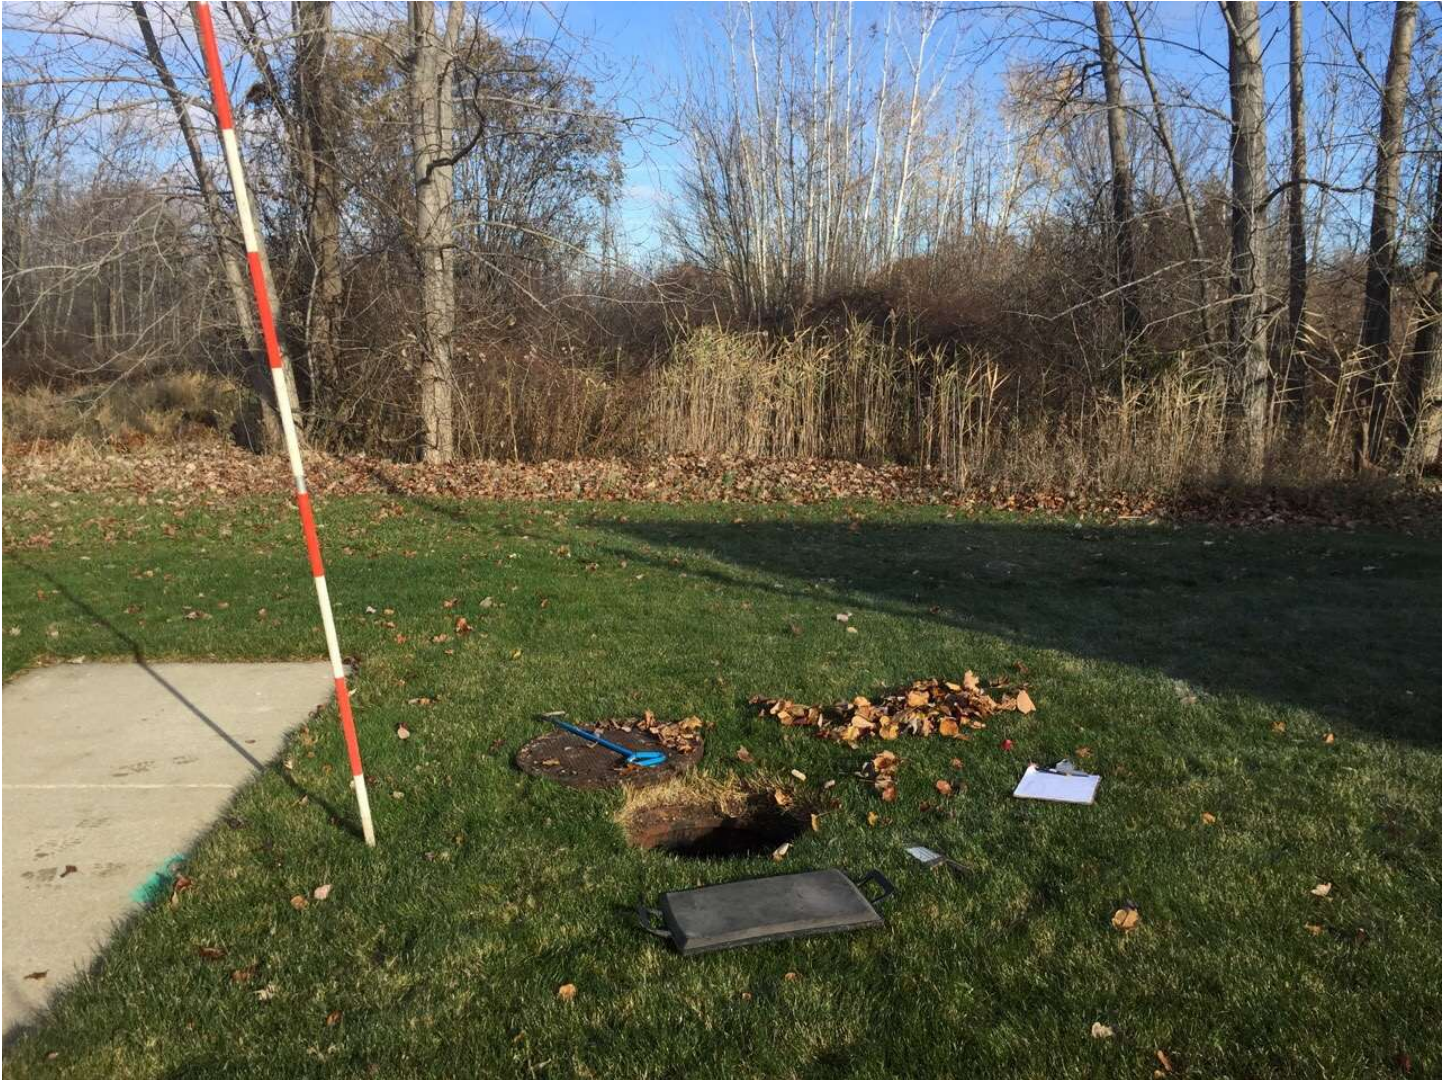
Recommendation 7	<null>	Recommendation 8	<null>
Manhole Rating	2 – Failure unlikely in 20 years (Good)	Comments	Truss pipe
