Manhole Inspection Form

M2-16-14-36-9-1

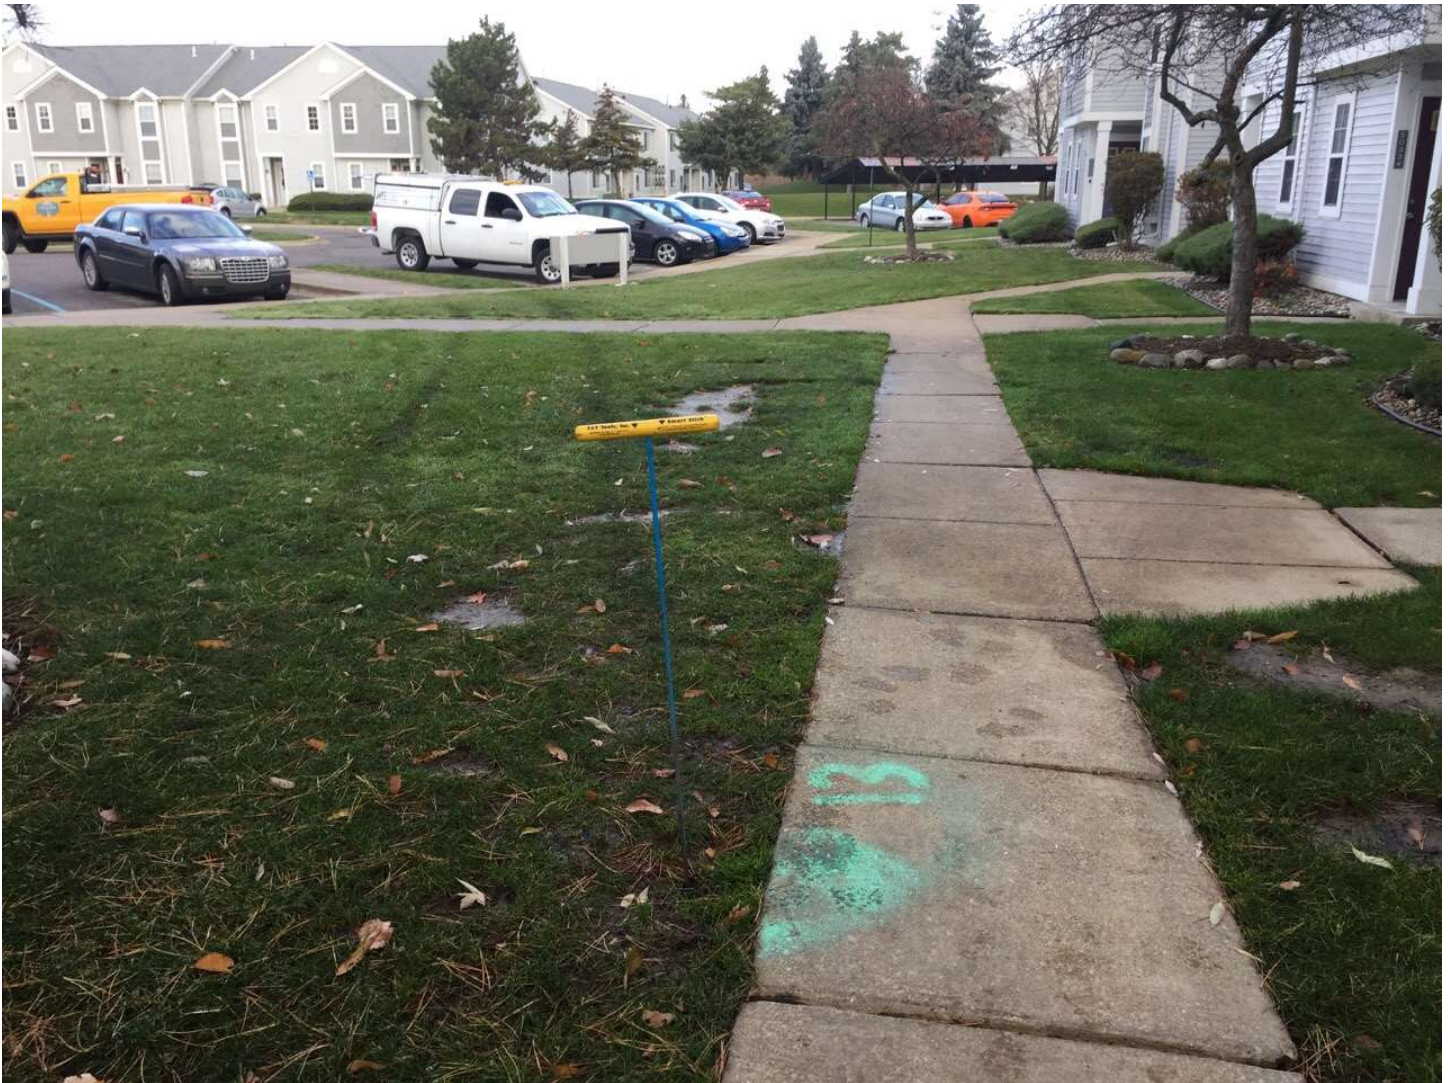
M2-16-14-36-9-1

Recommendation 7	<null>	Recommendation 8	<null>
Manhole Rating	<null>	Comments	Buried 10", partially under walk. (Still buried 7-31-2017)
