Manhole Inspection Form

M2-16-24

| Street | Sugarbush -Remington | Address | 29698 |

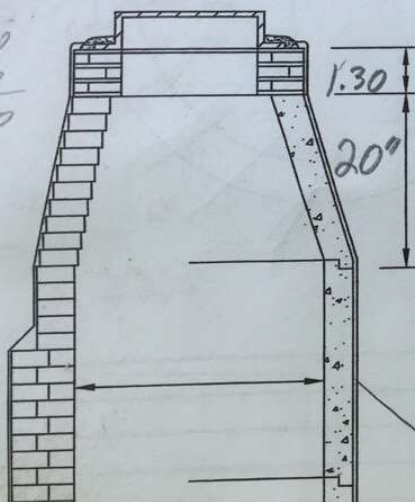
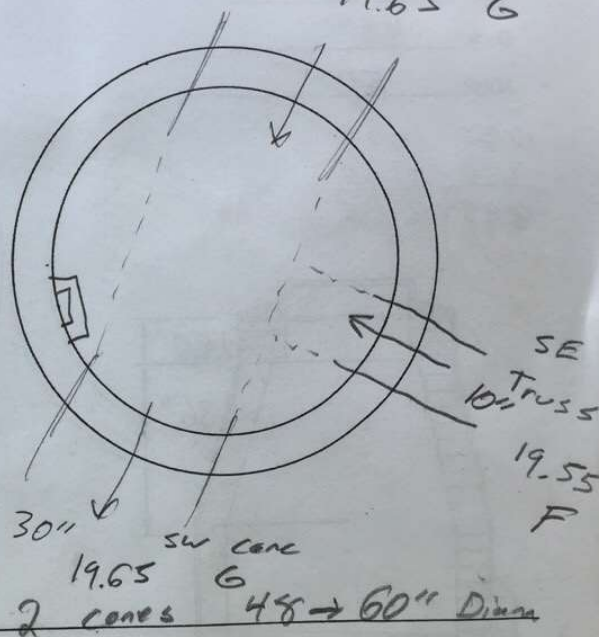
NE conc
30" 19.65 G

2 cones 48 → 60" Dia
