Manhole Inspection Form

M2-16-25-5-P4-3-2

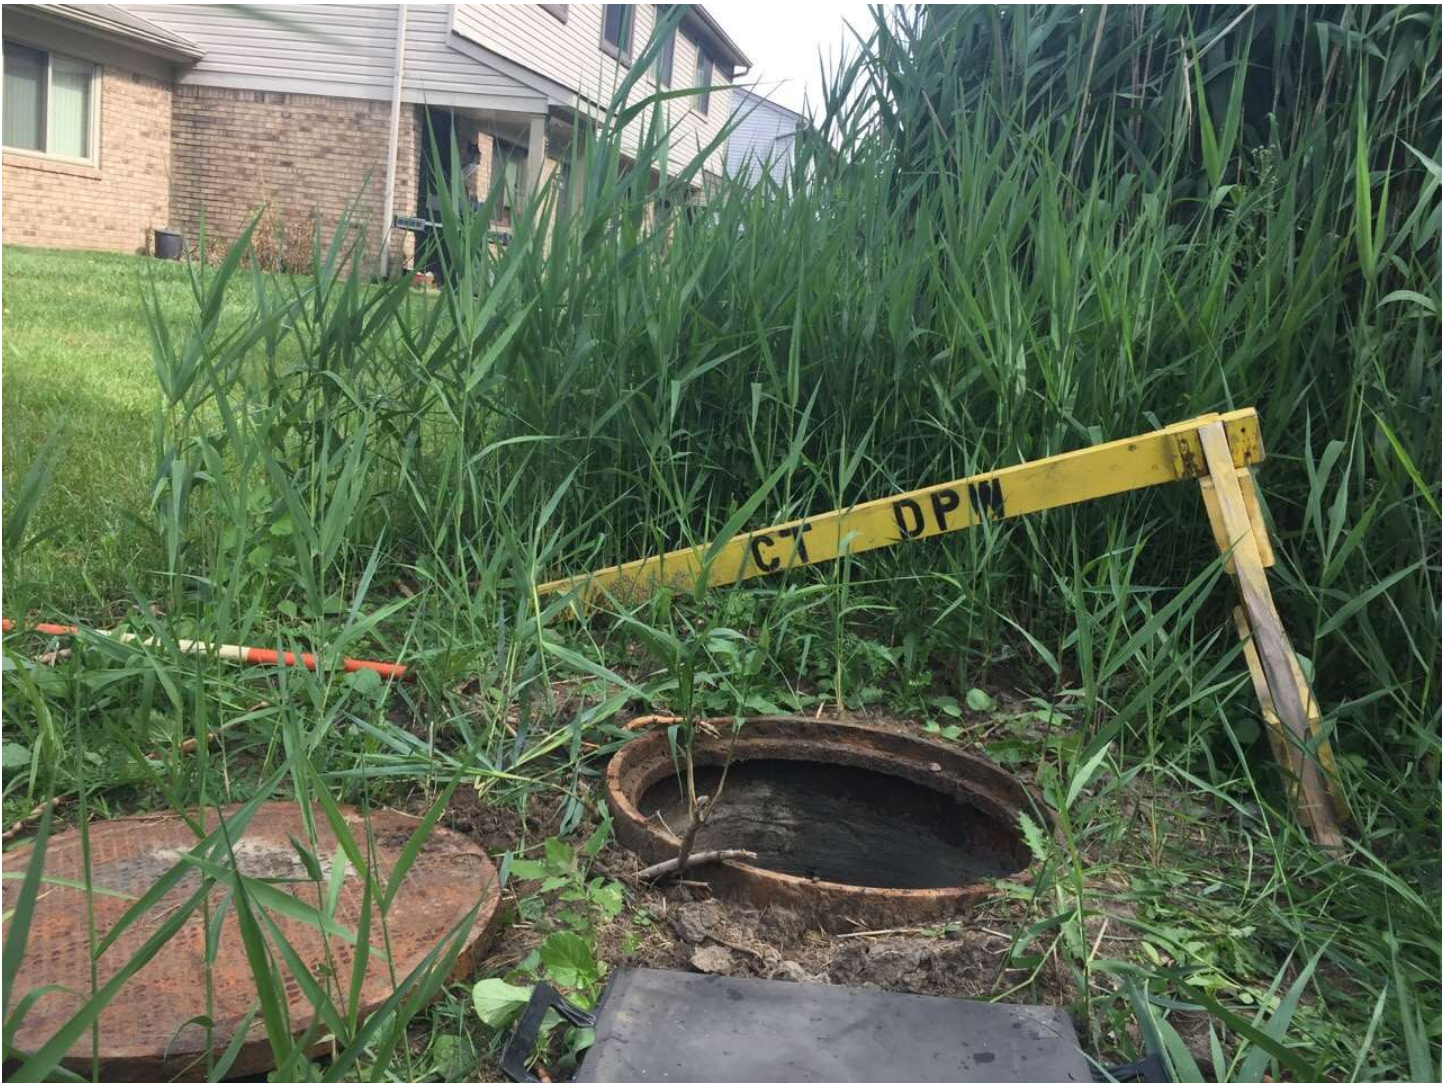
Recommendation 7	<null>	Recommendation 8	<null>
Manhole Rating	2 – Failure unlikely in 20 years (Good)	Comments	Brick and precast built chimney.

Pipe 6 Flow	<null>	Pipe 6 Diameter	<null>
Pipe 6 Direction	<null>	Pipe 6 Depth	<null>
Pipe 6 Material	<null>	Pipe 6 Seal Condition	<null>
Pipe 6 Drop	<null>	Pipe 6 Comments	<null>
Recommendation 1	Point Pipes	Recommendation 2	Internal Chimney Seal
Recommendation 3	<null>	Recommendation 4	<null>
Recommendation 5	<null>	Recommendation 6	<null>
