Manhole Inspection Form

M2-16-25-5-P4-18-3W-1

Community: Chesterfield

Address: 51020 West Village

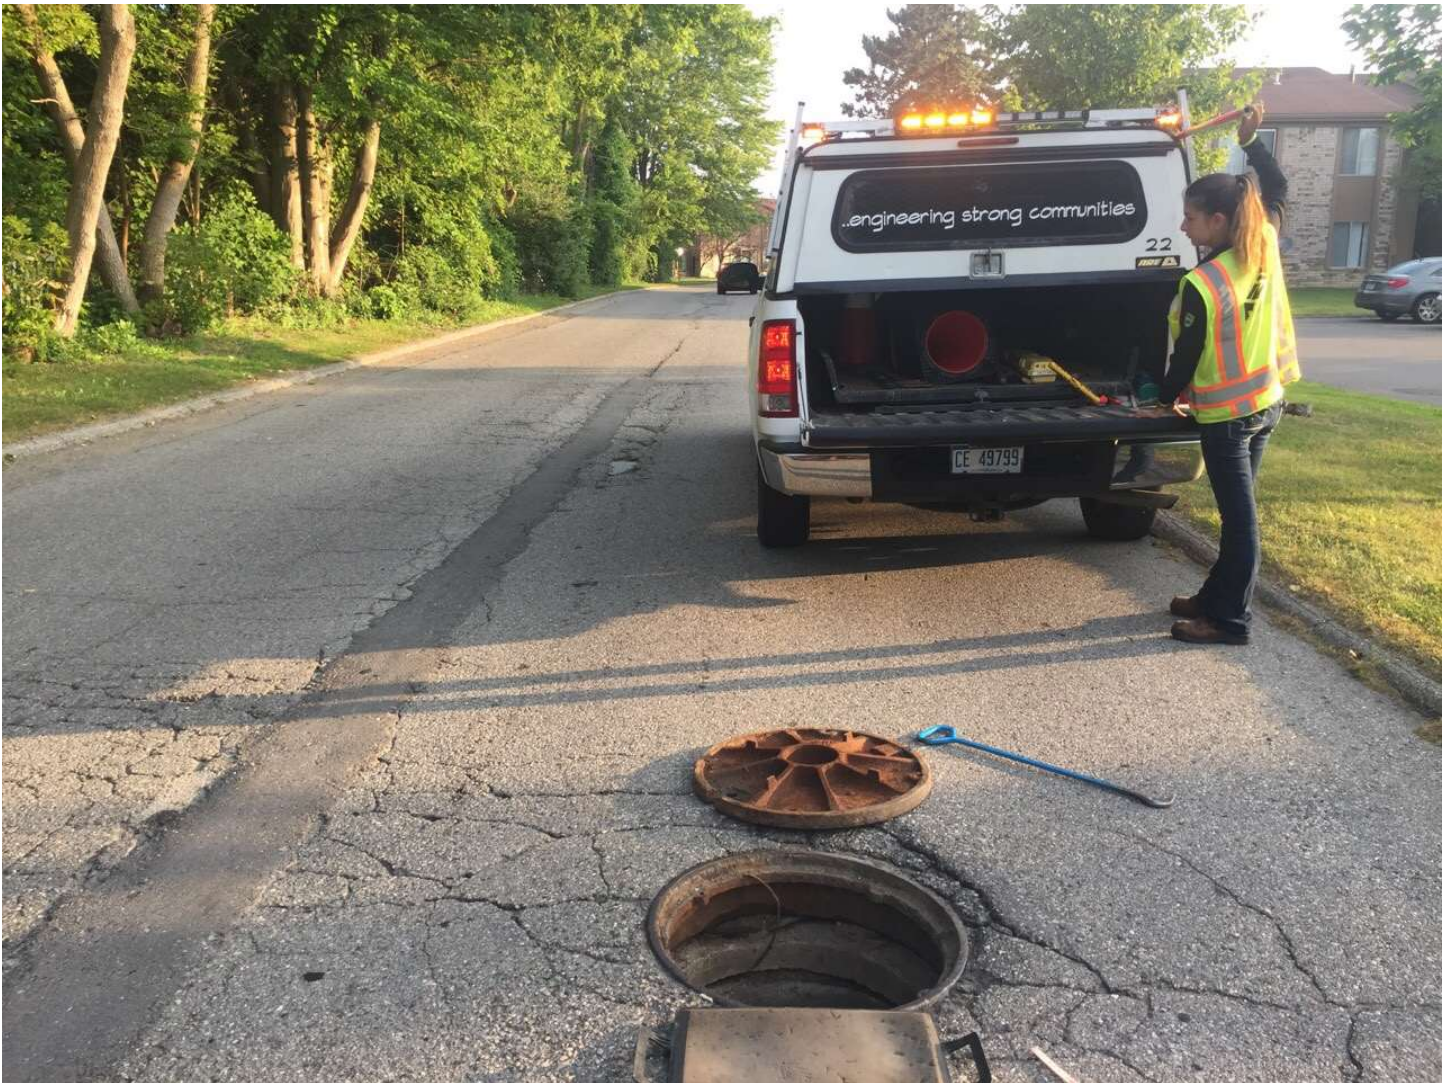
Recommendation 7	<null>	Recommendation 8	<null>
Manhole Rating	3 – Failure likely in 10 to 20 years (Fair)	Comments	Hole in cover. Inspected 8-2-2017

Pipe 6 Flow	<null>	Pipe 6 Diameter	<null>
Pipe 6 Direction	<null>	Pipe 6 Depth	<null>
Pipe 6 Material	<null>	Pipe 6 Seal Condition	<null>
Pipe 6 Drop	<null>	Pipe 6 Comments	<null>
Recommendation 1	Seal Wall Joints	Recommendation 2	<null>
Recommendation 3	<null>	Recommendation 4	<null>
Recommendation 5	<null>	Recommendation 6	<null>

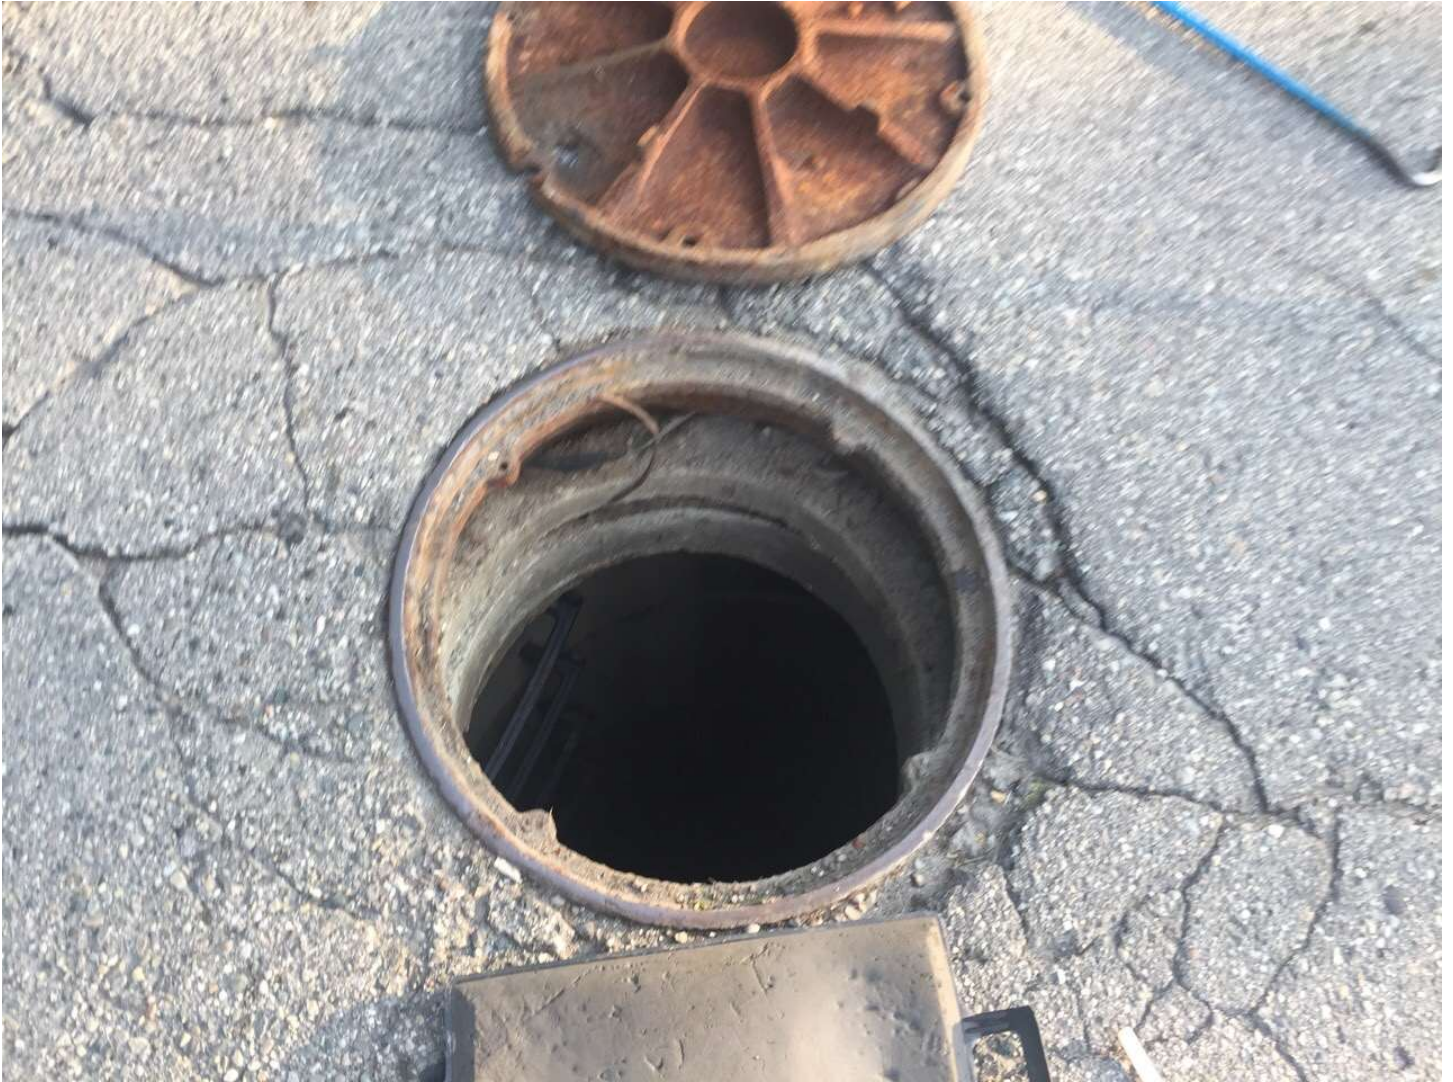
Cone Inflow	Low	Cone Defect Location	<null>
Wall Construction	Precast	Wall Condition	Fair
Wall Inflow	Low	Wall Defect Location	Wall Joint
Wall Defect Location 2	<null>	Wall Defect Location 3	<null>
Wall Defect Location 4	<null>	Wall Defect Location 5	<null>
Bench Construction	Poured	Bench Condition	Good
Bench Inflow	None	Channel Construction	Poured
Channel Condition	Good	Channel Inflow	None
Channel Hydraulics	Fair	Channel Exposure	Fully
