Manhole Inspection Form

M1-21

Manhole Number	M1-21	Historic Manhole Number	Brandenburg 17
Year Installed	1999	Structure Type	Sanitary Manhole
Street	Shady Glen	Address	48301
Elevation	591.422	Weather	Partly Cloudy
Temperature	70°	Ground Condition	Dry
Status	Not Found	Location	Driveway Concrete
Pavment Condition	Good	Traffic	Driveway
Inspector 1	Ac	Inspector 2	Npt
Cover Type	Ej1040apt	Number of Cover Holes	3 - 5
Catch Basin Cover	<null>	Cover Insert	No
Cover Gasket	No	Cover Grade	Cover is At Grade
Grade Dist	<null>	Cover Fit	Good Fit
Cover Condition	Corroded	Frame Condition	Fair
Frame Offset	<null>	Frame Seal Condition	Fair
Frame Seal Inflow	Low	Frame Riser	No
Frame Riser Height	<null>	Frame Riser Material	<null>
Manhole Diameter	48	Manhole Depth	19.25
Chimney Depth	3.6	Chimney Construction	<null>
Chimney Condition	<null>	Chimney Inflow	<null>
Cone Shape	<null>	Cone Depth	<null>
Cone Construction	<null>	Cone Condition	<null>
Cone Inflow	<null>	Cone Defect Location	<null>

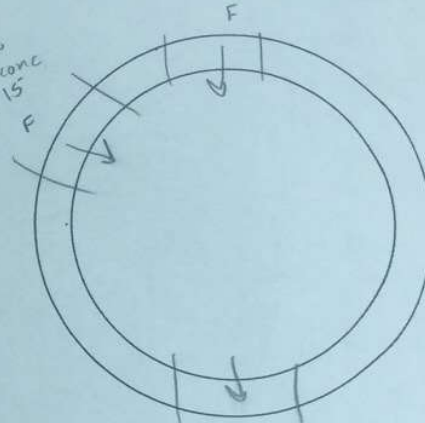
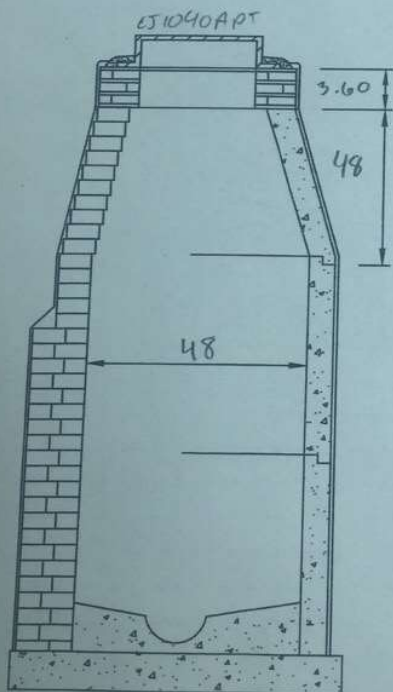
24" N
conc
18.15
F

Nw
24" conc
17.15
F

24" S
conc
19.25
F
