# Manhole Inspection Form

M1-30-10-6

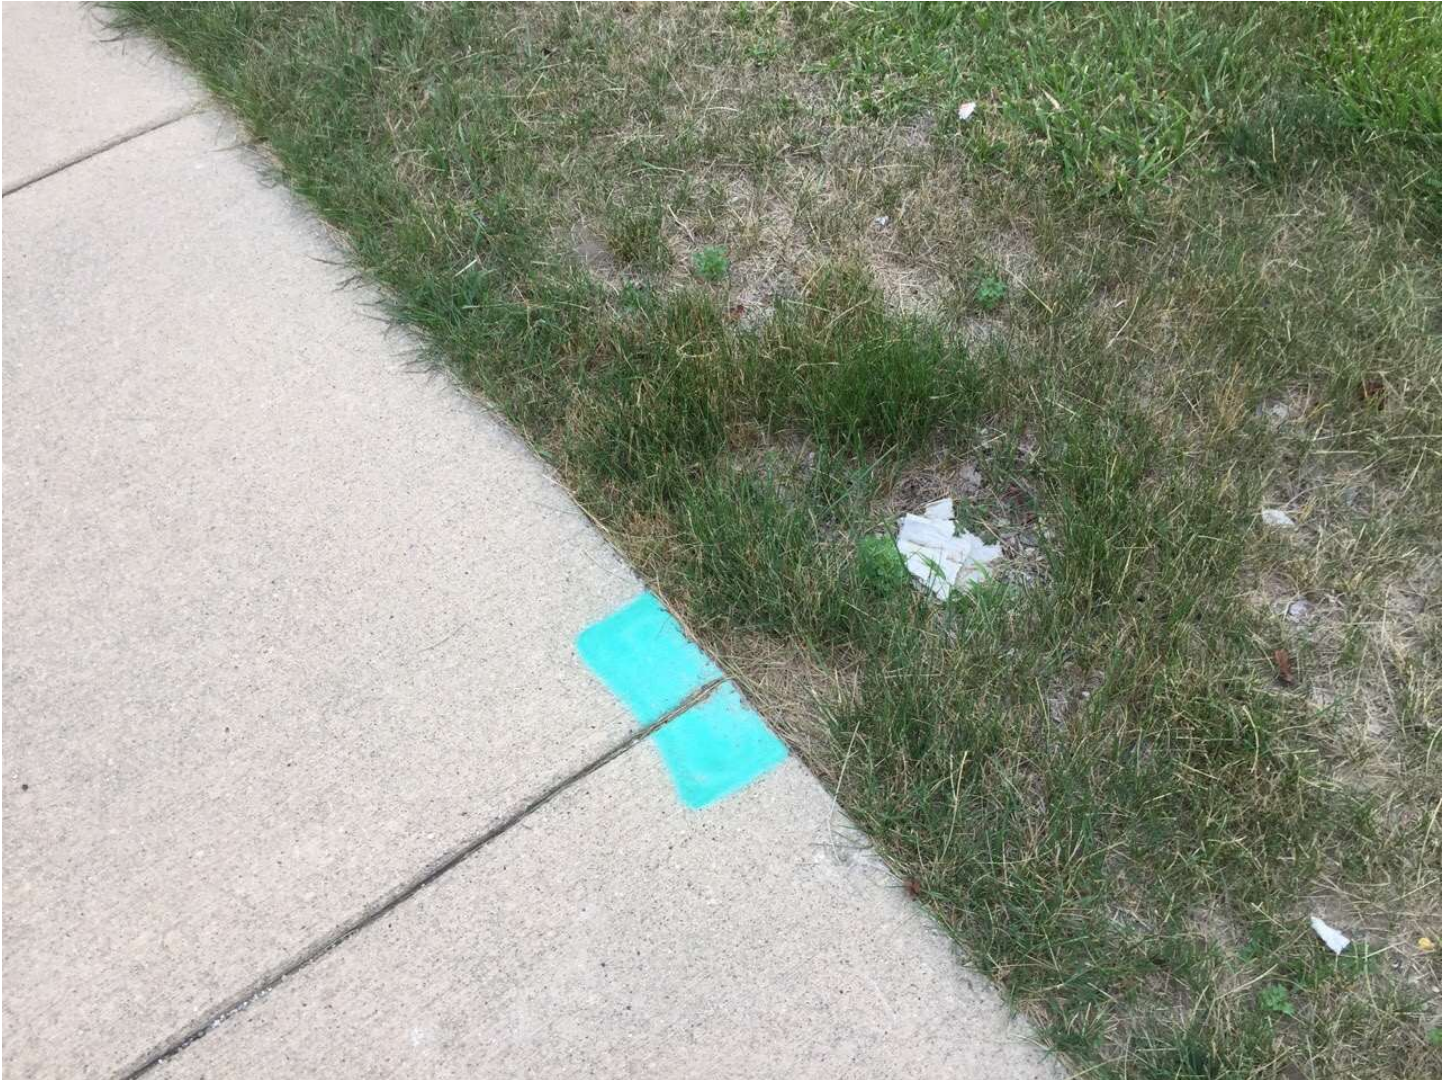
M1-30-10-6

Recommendation 7	<null>	Recommendation 8	<null>
Manhole Rating	<null>	Comments	Buried 6", partially under walk also. (Still buried 7-6-17 npt)
