Manhole Inspection Form

M1-30-14-13-3-3

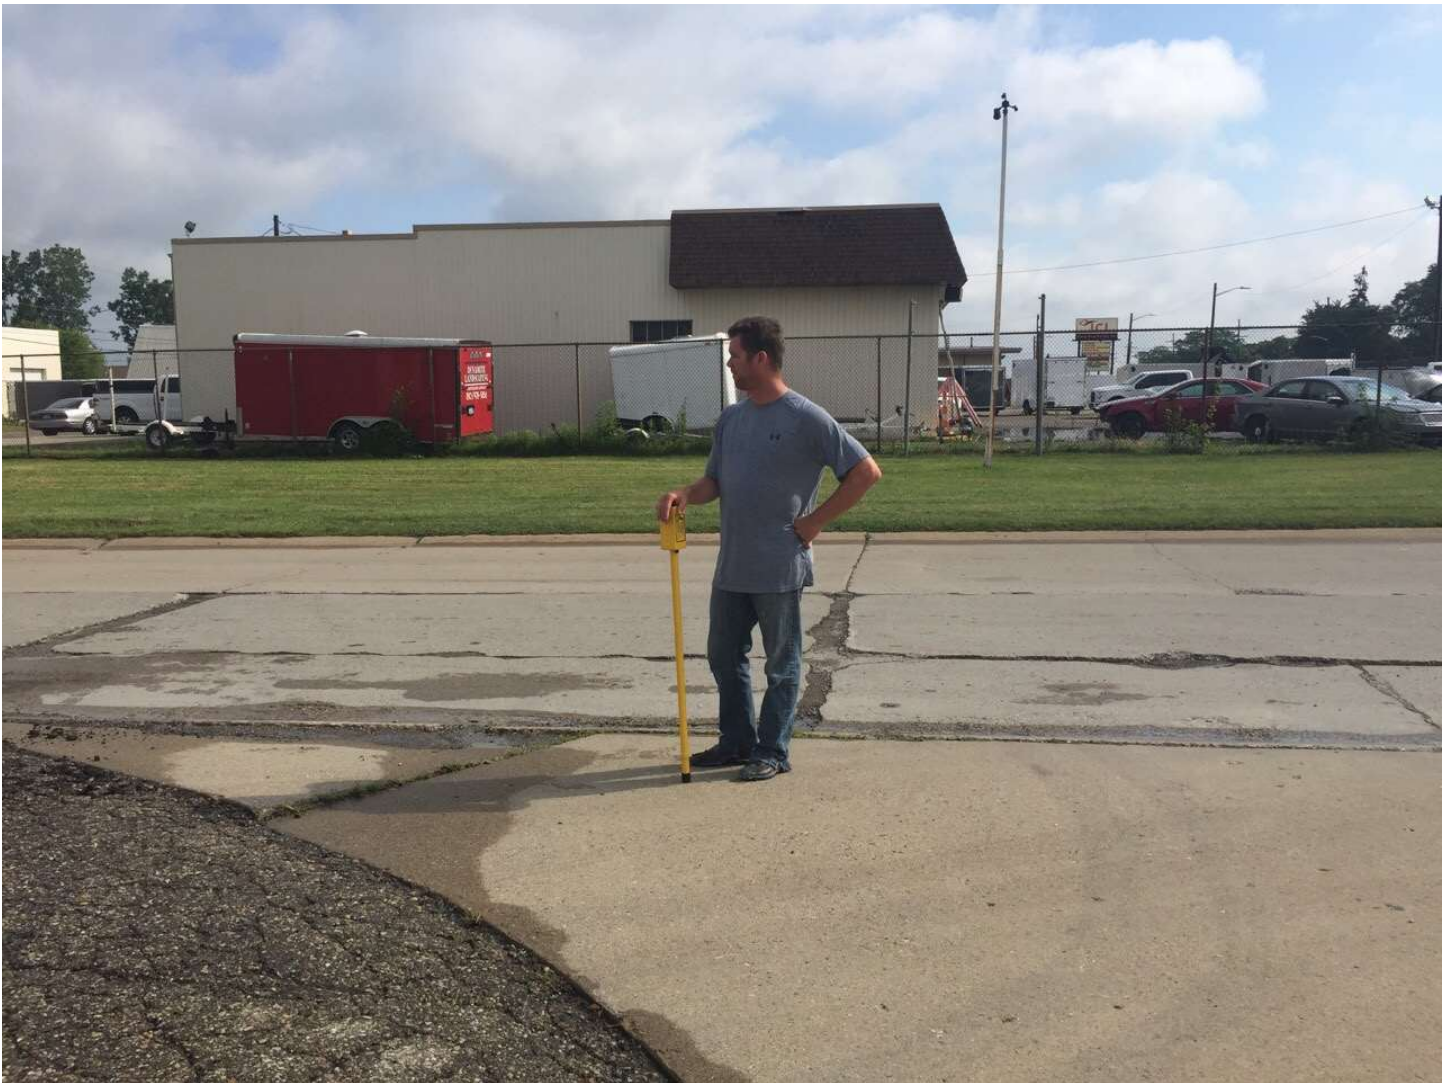
Recommendation 7	<null>	Recommendation 8	<null>
Manhole Rating	<null>	Comments	Possibly buried under pavement, see picture.
