Manhole Inspection Form

M1-30-18-5-1

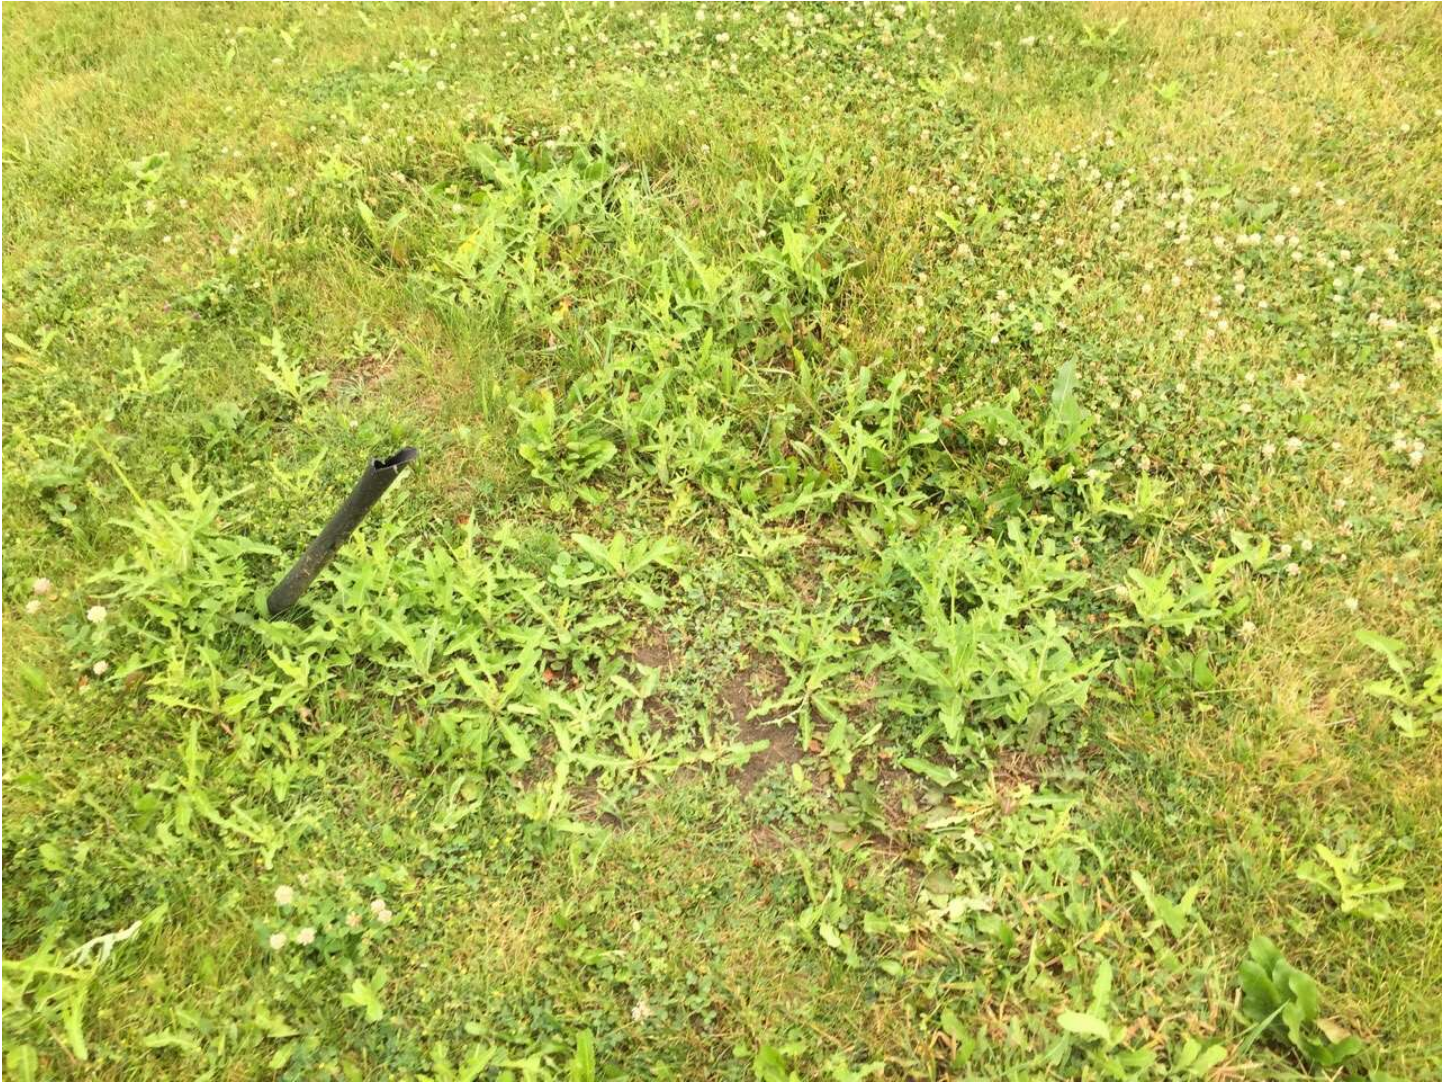
Recommendation 7	<null>	Recommendation 8	<null>
Manhole Rating	<null>	Comments	Buried 8". (Still buried 7-11-2017 Npt)

Pipe 5 Drop	<null>	Pipe 5 Comments	<null>
Pipe 6 Flow	<null>	Pipe 6 Diameter	<null>
Pipe 6 Direction	<null>	Pipe 6 Depth	<null>
Pipe 6 Material	<null>	Pipe 6 Seal Condition	<null>
Pipe 6 Drop	<null>	Pipe 6 Comments	<null>
Recommendation 1	Raise	Recommendation 2	<null>
Recommendation 3	<null>	Recommendation 4	<null>
Recommendation 5	<null>	Recommendation 6	<null>
