Manhole Inspection Form

M1-30-18-6

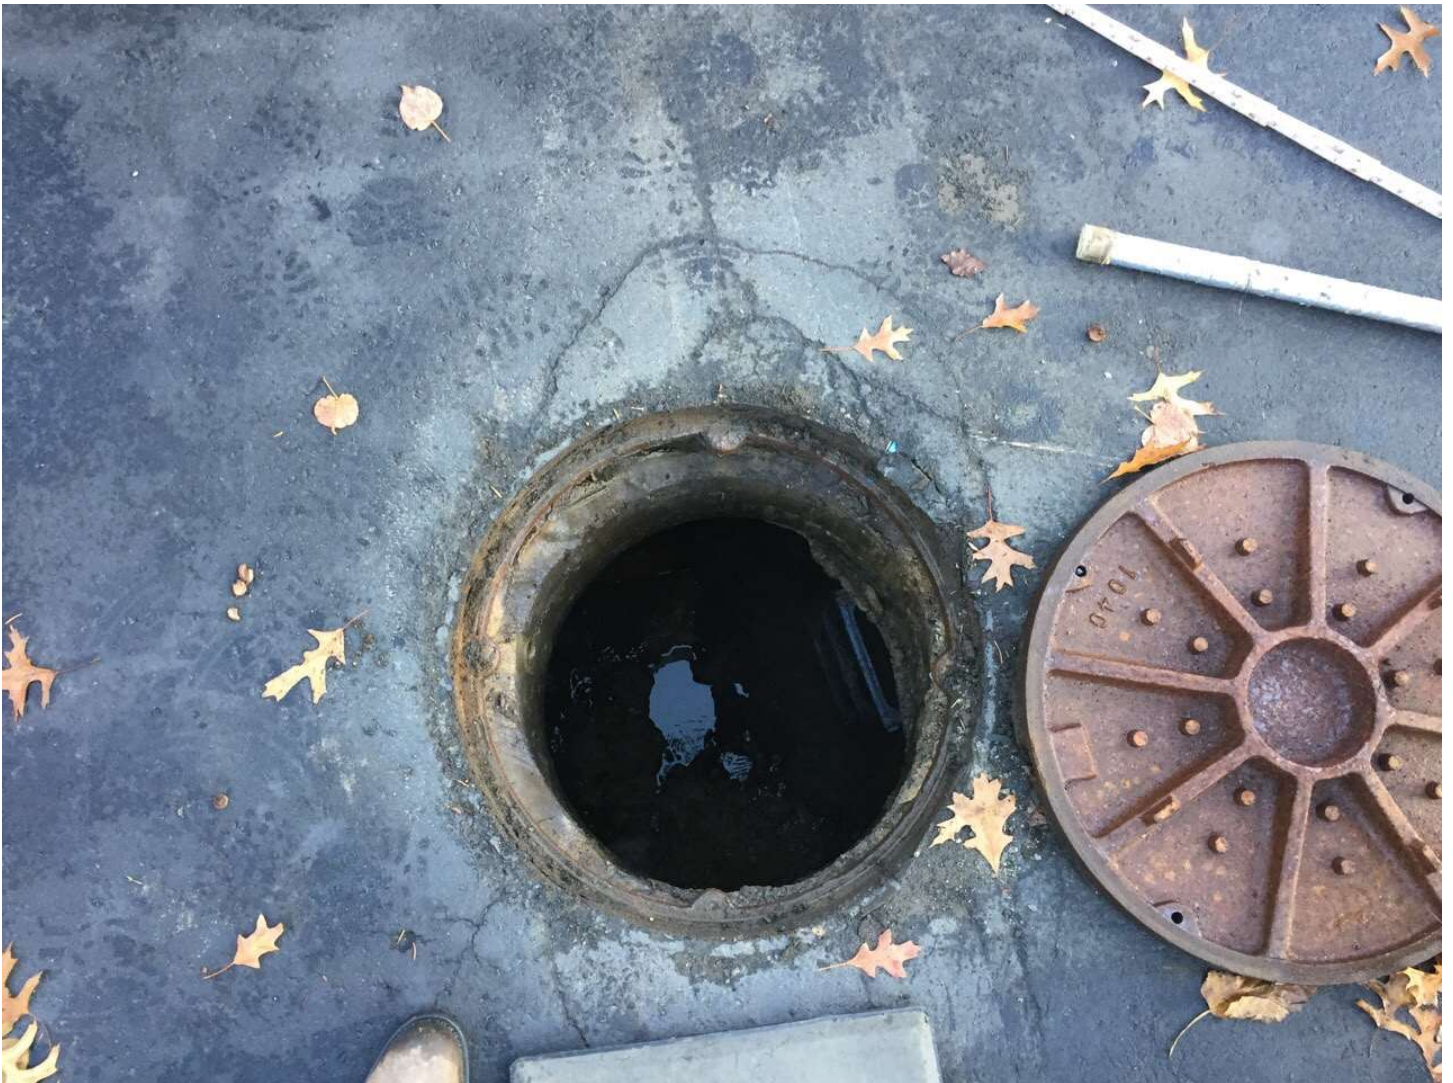
M1-30-18-6

Recommendation 7	<null>	Recommendation 8	<null>
Manhole Rating	3 – Failure likely in 10 to 20 years (Fair)	Comments	Needs cleaned out, mike from DPW called in for cleanout, frame cracked replace, R&r asphalt as needed

Pipe 6 Flow	<null>	Pipe 6 Diameter	<null>
Pipe 6 Direction	<null>	Pipe 6 Depth	<null>
Pipe 6 Material	<null>	Pipe 6 Seal Condition	<null>
Pipe 6 Drop	<null>	Pipe 6 Comments	<null>
Recommendation 1	Vactor Clean	Recommendation 2	Reset F&C w/Ext. Seal
Recommendation 3	<null>	Recommendation 4	<null>
Recommendation 5	<null>	Recommendation 6	<null>
