# Manhole Inspection Form

M2-16-36-P5-2W-1

Manhole Number: M2-16-36-P5-2W-1  
Community: Chesterfield  
Inspector Initials: AMC/JEF

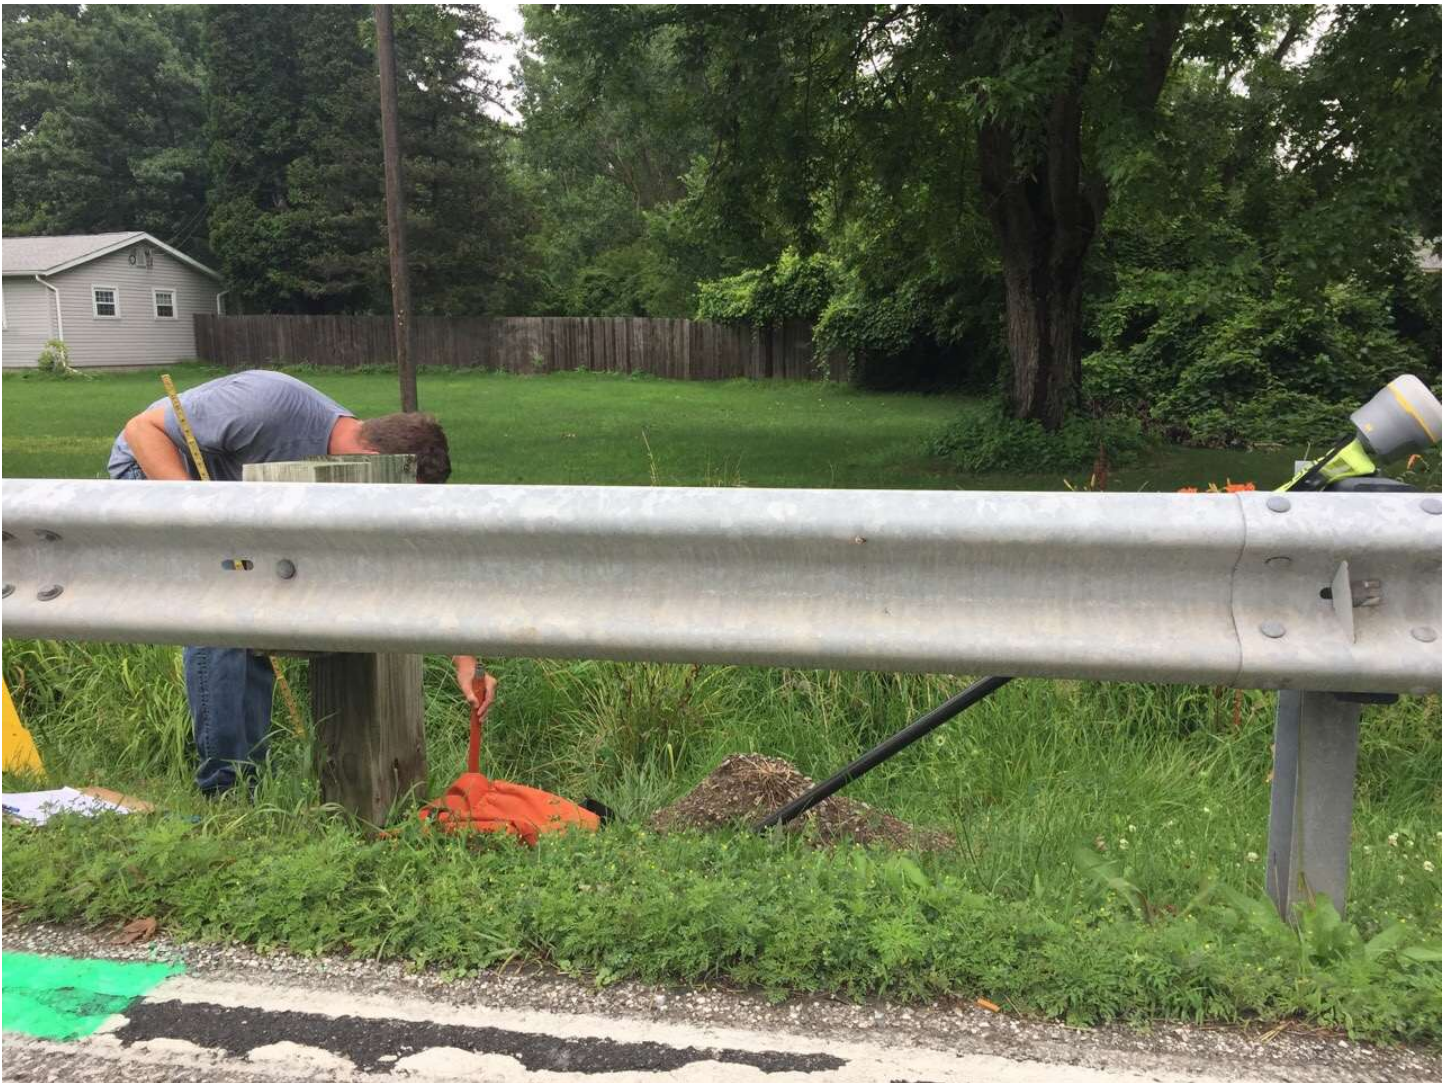
Manhole Number	M2-16-36-P5-2W-1	Historic Manhole Number	Sugarbush 2
Year Installed	1971	Structure Type	Sanitary Manhole
Street	Callens	Address	48515
Elevation	584.406	Weather	Sunny
Temperature	55°	Ground Condition	Damp
Status	Not Found	Location	Ditch
Pavment Condition	N/A	Traffic	Two Lane Road
Inspector 1	Jef	Inspector 2	Amc
Cover Type	EJ 1040APT	Number of Cover Holes	Solid Cover
Catch Basin Cover	N/A	Cover Insert	No
Cover Gasket	Yes	Cover Grade	Cover is At Grade
Grade Dist	<null>	Cover Fit	Good Fit
Cover Condition	Good	Frame Condition	Good
Frame Offset	<null>	Frame Seal Condition	Good
Frame Seal Inflow	None	Frame Riser	No
Frame Riser Height	<null>	Frame Riser Material	N/A
Manhole Diameter	48	Manhole Depth	9.95
Chimney Depth	0.6	Chimney Construction	Precast
Chimney Condition	Fair	Chimney Inflow	Low
Cone Shape	<null>	Cone Depth	30
Cone Construction	Precast	Cone Condition	Good
Cone Inflow	Low	Cone Defect Location	None

Wall Construction	Precast	Wall Condition	Good
Wall Inflow	None	Wall Defect Location	<null>
Wall Defect Location 2	<null>	Wall Defect Location 3	<null>
Wall Defect Location 4	<null>	Wall Defect Location 5	<null>
Bench Construction	Poured	Bench Condition	Good
Bench Inflow	None	Channel Construction	Poured
Channel Condition	Good	Channel Inflow	None
Channel Hydraulics	Good	Channel Exposure	Fully

Recommendation 7	<null>	Recommendation 8	<null>
Manhole Rating	2 – Failure unlikely in 20 years (Good)	Comments	<null>

Pipe 5 Drop	<null>	Pipe 5 Comments	<null>
Pipe 6 Flow	<null>	Pipe 6 Diameter	<null>
Pipe 6 Direction	<null>	Pipe 6 Depth	<null>
Pipe 6 Material	<null>	Pipe 6 Seal Condition	<null>
Pipe 6 Drop	<null>	Pipe 6 Comments	<null>
Recommendation 1	Internal Chimney Seal	Recommendation 2	Raise
Recommendation 3	<null>	Recommendation 4	<null>
Recommendation 5	<null>	Recommendation 6	<null>
