Manhole Inspection Form

M2-16-36-P5-10E-P6-23-4-3

Manhole Number: M2-16-36-P5-10E-P6-23-4-3
Community: Chesterfield
Inspector Initials: BSR / KMD

Date: 11-22-16
Address: 5144 LAUREL DAWN
R.T. = 12.50
D = 48"
Map: 23

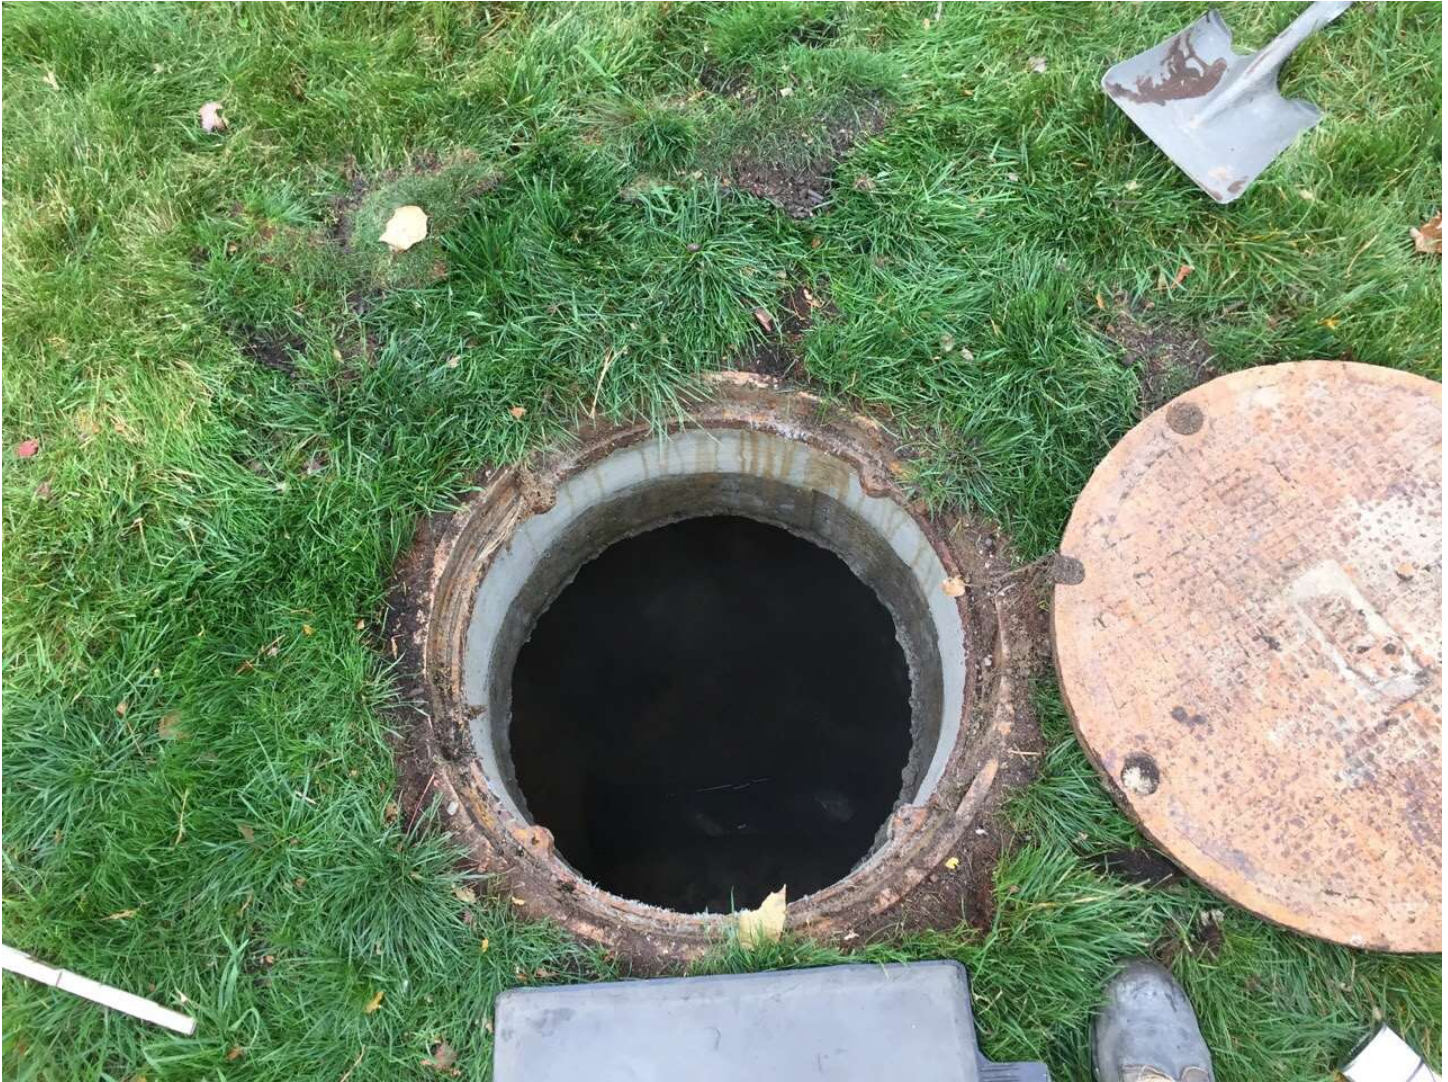
Recommendation 7	<null>	Recommendation 8	<null>
Manhole Rating	2 – Failure unlikely in 20 years (Good)	Comments	Gasket missing. Chimney recently raised block and precast combo.

Pipe 6 Flow	<null>	Pipe 6 Diameter	<null>
Pipe 6 Direction	<null>	Pipe 6 Depth	<null>
Pipe 6 Material	<null>	Pipe 6 Seal Condition	<null>
Pipe 6 Drop	<null>	Pipe 6 Comments	<null>
Recommendation 1	Seal Wall Joints	Recommendation 2	Internal Chimney Seal
Recommendation 3	<null>	Recommendation 4	<null>
Recommendation 5	<null>	Recommendation 6	<null>
