Manhole Inspection Form

M2-16-36-P5-10E-P6-51

Manhole Number	M2-16-36-P5-10E-P6-51	Historic Manhole Number	Baker 18
Year Installed	1994	Structure Type	Sanitary Manhole
Street	Baker	Address	52747
Elevation	594.957	Weather	Overcast
Temperature	55°	Ground Condition	Dry
Status	Not Found	Location	Yard Back
Pavment Condition	<null>	Traffic	<null>
Inspector 1	Npt	Inspector 2	AC
Cover Type	Ej 1040apt	Number of Cover Holes	Solid Cover
Catch Basin Cover	<null>	Cover Insert	No
Cover Gasket	No	Cover Grade	Cover is Below Grade
Grade Dist	4	Cover Fit	Good Fit
Cover Condition	Good	Frame Condition	Fair
Frame Offset	<null>	Frame Seal Condition	Fair
Frame Seal Inflow	Low	Frame Riser	No
Frame Riser Height	<null>	Frame Riser Material	<null>
Manhole Diameter	48	Manhole Depth	15.25
Chimney Depth	<null>	Chimney Construction	None
Chimney Condition	<null>	Chimney Inflow	<null>
Cone Shape	<null>	Cone Depth	15
Cone Construction	Precast	Cone Condition	Good
Cone Inflow	Low	Cone Defect Location	<null>

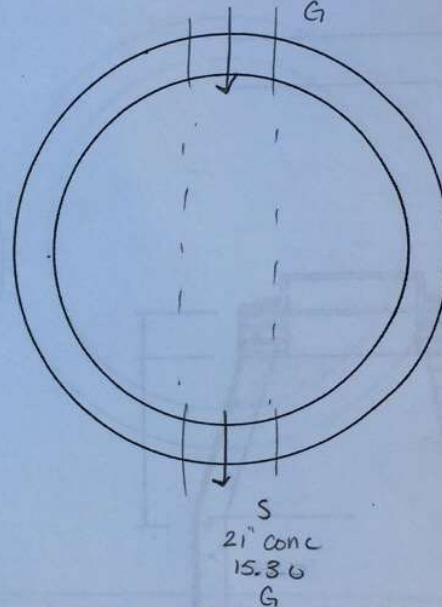
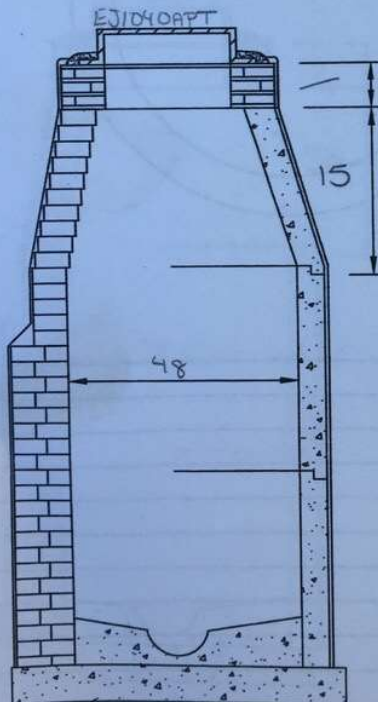
Manhole Number: 472

R.T. = 15.25

D = 48

N
2' conc.
15.25
G
