Manhole Inspection Form

M2-29-4-1S

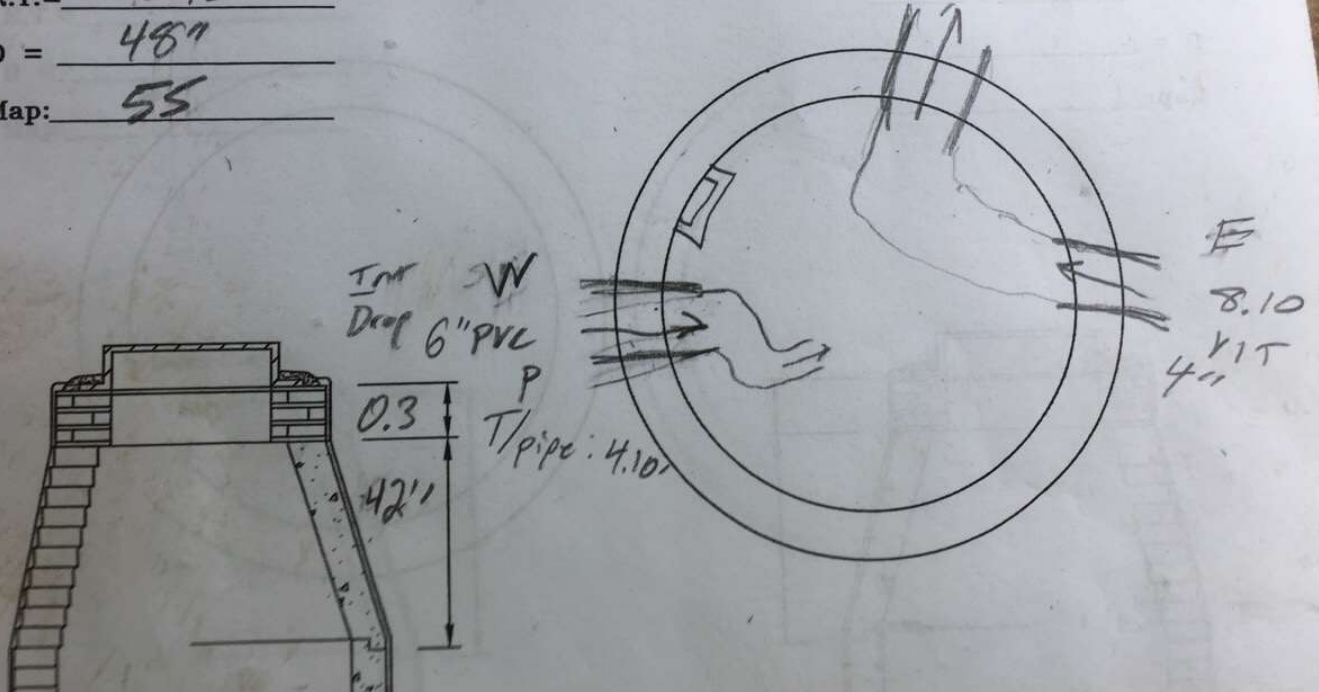
Manhole Number: M2-29-4-25

NE VIT
8.15 8"
