Manhole Inspection Form

M2-32-P1-7S-2A-1

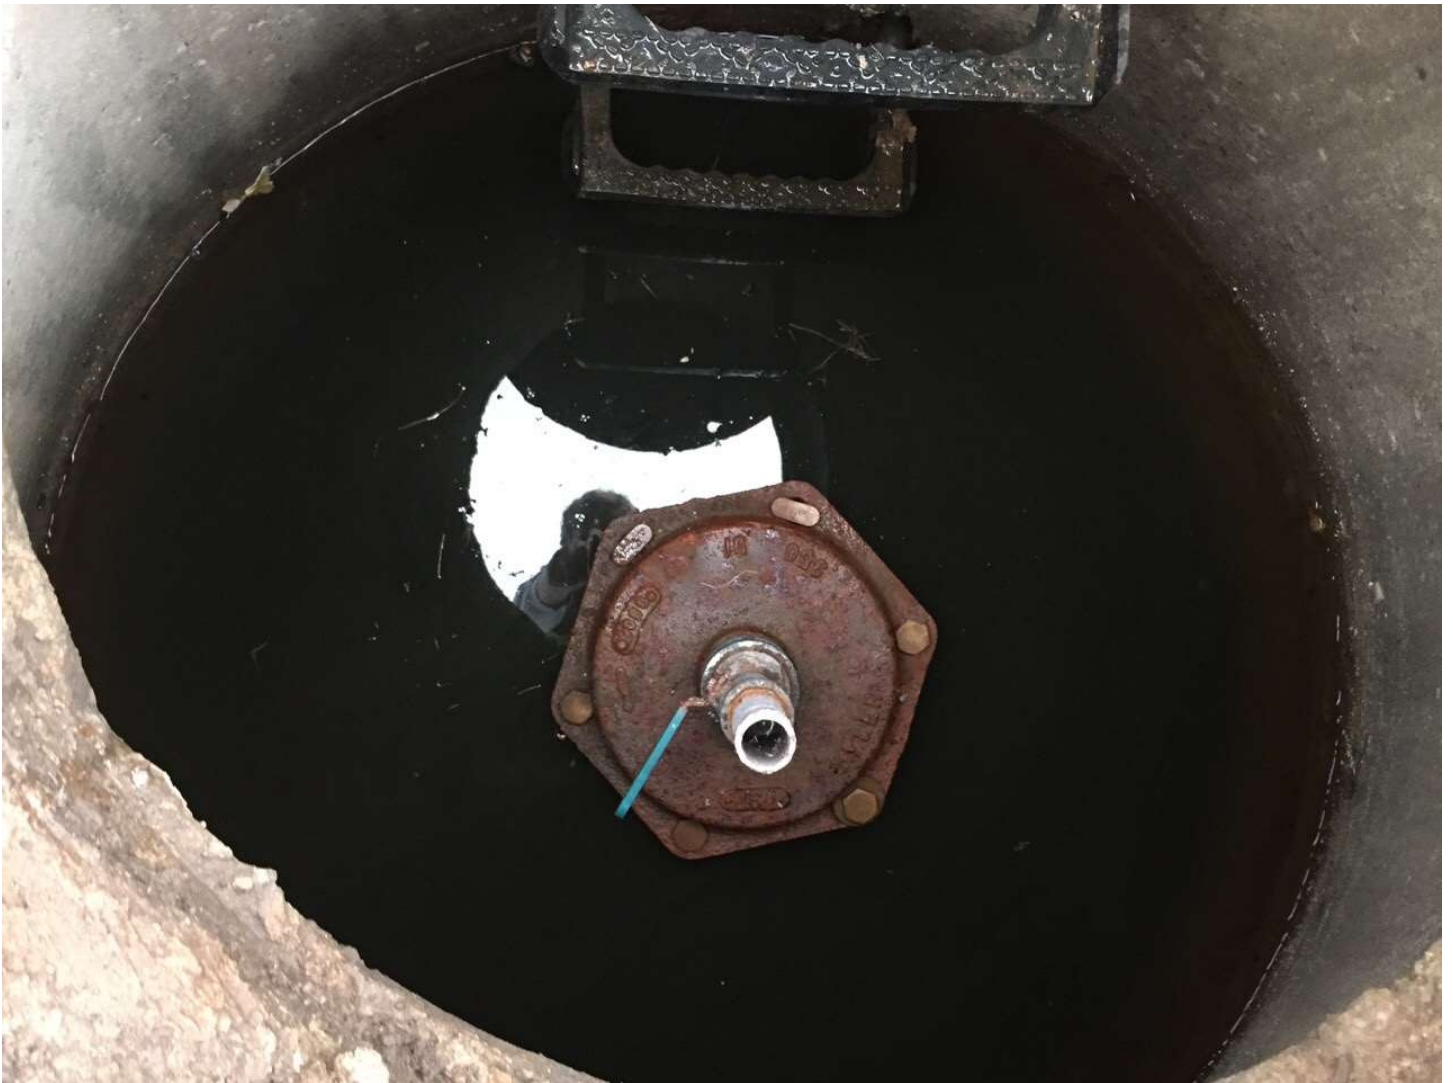
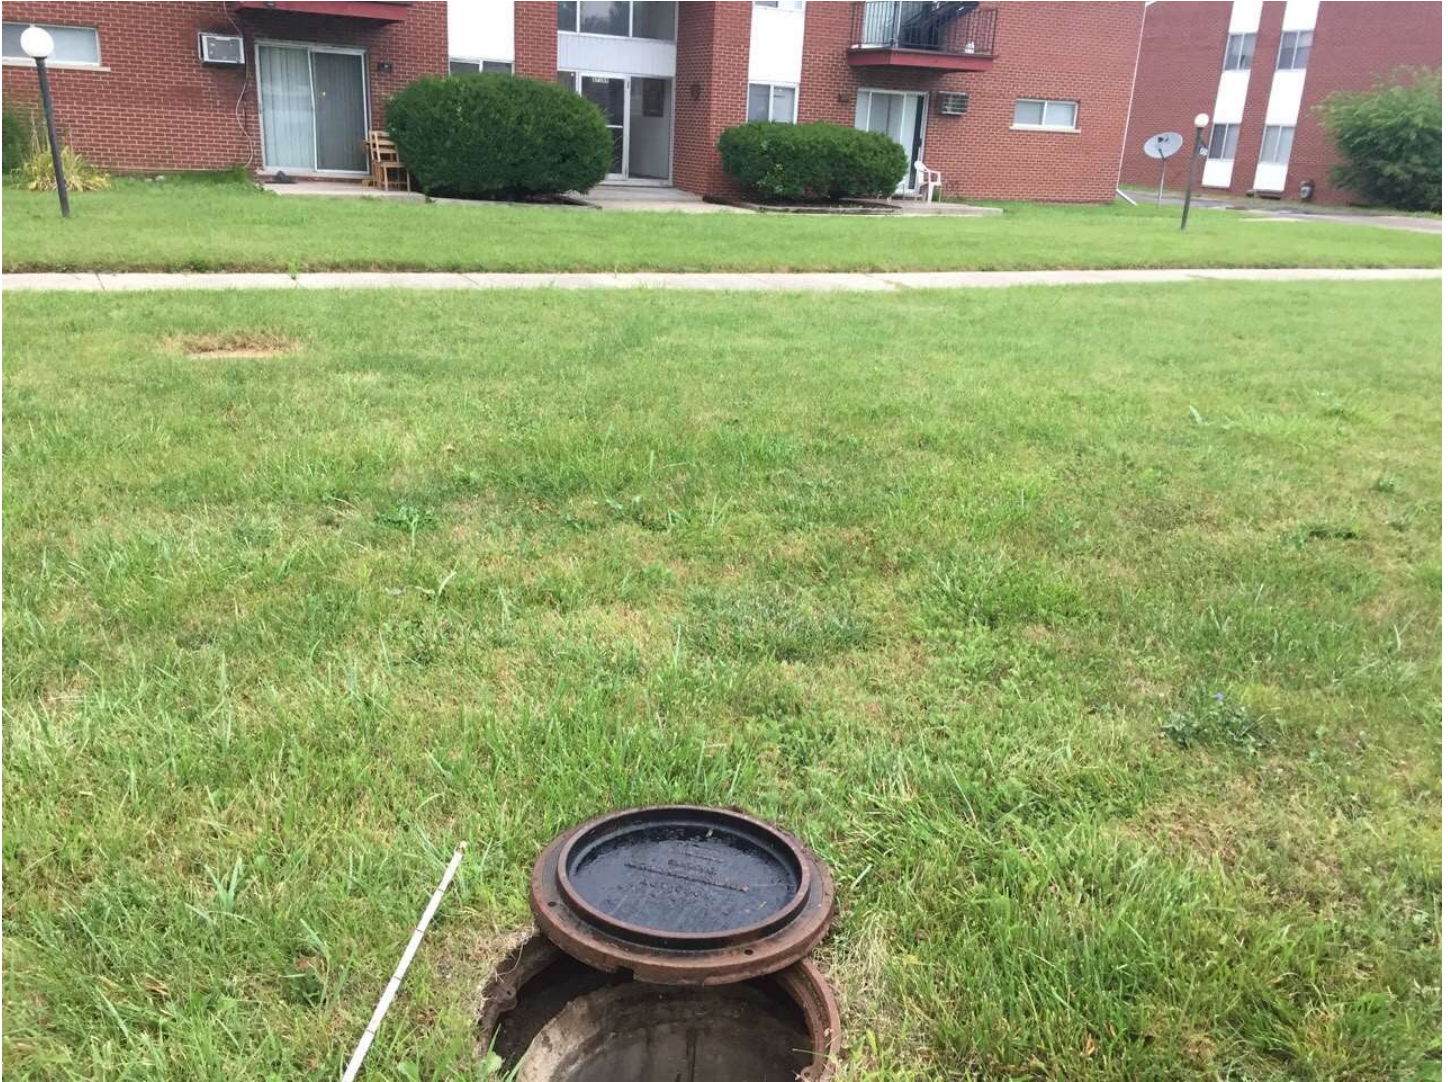
Recommendation 5	<null>	Recommendation 6	<null>
Recommendation 7	<null>	Recommendation 8	<null>
Manhole Rating	<null>	Comments	Watergate valve
