# Manhole Inspection Form

## M2-32-P1-7S-5A

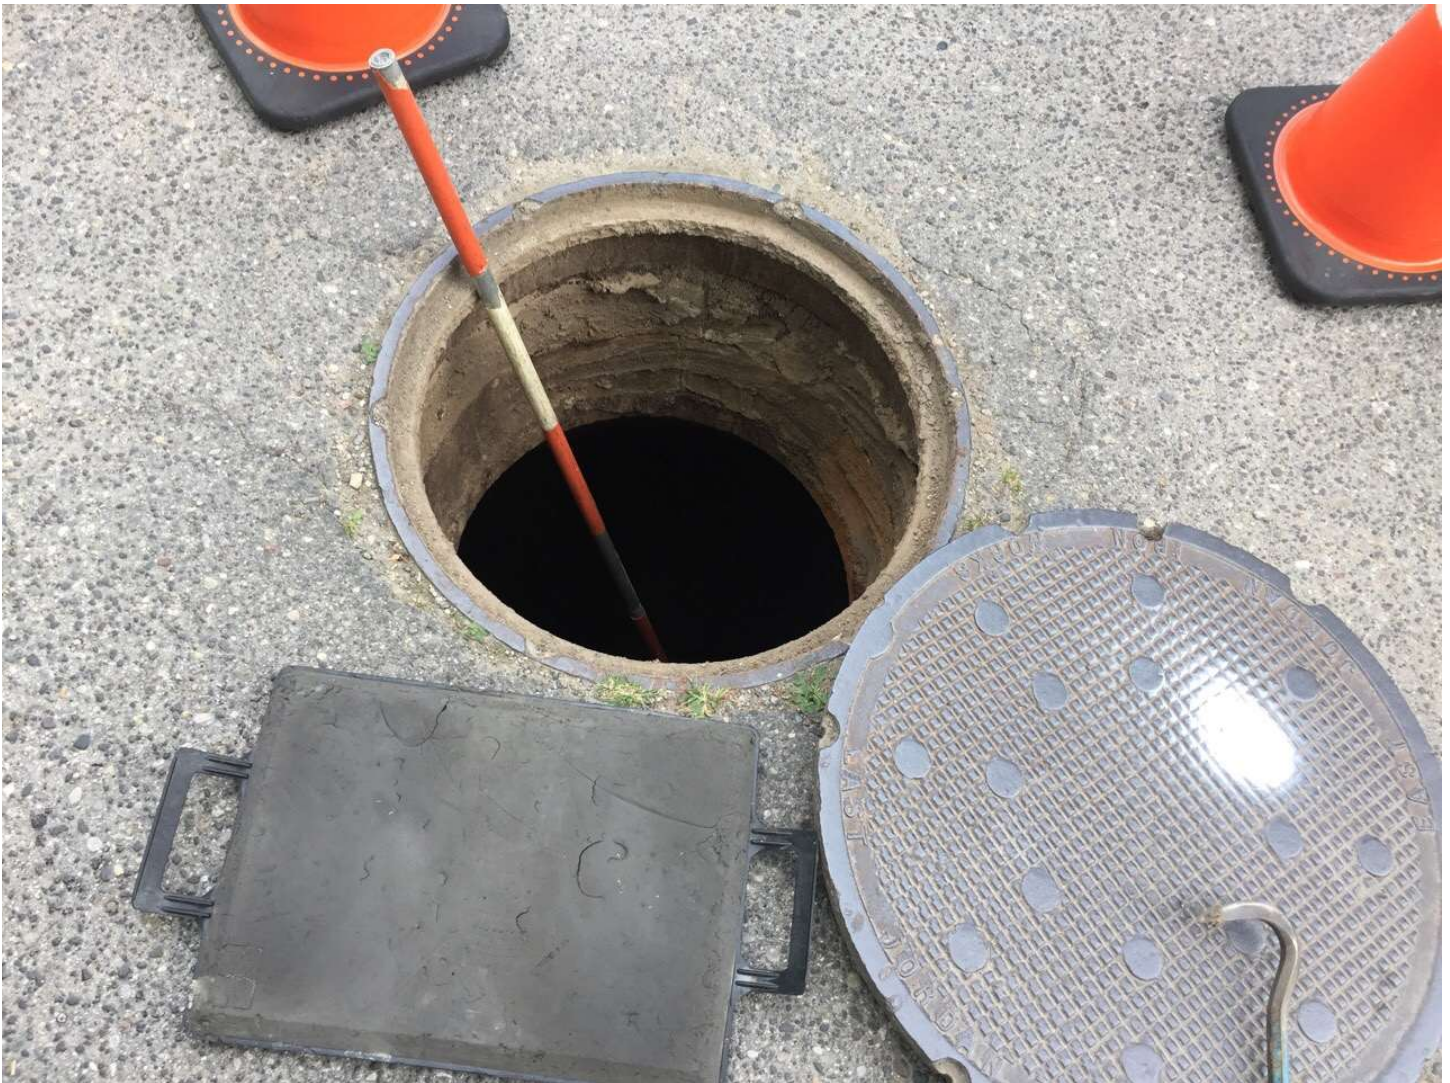
Manhole Number	M2-32-P1-7S-5A	Historic Manhole Number	Wand 1B
Year Installed	1971	Structure Type	Sanitary Manhole
Street	Wand	Address	47110
Elevation	578.876	Weather	Partly Cloudy
Temperature	70°	Ground Condition	Dry
Status	Not Found	Location	Paved Asphalt
Pavment Condition	Good	Traffic	Two Lane Road
Inspector 1	Ac	Inspector 2	Rbc
Cover Type	Ej1040apt	Number of Cover Holes	Solid Cover
Catch Basin Cover	<null>	Cover Insert	No
Cover Gasket	No	Cover Grade	Cover is At Grade
Grade Dist	<null>	Cover Fit	Good Fit
Cover Condition	Good	Frame Condition	Fair
Frame Offset	<null>	Frame Seal Condition	Fair
Frame Seal Inflow	Low	Frame Riser	No
Frame Riser Height	<null>	Frame Riser Material	<null>
Manhole Diameter	48	Manhole Depth	10.95
Chimney Depth	1.35	Chimney Construction	Brick
Chimney Condition	Fair	Chimney Inflow	Low
Cone Shape	<null>	Cone Depth	32
Cone Construction	Precast	Cone Condition	Fair
Cone Inflow	Moderate	Cone Defect Location	Wall/Cone Joint

Wall Construction	Precast	Wall Condition	Poor
Wall Inflow	Heavy	Wall Defect Location	Wall Joint
Wall Defect Location 2	Entire Depth	Wall Defect Location 3	<null>
Wall Defect Location 4	<null>	Wall Defect Location 5	<null>
Bench Construction	Poured	Bench Condition	Good
Bench Inflow	None	Channel Construction	Poured
Channel Condition	Good	Channel Inflow	None
Channel Hydraulics	Good	Channel Exposure	Fully

Recommendation 7	<null>	Recommendation 8	<null>
Manhole Rating	3 – Failure likely in 10 to 20 years (Fair)	Comments	<null>

Pipe 6 Flow	<null>	Pipe 6 Diameter	<null>
Pipe 6 Direction	<null>	Pipe 6 Depth	<null>
Pipe 6 Material	<null>	Pipe 6 Seal Condition	<null>
Pipe 6 Drop	<null>	Pipe 6 Comments	<null>
Recommendation 1	Internal Chimney Seal	Recommendation 2	Seal Wall Joints
Recommendation 3	<null>	Recommendation 4	<null>
Recommendation 5	<null>	Recommendation 6	<null>

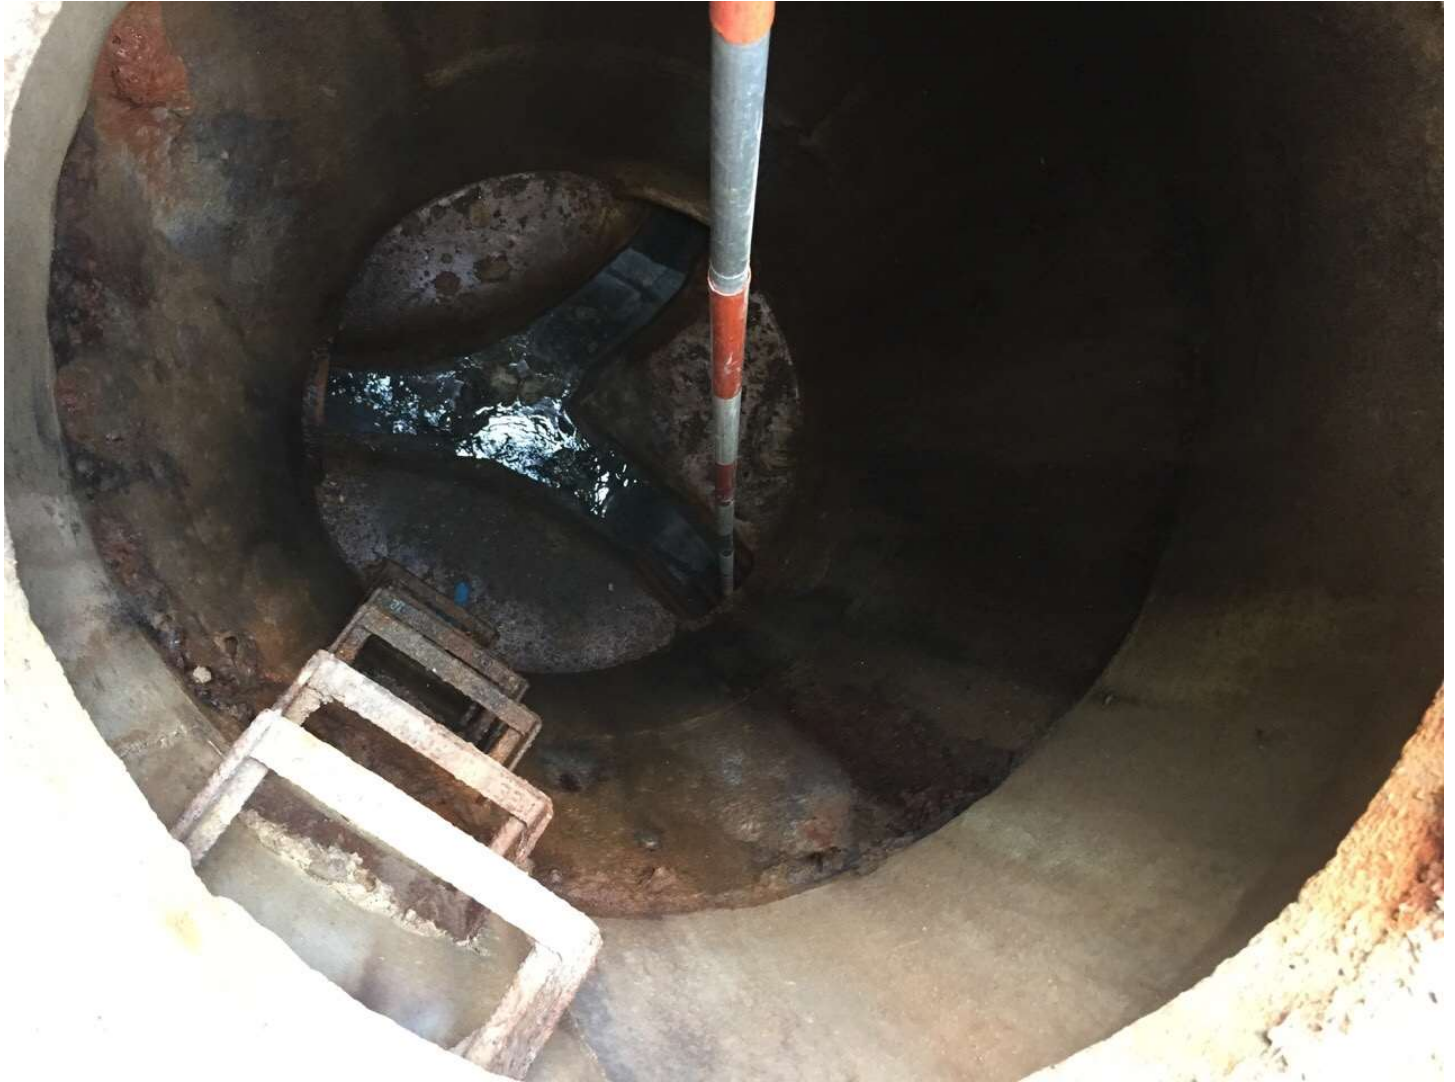
M2-32-P1-7S-5A

Nw vit 12" 10.95' P  
 NE vit 12" 10.95' G  
 SE vit 10' 10.80' 6
