Manhole Inspection Form

M2-32-P1-30N-5

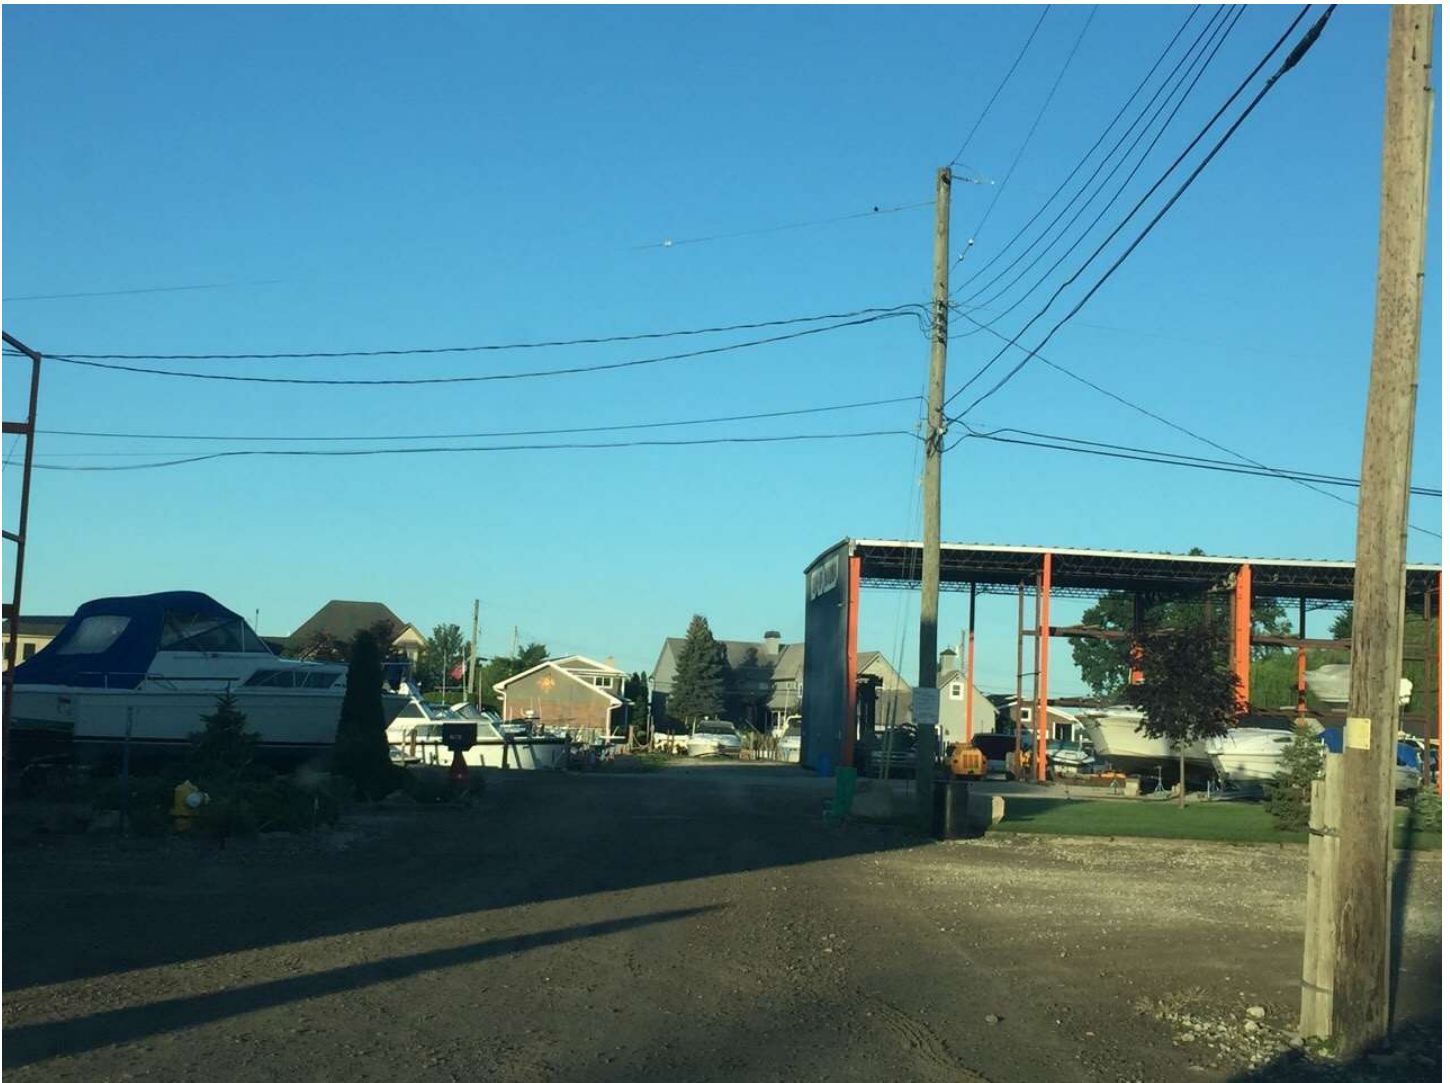
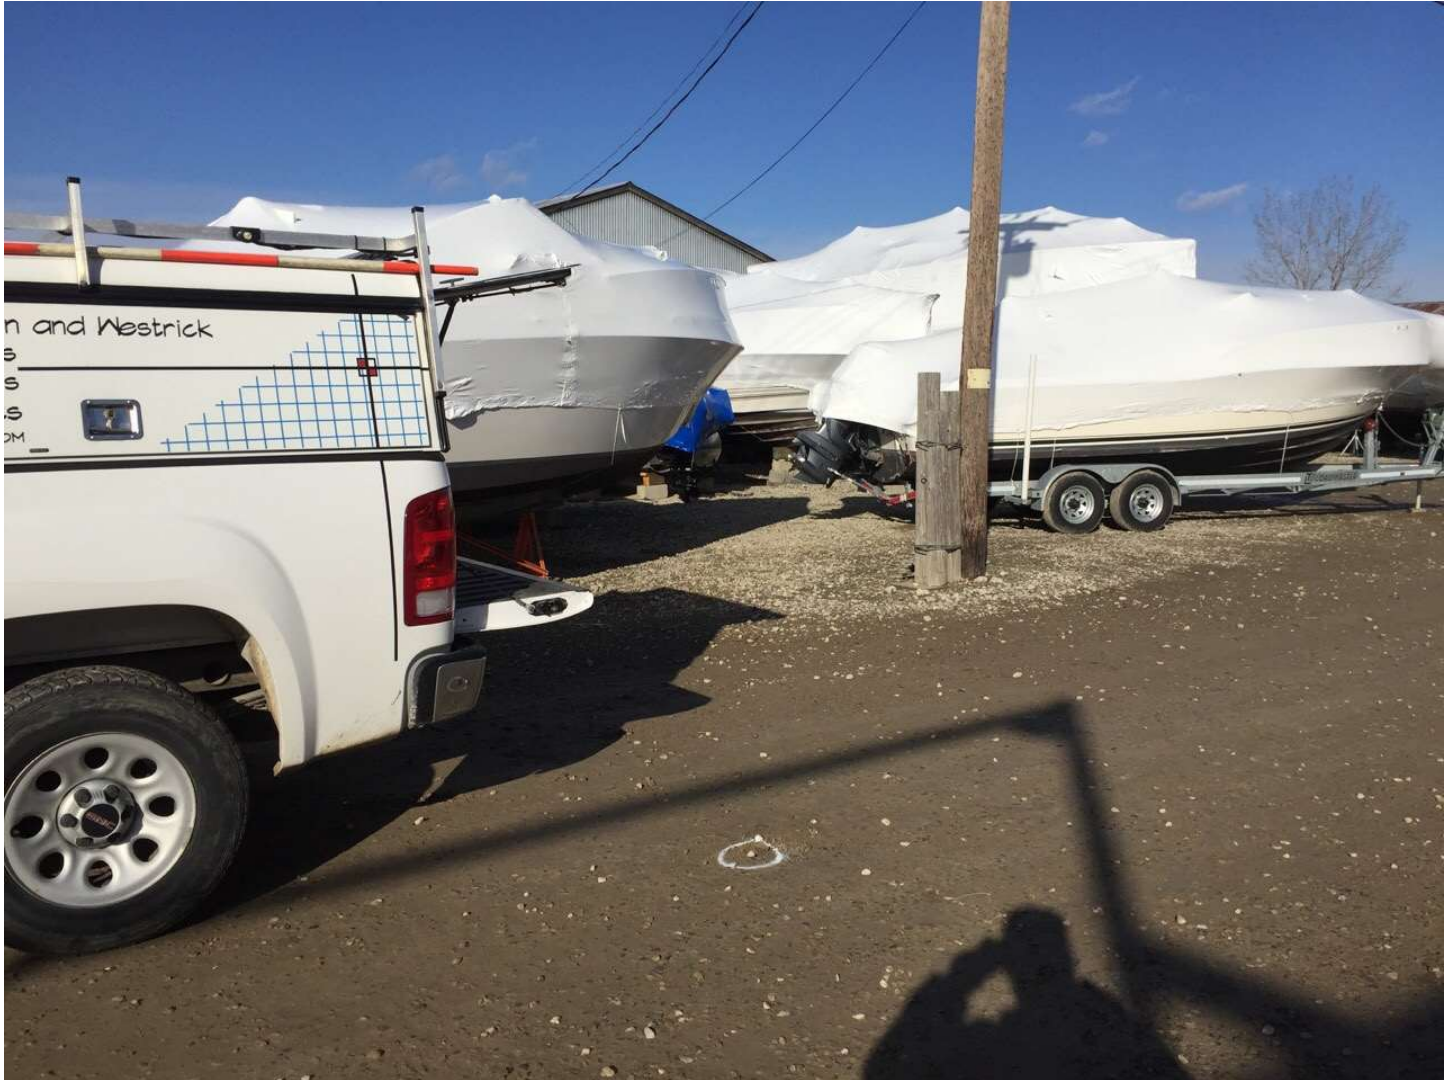
Recommendation 7	<null>	Recommendation 8	<null>
Manhole Rating	<null>	Comments	Buried under gravel rd
