Manhole Inspection Form

M2-32-P1-32N-P2-10E-5

Manhole Number	M2-32-P1-32N-P2-10E-5	Historic Manhole Number	Schneider 4
Year Installed	1969	Structure Type	Sanitary Manhole
Street	Schneider	Address	33911
Elevation	577.516	Weather	Overcast
Temperature	30°	Ground Condition	Dry
Status	At Surface Grade	Location	Yard Front
Pavment Condition	<null>	Traffic	Two Lane Road
Inspector 1	Brs	Inspector 2	Kmd
Cover Type	Ej1040a	Number of Cover Holes	Solid Cover
Catch Basin Cover	<null>	Cover Insert	No
Cover Gasket	No	Cover Grade	Cover is Above Grade
Grade Dist	4	Cover Fit	Good Fit
Cover Condition	Corroded	Frame Condition	Fair
Frame Offset	<null>	Frame Seal Condition	Good
Frame Seal Inflow	None	Frame Riser	No
Frame Riser Height	<null>	Frame Riser Material	N/A
Manhole Diameter	48	Manhole Depth	7.8
Chimney Depth	0.95	Chimney Construction	Combination- S.C.
Chimney Condition	Fair	Chimney Inflow	None
Cone Shape	Eccentric	Cone Depth	24
Cone Construction	Precast	Cone Condition	Fair

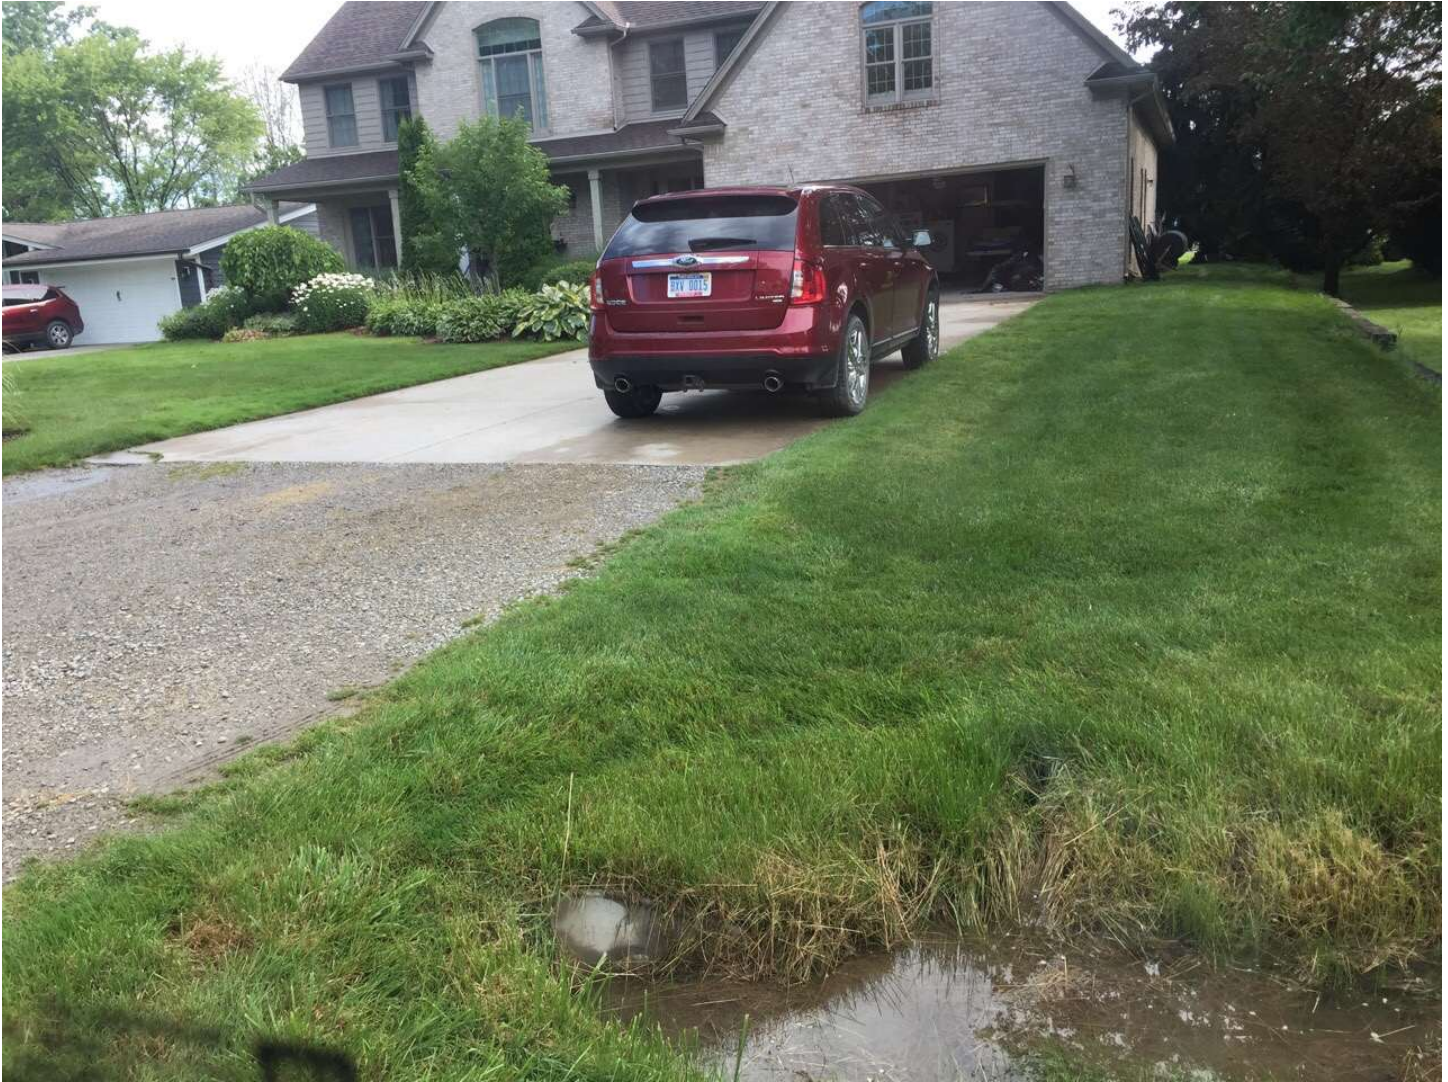
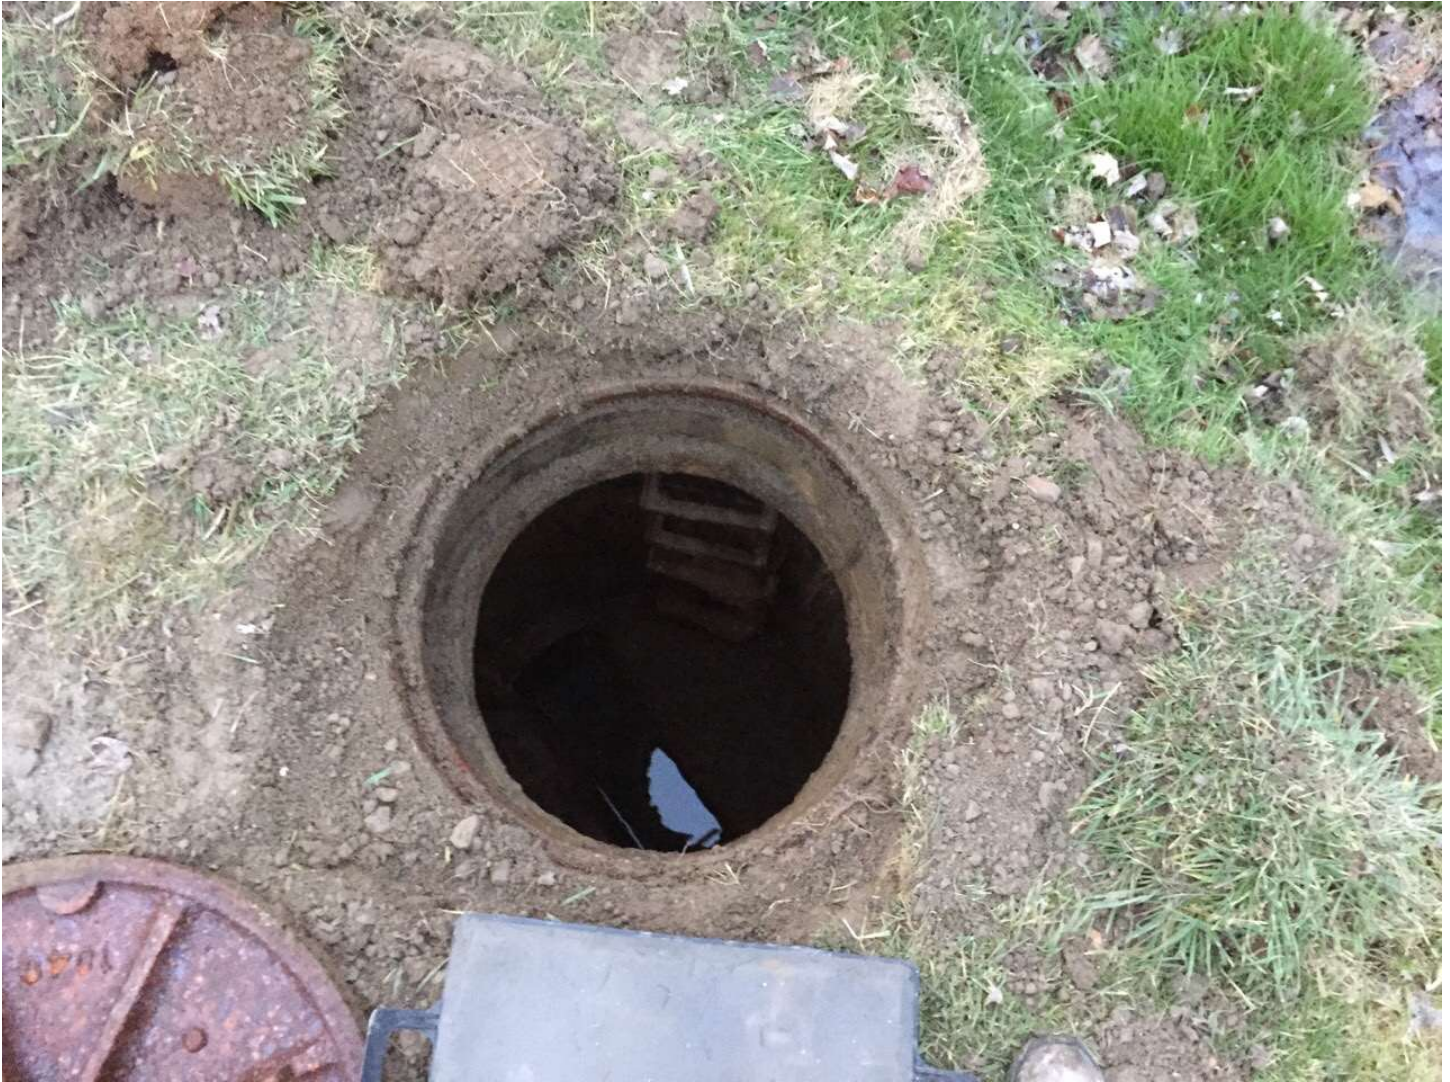
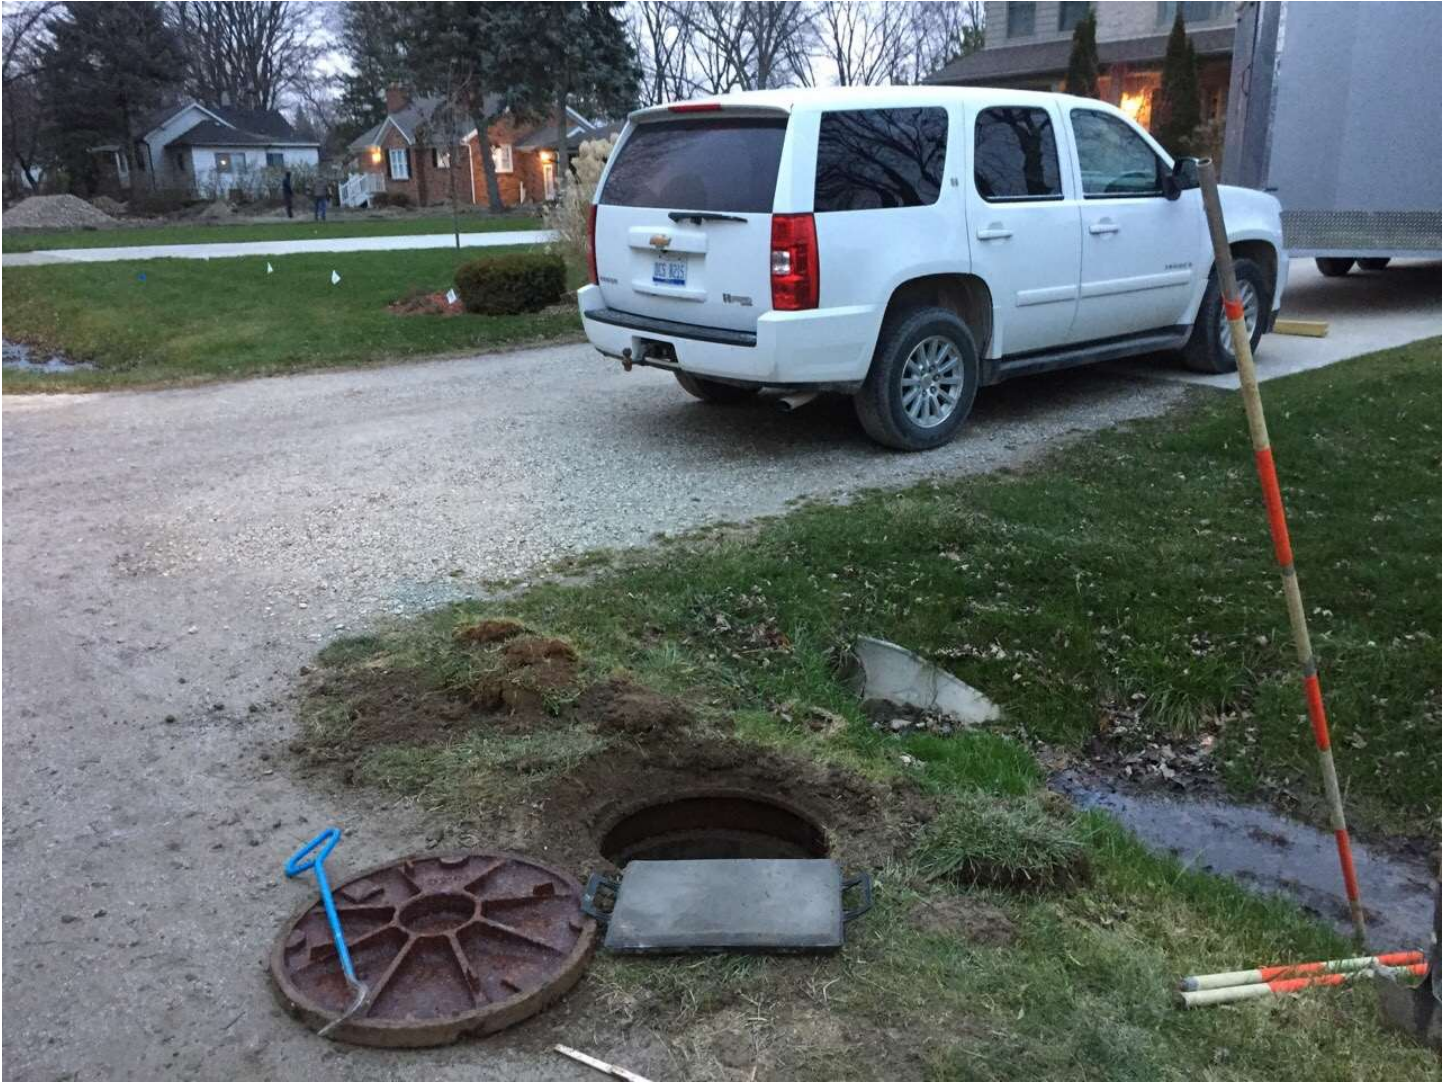
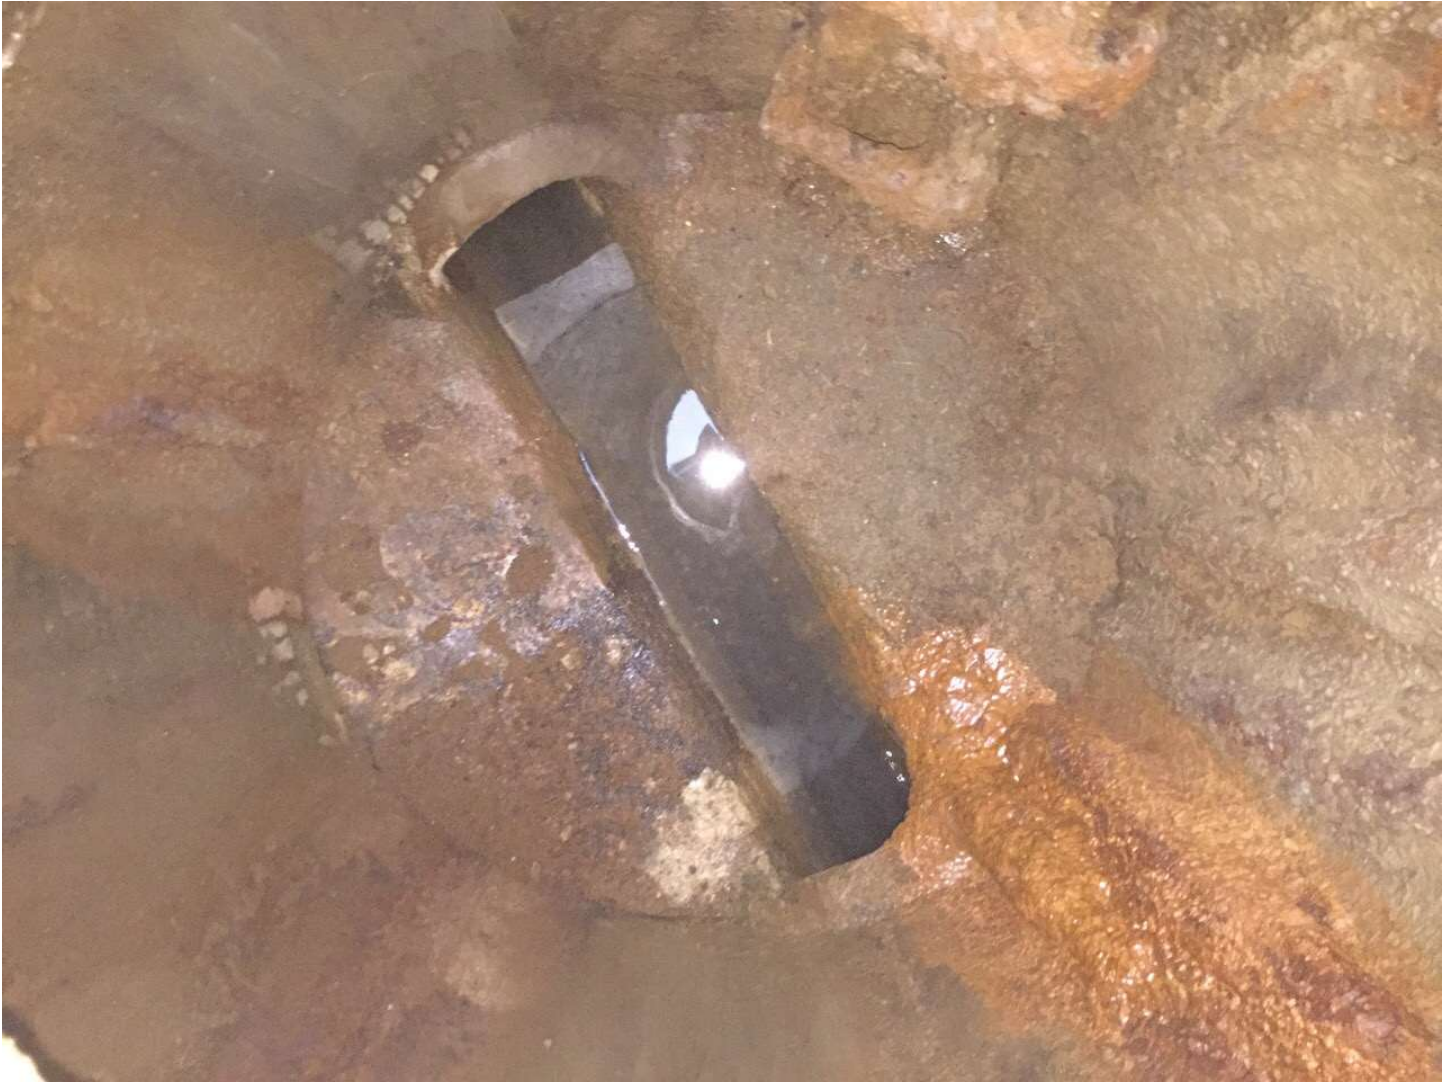
M2-32-P1-32N-P2-10E-5

Recommendation 7	<null>	Recommendation 8	<null>
Manhole Rating	3 – Failure likely in 10 to 20 years (Fair)	Comments	Brick/block chimney, roadside of dirt road e of driveway
