Manhole Inspection Form

M2-16-36-P5-6E-9-4-2-2

Community: Chesterfield 4-2-2

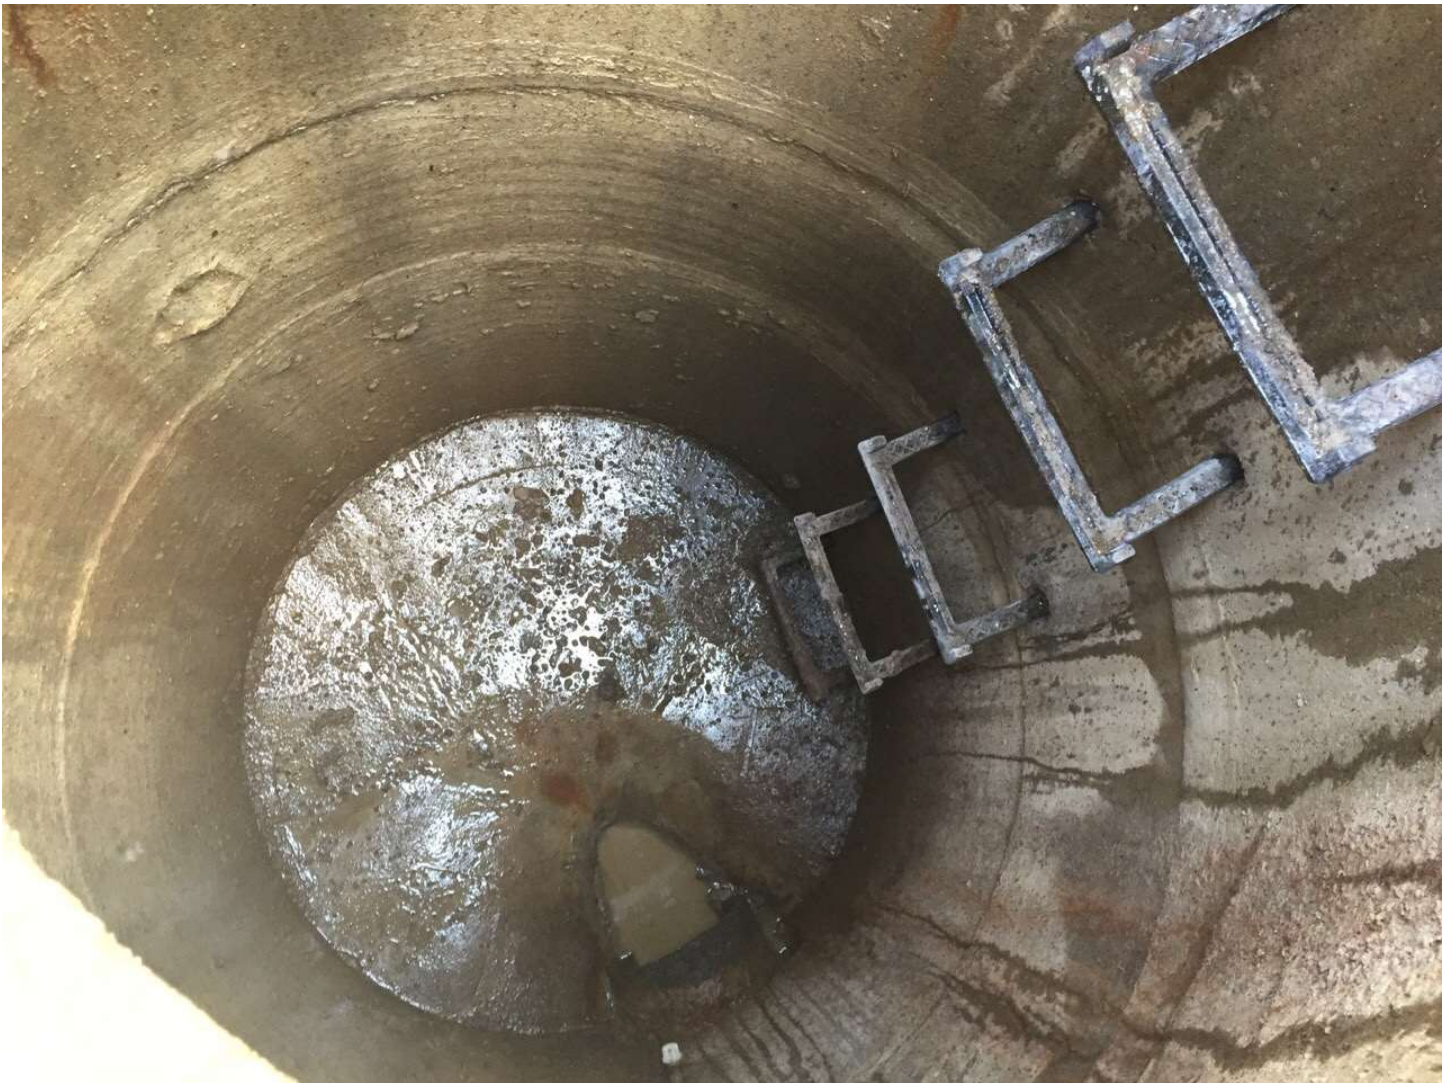
Manhole Number	M2-16-36-P5-6E-9-4-2-2	Historic Manhole Number	S Adele 6
Year Installed	1978	Structure Type	Sanitary Manhole
Street	S. Adele circle	Address	51310
Elevation	589.168	Weather	Partly Cloudy
Temperature	75°	Ground Condition	Damp
Status	At Surface Grade	Location	Yard Front
Pavment Condition	<null>	Traffic	Two Lane Road
Inspector 1	JEF	Inspector 2	Amc
Cover Type	EJ 1040APT	Number of Cover Holes	Solid Cover
Catch Basin Cover	<null>	Cover Insert	No
Cover Gasket	No	Cover Grade	Cover is Below Grade
Grade Dist	0.9	Cover Fit	Good Fit
Cover Condition	Good	Frame Condition	Good
Frame Offset	<null>	Frame Seal Condition	Fair
Frame Seal Inflow	None	Frame Riser	No
Frame Riser Height	<null>	Frame Riser Material	<null>
Manhole Diameter	48	Manhole Depth	9
Chimney Depth	0.45	Chimney Construction	Precast
Chimney Condition	Fair	Chimney Inflow	Low
Cone Shape	<null>	Cone Depth	26
Cone Construction	Precast	Cone Condition	Fair

Cone Inflow	Low	Cone Defect Location	Cone Surface
Wall Construction	Precast	Wall Condition	Good
Wall Inflow	Low	Wall Defect Location	Wall Joint +
Wall Defect Location 2	<null>	Wall Defect Location 3	<null>
Wall Defect Location 4	<null>	Wall Defect Location 5	<null>
Bench Construction	Poured	Bench Condition	Good
Bench Inflow	None	Channel Construction	Poured
Channel Condition	Good	Channel Inflow	None
Channel Hydraulics	Good	Channel Exposure	Fully

Pipe 6 Flow	<null>	Pipe 6 Diameter	<null>
Pipe 6 Direction	<null>	Pipe 6 Depth	<null>
Pipe 6 Material	<null>	Pipe 6 Seal Condition	<null>
Pipe 6 Drop	<null>	Pipe 6 Comments	<null>
Recommendation 1	Internal Chimney Seal	Recommendation 2	Seal Wall Joints
Recommendation 3	Point Pipes	Recommendation 4	<null>
Recommendation 5	<null>	Recommendation 6	<null>

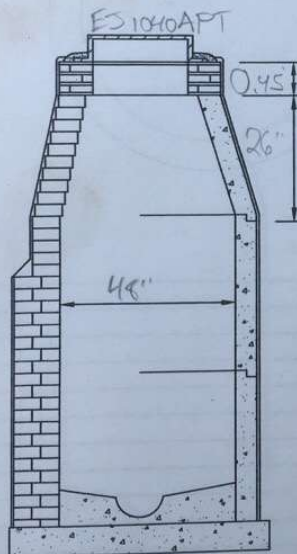
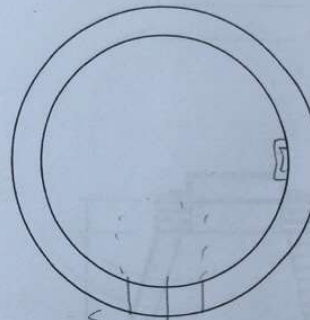
Manhole Number: M2-16-36-P5-6E-9

R.T. = 9.00

D = 48"
