Manhole Inspection Form

M2-16-36-P5-6E-9-4-5-6

Community: Chesterfield

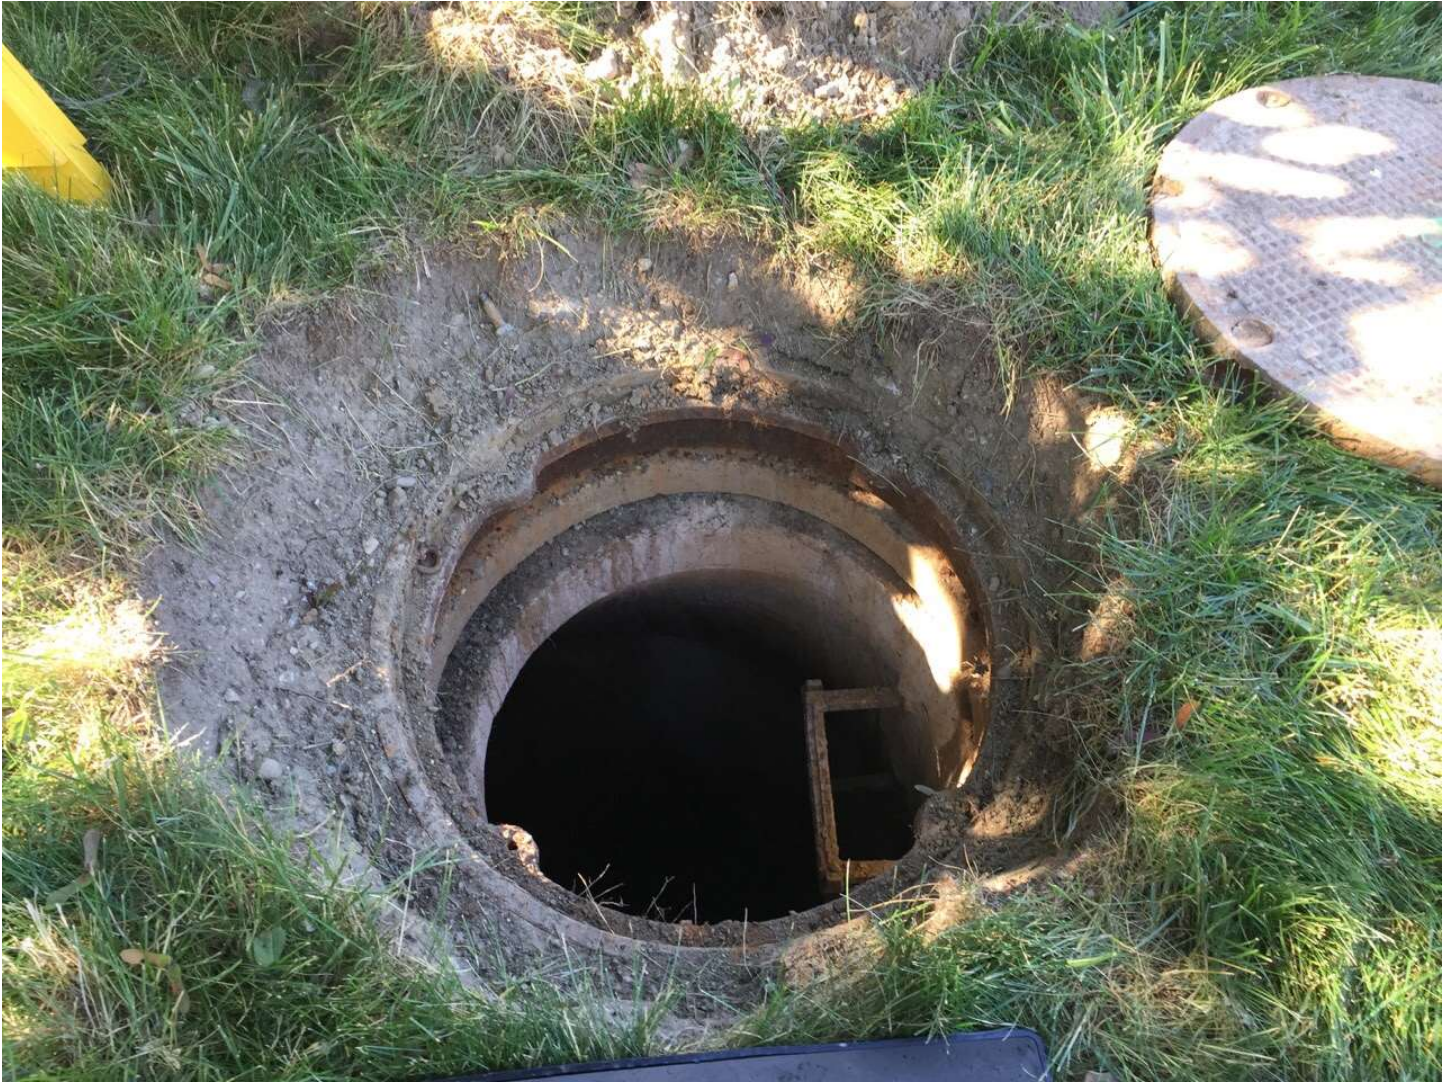
Manhole Number	M2-16-36-P5-6E-9-4-5-6	Historic Manhole Number	Deborah 6
Year Installed	1978	Structure Type	Sanitary Manhole
Street	Deborah	Address	51796
Elevation	591.756	Weather	Partly Cloudy
Temperature	60°	Ground Condition	Dry
Status	At Surface Grade	Location	Yard Front
Pavment Condition	<null>	Traffic	<null>
Inspector 1	Npt	Inspector 2	Ac
Cover Type	Ej 1040apt	Number of Cover Holes	Solid Cover
Catch Basin Cover	<null>	Cover Insert	No
Cover Gasket	Yes	Cover Grade	Cover is Below Grade
Grade Dist	4	Cover Fit	Good Fit
Cover Condition	Corroded	Frame Condition	Fair
Frame Offset	<null>	Frame Seal Condition	Fair
Frame Seal Inflow	Low	Frame Riser	No
Frame Riser Height	<null>	Frame Riser Material	<null>
Manhole Diameter	48	Manhole Depth	9.45
Chimney Depth	0.9	Chimney Construction	Precast
Chimney Condition	Fair	Chimney Inflow	Low
Cone Shape	<null>	Cone Depth	36
Cone Construction	Precast	Cone Condition	Fair
Cone Inflow	Low	Cone Defect Location	Wall/Cone Joint

Wall Construction	Precast	Wall Condition	Fair
Wall Inflow	Low	Wall Defect Location	Wall Joint
Wall Defect Location 2	<null>	Wall Defect Location 3	<null>
Wall Defect Location 4	<null>	Wall Defect Location 5	<null>
Bench Construction	Poured	Bench Condition	Good
Bench Inflow	None	Channel Construction	Poured
Channel Condition	Good	Channel Inflow	None
Channel Hydraulics	Fair	Channel Exposure	Fully

Pipe 5 Drop	<null>	Pipe 5 Comments	<null>
Pipe 6 Flow	<null>	Pipe 6 Diameter	<null>
Pipe 6 Direction	<null>	Pipe 6 Depth	<null>
Pipe 6 Material	<null>	Pipe 6 Seal Condition	<null>
Pipe 6 Drop	<null>	Pipe 6 Comments	<null>
Recommendation 1	Seal Wall Joints	Recommendation 2	Point Pipes
Recommendation 3	<null>	Recommendation 4	<null>
Recommendation 5	<null>	Recommendation 6	<null>

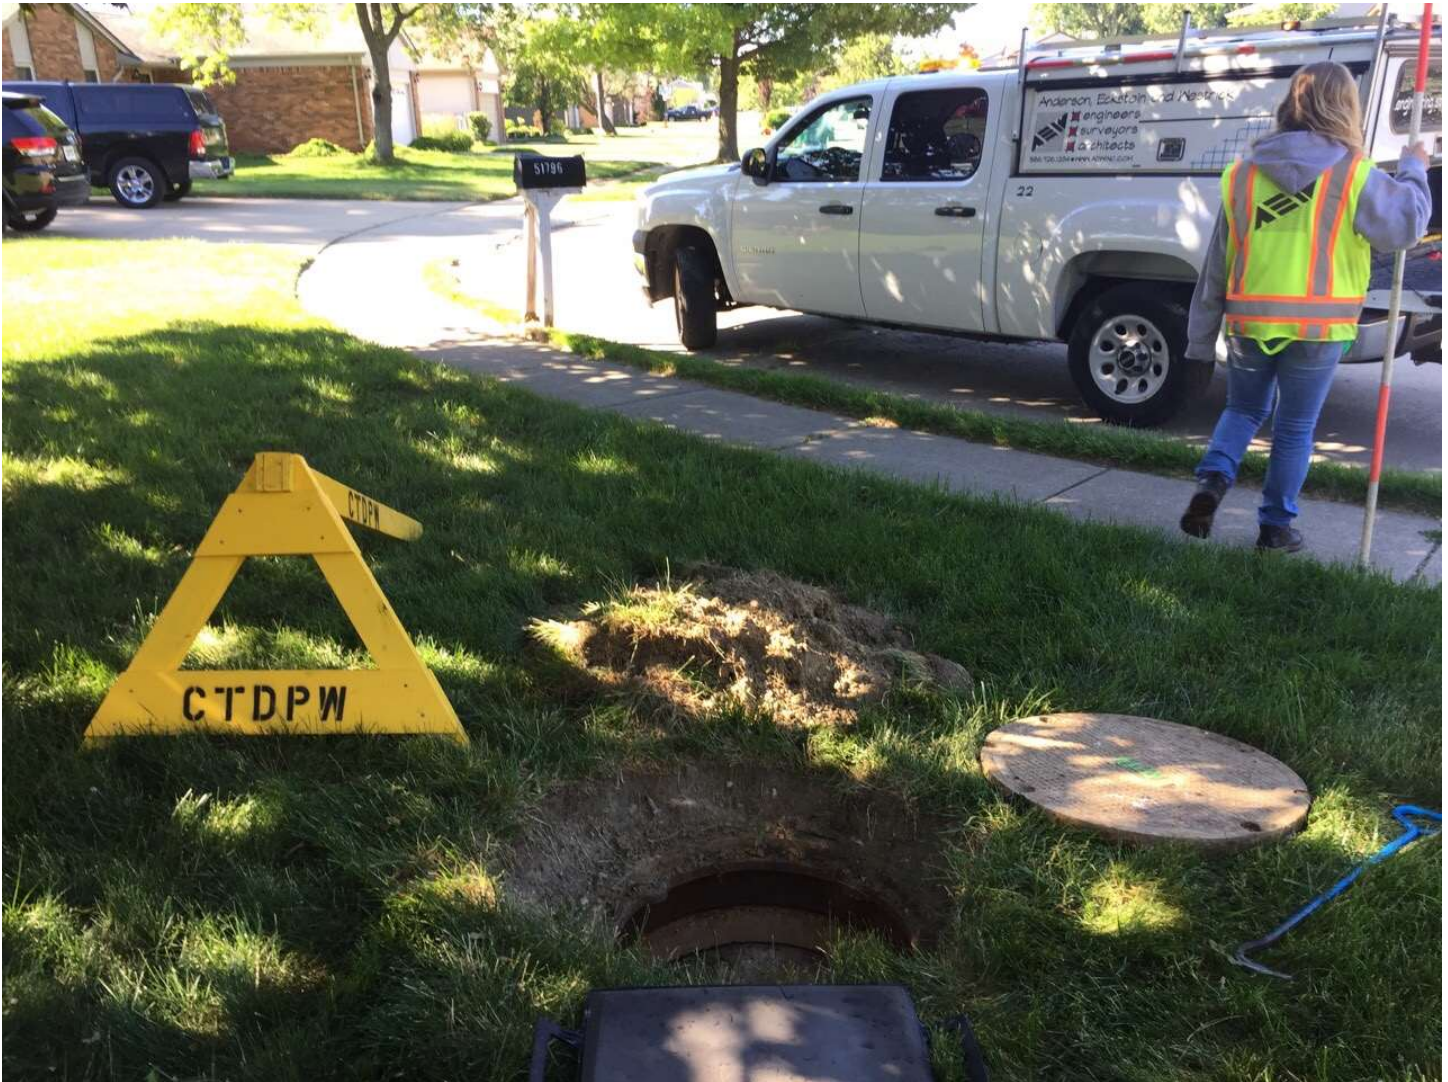
Step Construction	Plastic	Step Condition	Fair
Surcharge Evidence	<null>		
Pipe 1 Flow	Outward Flow	Pipe 1 Diameter	12
Pipe 1 Direction	SE	Pipe 1 Depth	9.45
Pipe 1 Material	Truss	Pipe 1 Seal Condition	Poor
Pipe 1 Drop	<null>	Pipe 1 Comments	<null>
Pipe 2 Flow	<null>	Pipe 2 Diameter	<null>
Pipe 2 Direction	<null>	Pipe 2 Depth	<null>
Pipe 2 Material	<null>	Pipe 2 Seal Condition	<null>
Pipe 2 Drop	<null>	Pipe 2 Comments	<null>
Pipe 3 Flow	<null>	Pipe 3 Diameter	<null>
Pipe 3 Direction	<null>	Pipe 3 Depth	<null>
Pipe 3 Material	<null>	Pipe 3 Seal Condition	<null>
Pipe 3 Drop	<null>	Pipe 3 Comments	<null>
Pipe 4 Flow	<null>	Pipe 4 Diameter	<null>
Pipe 4 Direction	<null>	Pipe 4 Depth	<null>
Pipe 4 Material	<null>	Pipe 4 Seal Condition	<null>
Pipe 4 Drop	<null>	Pipe 4 Comments	<null>
Pipe 5 Flow	<null>	Pipe 5 Diameter	<null>
Pipe 5 Direction	<null>	Pipe 5 Depth	<null>
Pipe 5 Material	<null>	Pipe 5 Seal Condition	<null>
