Manhole Inspection Form

M2-16-36-P5-6E-9-4-6

Manhole Number	M2-16-36-P5-6E-9-4-6	Historic Manhole Number	N Adele 1
Year Installed	1978	Structure Type	Sanitary Manhole
Street	Adelle	Address	51613
Elevation	589.192	Weather	Partly Cloudy
Temperature	65°	Ground Condition	Dry
Status	At Surface Grade	Location	Yard Front
Pavment Condition	<null>	Traffic	<null>
Inspector 1	Npt	Inspector 2	Ac
Cover Type	Ej 1040apt	Number of Cover Holes	Solid Cover
Catch Basin Cover	<null>	Cover Insert	No
Cover Gasket	Yes	Cover Grade	Cover is Below Grade
Grade Dist	6	Cover Fit	Good Fit
Cover Condition	Good	Frame Condition	Fair
Frame Offset	<null>	Frame Seal Condition	Fair
Frame Seal Inflow	Low	Frame Riser	No
Frame Riser Height	<null>	Frame Riser Material	<null>
Manhole Diameter	48	Manhole Depth	10.95
Chimney Depth	0.9	Chimney Construction	Precast
Chimney Condition	Fair	Chimney Inflow	Low
Cone Shape	<null>	Cone Depth	24
Cone Construction	Precast	Cone Condition	Good
Cone Inflow	Low	Cone Defect Location	<null>

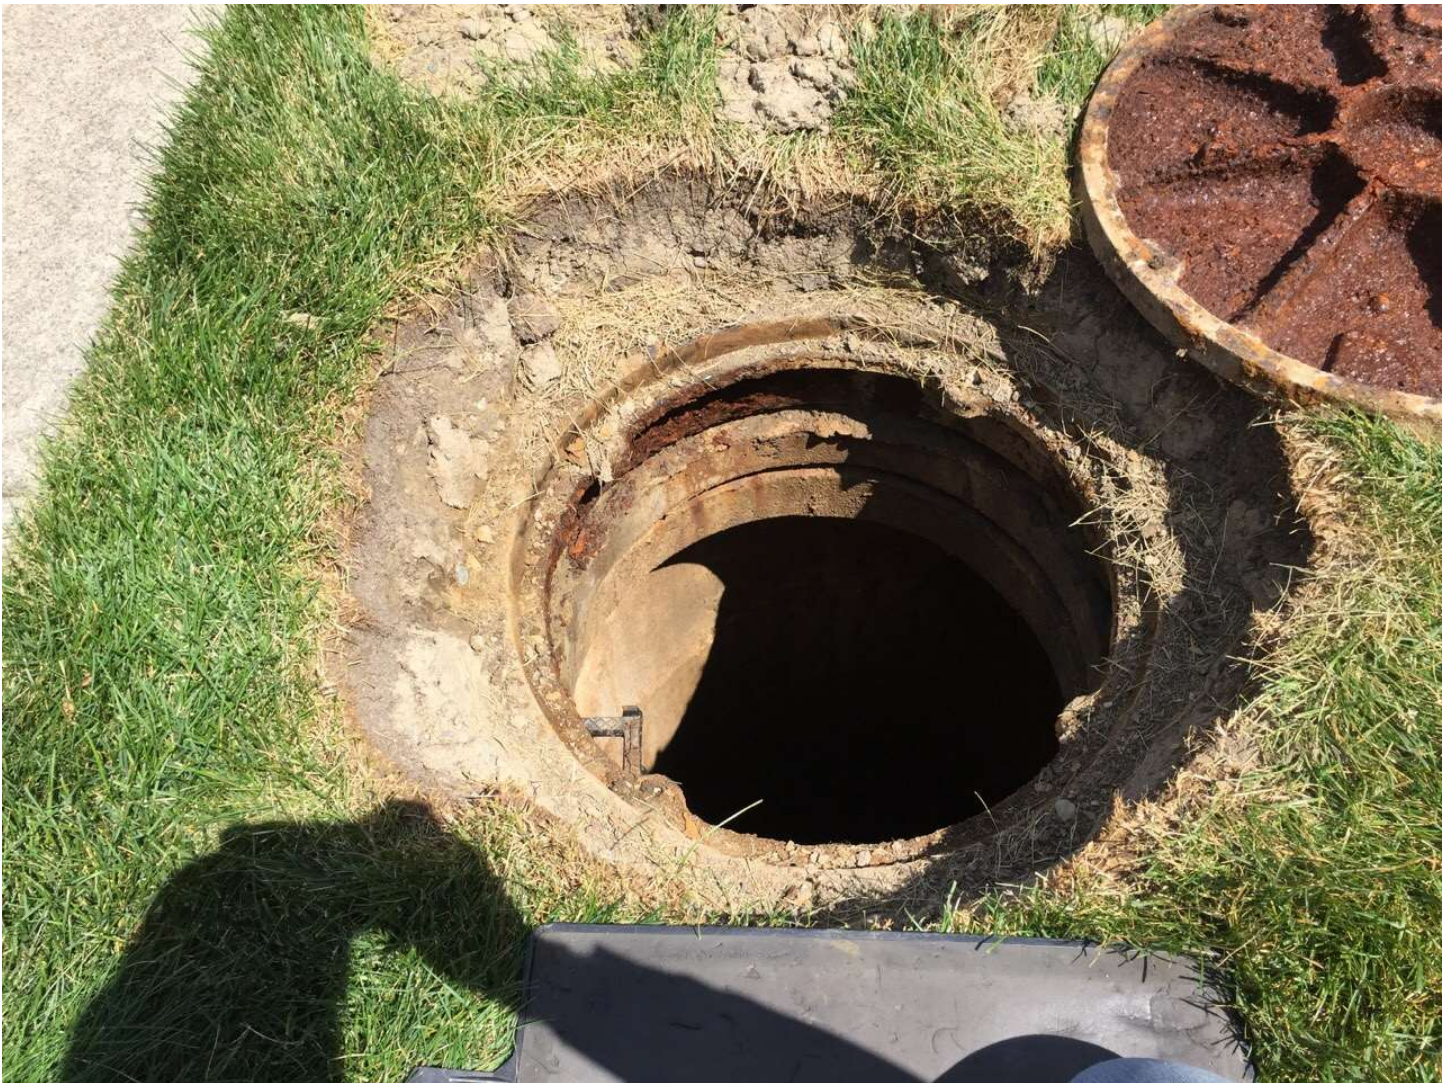
Wall Construction	Precast	Wall Condition	Fair
Wall Inflow	Low	Wall Defect Location	Wall Joint
Wall Defect Location 2	<null>	Wall Defect Location 3	<null>
Wall Defect Location 4	<null>	Wall Defect Location 5	<null>
Bench Construction	Poured	Bench Condition	Good
Bench Inflow	None	Channel Construction	Poured
Channel Condition	Good	Channel Inflow	None
Channel Hydraulics	Fair	Channel Exposure	Fully

Pipe 6 Flow	<null>	Pipe 6 Diameter	<null>
Pipe 6 Direction	<null>	Pipe 6 Depth	<null>
Pipe 6 Material	<null>	Pipe 6 Seal Condition	<null>
Pipe 6 Drop	<null>	Pipe 6 Comments	<null>
Recommendation 1	Seal Wall Joints	Recommendation 2	<null>
Recommendation 3	<null>	Recommendation 4	<null>
Recommendation 5	<null>	Recommendation 6	<null>
