# Manhole Inspection Form

M2-16-36-P5-6E-13-5W

Manhole Number: M2-16-36-P5-6E-13-5W  
Community: Chesterfield  
Inspector Initials: KMD / JEF

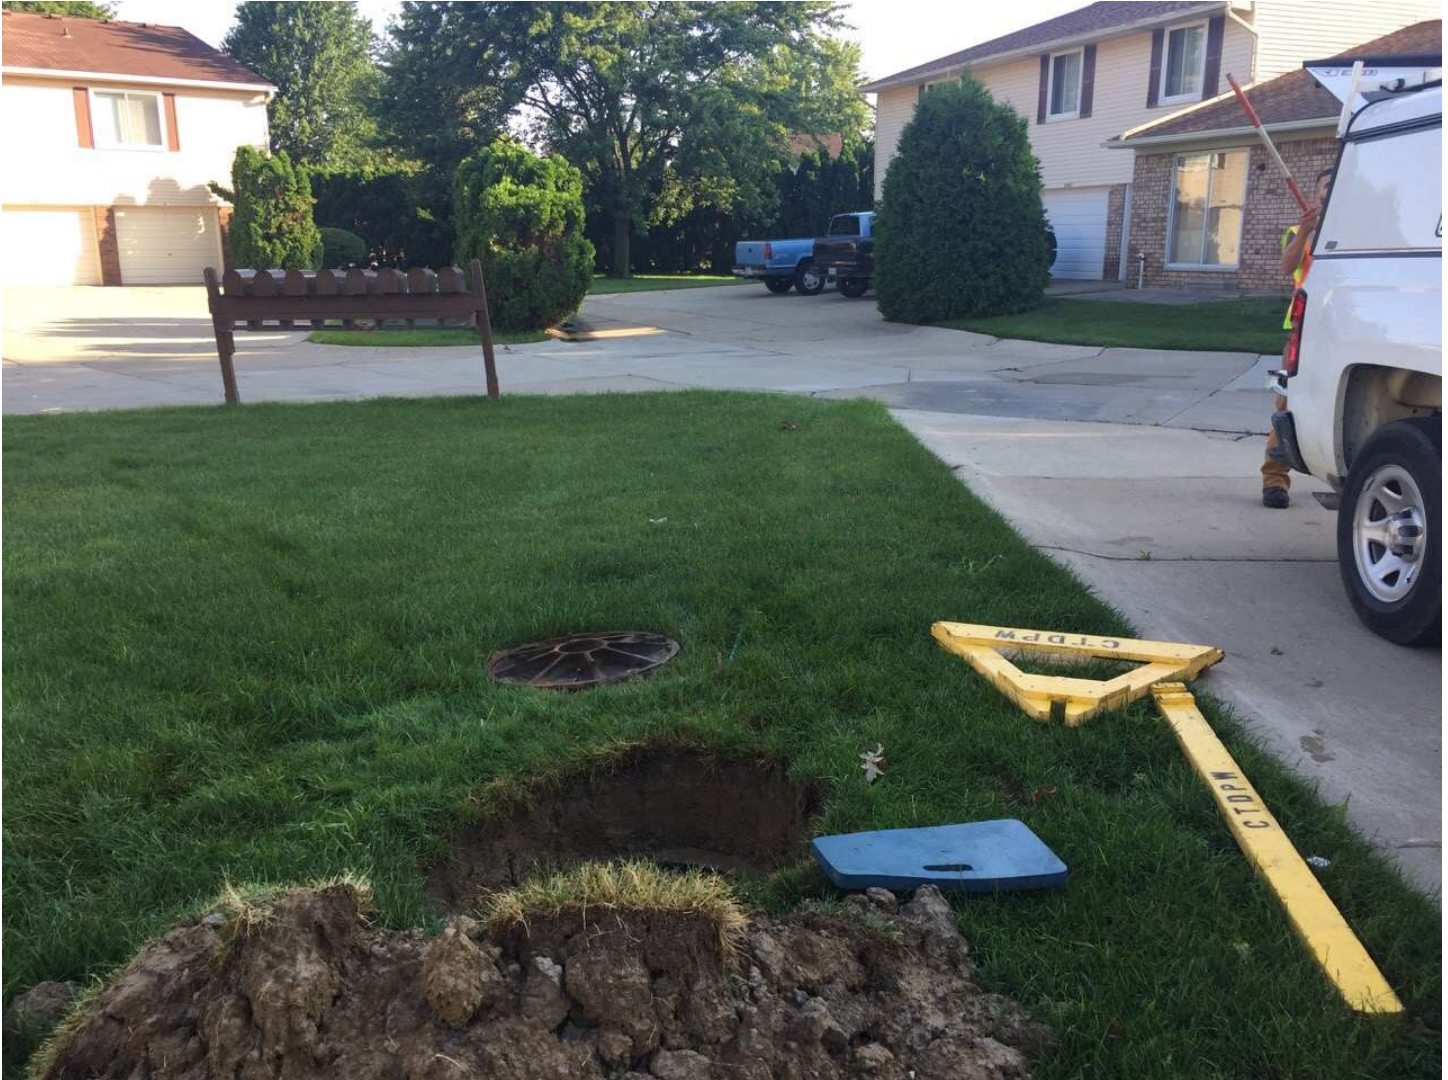
Manhole Number	M2-16-36-P5-6E-13-5W	Historic Manhole Number	Seaview 7
Year Installed	1974	Structure Type	Sanitary Manhole
Street	Breezeway (Seaview condos)	Address	31606
Elevation	588.309	Weather	Sunny
Temperature	70°	Ground Condition	Damp
Status	At Surface Grade	Location	Yard Front
Pavment Condition	N/A	Traffic	Two Lane Road
Inspector 1	Jef	Inspector 2	Amc
Cover Type	EJ 1040APT	Number of Cover Holes	Solid Cover
Catch Basin Cover	N/A	Cover Insert	No
Cover Gasket	Yes	Cover Grade	Cover is Below Grade
Grade Dist	1.1	Cover Fit	Good Fit
Cover Condition	Good	Frame Condition	Fair
Frame Offset	<null>	Frame Seal Condition	Good
Frame Seal Inflow	None	Frame Riser	No
Frame Riser Height	<null>	Frame Riser Material	N/A
Manhole Diameter	48	Manhole Depth	9.15
Chimney Depth	0.5	Chimney Construction	Precast
Chimney Condition	Good	Chimney Inflow	Low
Cone Shape	<null>	Cone Depth	31
Cone Construction	Precast	Cone Condition	Good
Cone Inflow	None	Cone Defect Location	<null>

Wall Construction	Precast	Wall Condition	Good
Wall Inflow	None	Wall Defect Location	<null>
Wall Defect Location 2	<null>	Wall Defect Location 3	<null>
Wall Defect Location 4	<null>	Wall Defect Location 5	<null>
Bench Construction	Poured	Bench Condition	Good
Bench Inflow	None	Channel Construction	None
Channel Condition	Good	Channel Inflow	None
Channel Hydraulics	Fair	Channel Exposure	Fully

Recommendation 7	<null>	Recommendation 8	<null>
Manhole Rating	2 – Failure unlikely in 20 years (Good)	Comments	<null>

Pipe 5 Drop	<null>	Pipe 5 Comments	<null>
Pipe 6 Flow	<null>	Pipe 6 Diameter	<null>
Pipe 6 Direction	<null>	Pipe 6 Depth	<null>
Pipe 6 Material	<null>	Pipe 6 Seal Condition	<null>
Pipe 6 Drop	<null>	Pipe 6 Comments	<null>
Recommendation 1	Internal Chimney Seal	Recommendation 2	Raise
Recommendation 3	<null>	Recommendation 4	<null>
Recommendation 5	<null>	Recommendation 6	<null>
