Manhole Inspection Form

M2-16-36-P5-6E-15-5

Manhole Number: m2-16-36-P5-6E-15-5
Community: Chesterfield
Inspector Initials: KMD / BRS

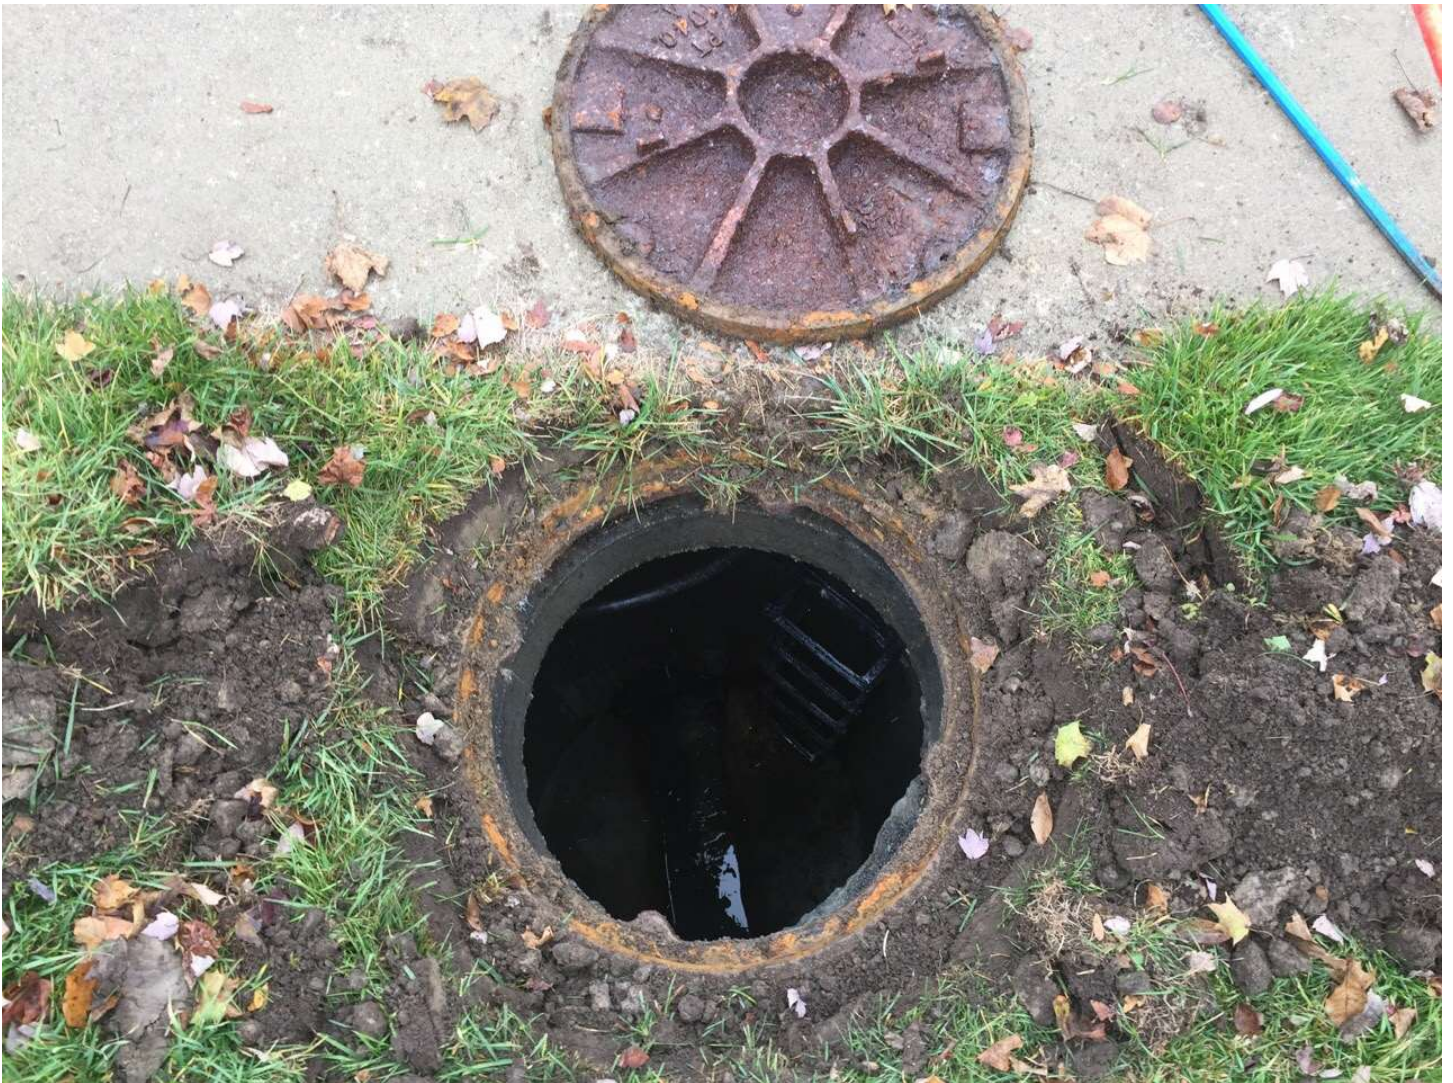
Recommendation 7	<null>	Recommendation 8	<null>
Manhole Rating	2 – Failure unlikely in 20 years (Good)	Comments	Buried 4",

Pipe 6 Flow	<null>	Pipe 6 Diameter	<null>
Pipe 6 Direction	<null>	Pipe 6 Depth	<null>
Pipe 6 Material	<null>	Pipe 6 Seal Condition	<null>
Pipe 6 Drop	<null>	Pipe 6 Comments	<null>
Recommendation 1	Raise	Recommendation 2	<null>
Recommendation 3	<null>	Recommendation 4	<null>
Recommendation 5	<null>	Recommendation 6	<null>
