Manhole Inspection Form

M2-16-36-P5-6E-15-10A

Community: Chesterfield

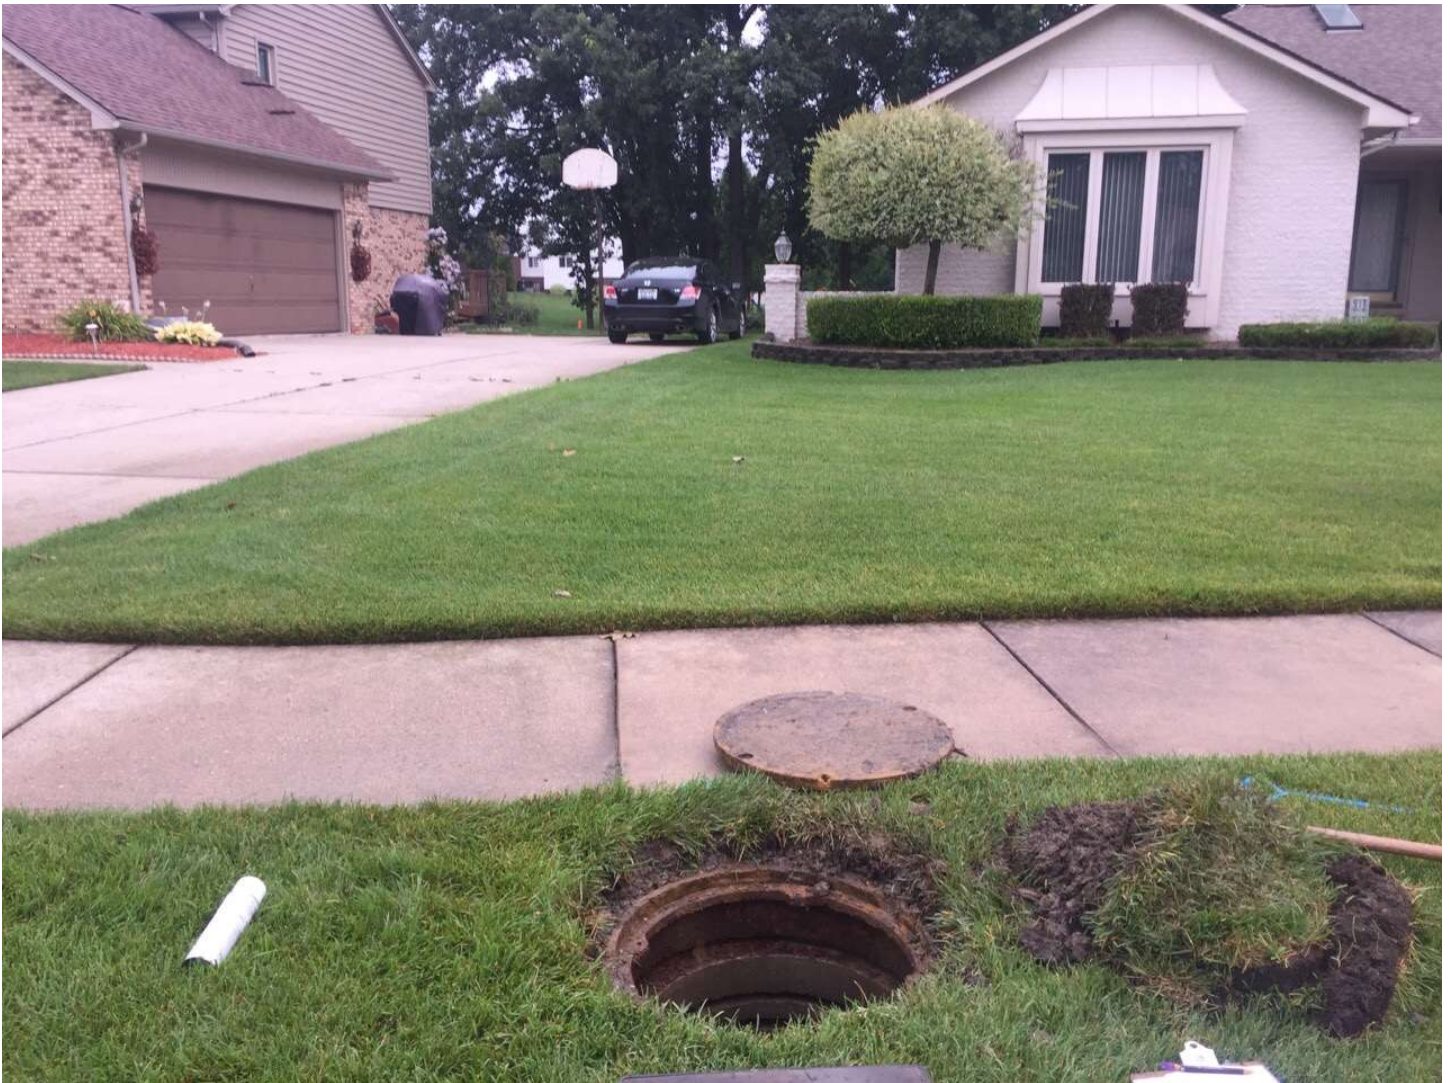
Recommendation 7	<null>	Recommendation 8	<null>
Manhole Rating	4 – Failure likely in 5 to 10 years (Poor)	Comments	Moderate inflow
