Manhole Inspection Form

M2-16-36-P5-10E-P6-3-1

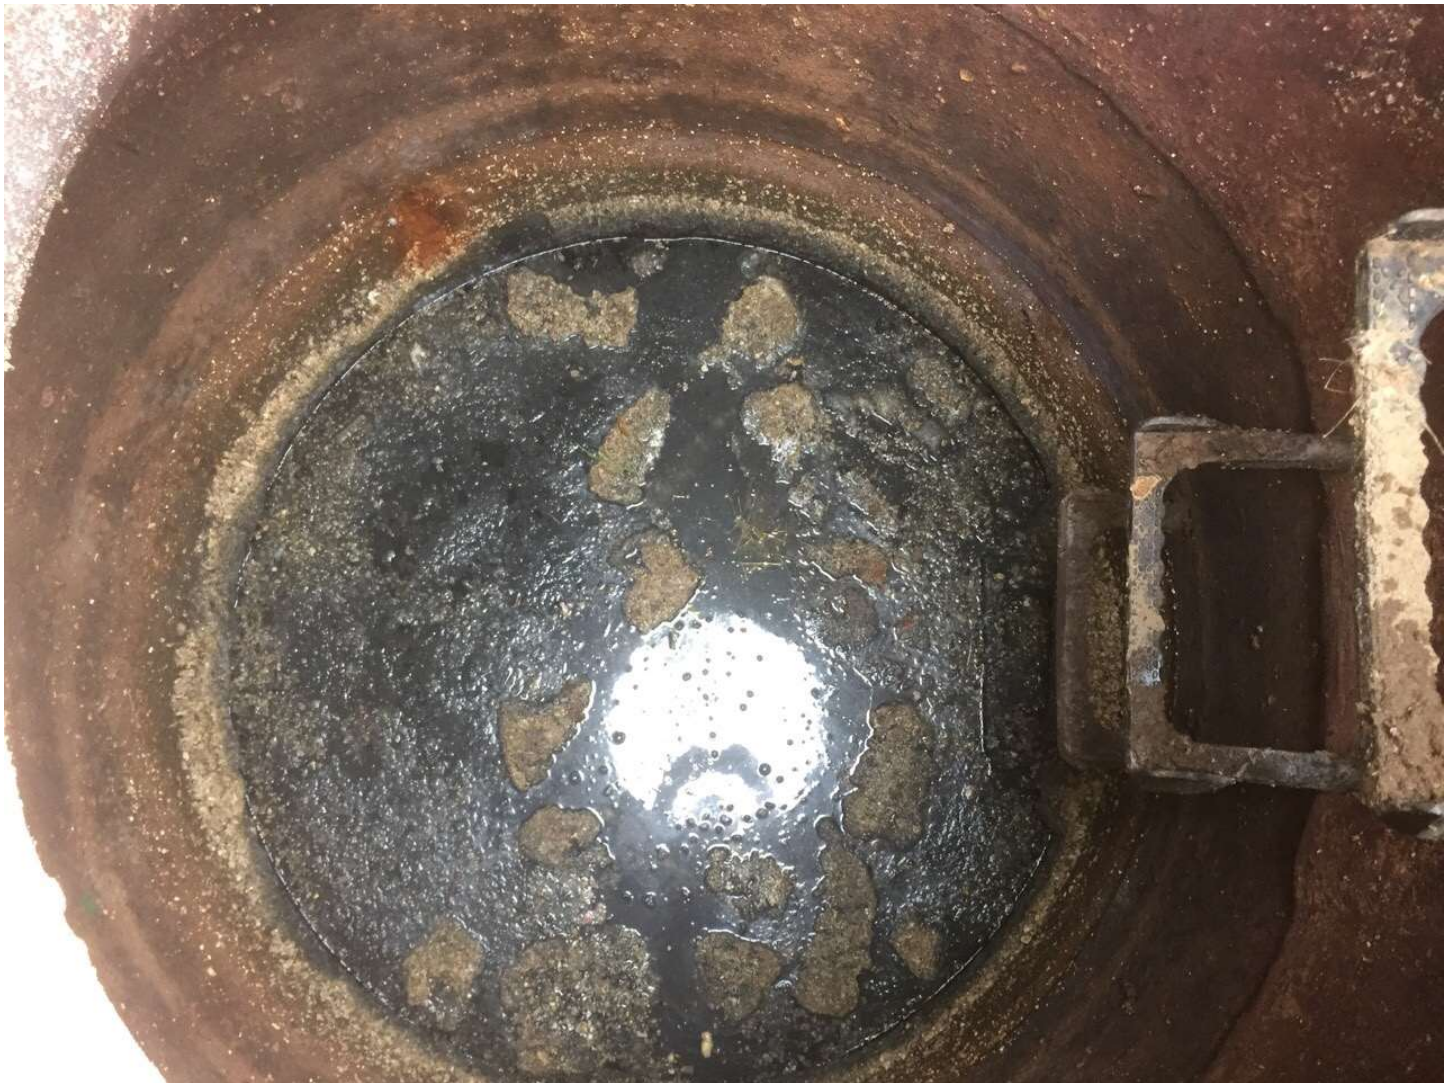
Wall Construction	Precast	Wall Condition	Poor
Wall Inflow	Heavy	Wall Defect Location	Entire Depth
Wall Defect Location 2	<null>	Wall Defect Location 3	<null>
Wall Defect Location 4	<null>	Wall Defect Location 5	<null>
Bench Construction	<null>	Bench Condition	<null>
Bench Inflow	<null>	Channel Construction	<null>
Channel Condition	<null>	Channel Inflow	<null>
Channel Hydraulics	<null>	Channel Exposure	<null>

Recommendation 7	<null>	Recommendation 8	<null>
Manhole Rating	4 – Failure likely in 5 to 10 years (Poor)	Comments

Pipe 5 Drop	<null>	Pipe 5 Comments	<null>
Pipe 6 Flow	<null>	Pipe 6 Diameter	<null>
Pipe 6 Direction	<null>	Pipe 6 Depth	<null>
Pipe 6 Material	<null>	Pipe 6 Seal Condition	<null>
Pipe 6 Drop	<null>	Pipe 6 Comments	<null>
Recommendation 1	Vector Clean	Recommendation 2	Seal Wall Joints
Recommendation 3	<null>	Recommendation 4	<null>
Recommendation 5	<null>	Recommendation 6	<null>
