# Manhole Inspection Form

M2-16-36-P5-10E-P6-7-7-1

Manhole Number: M2-16-36-P5-10E-P6-7-7-1  
 Community: Chesterfield  
 Inspector Initials: RES / KMD

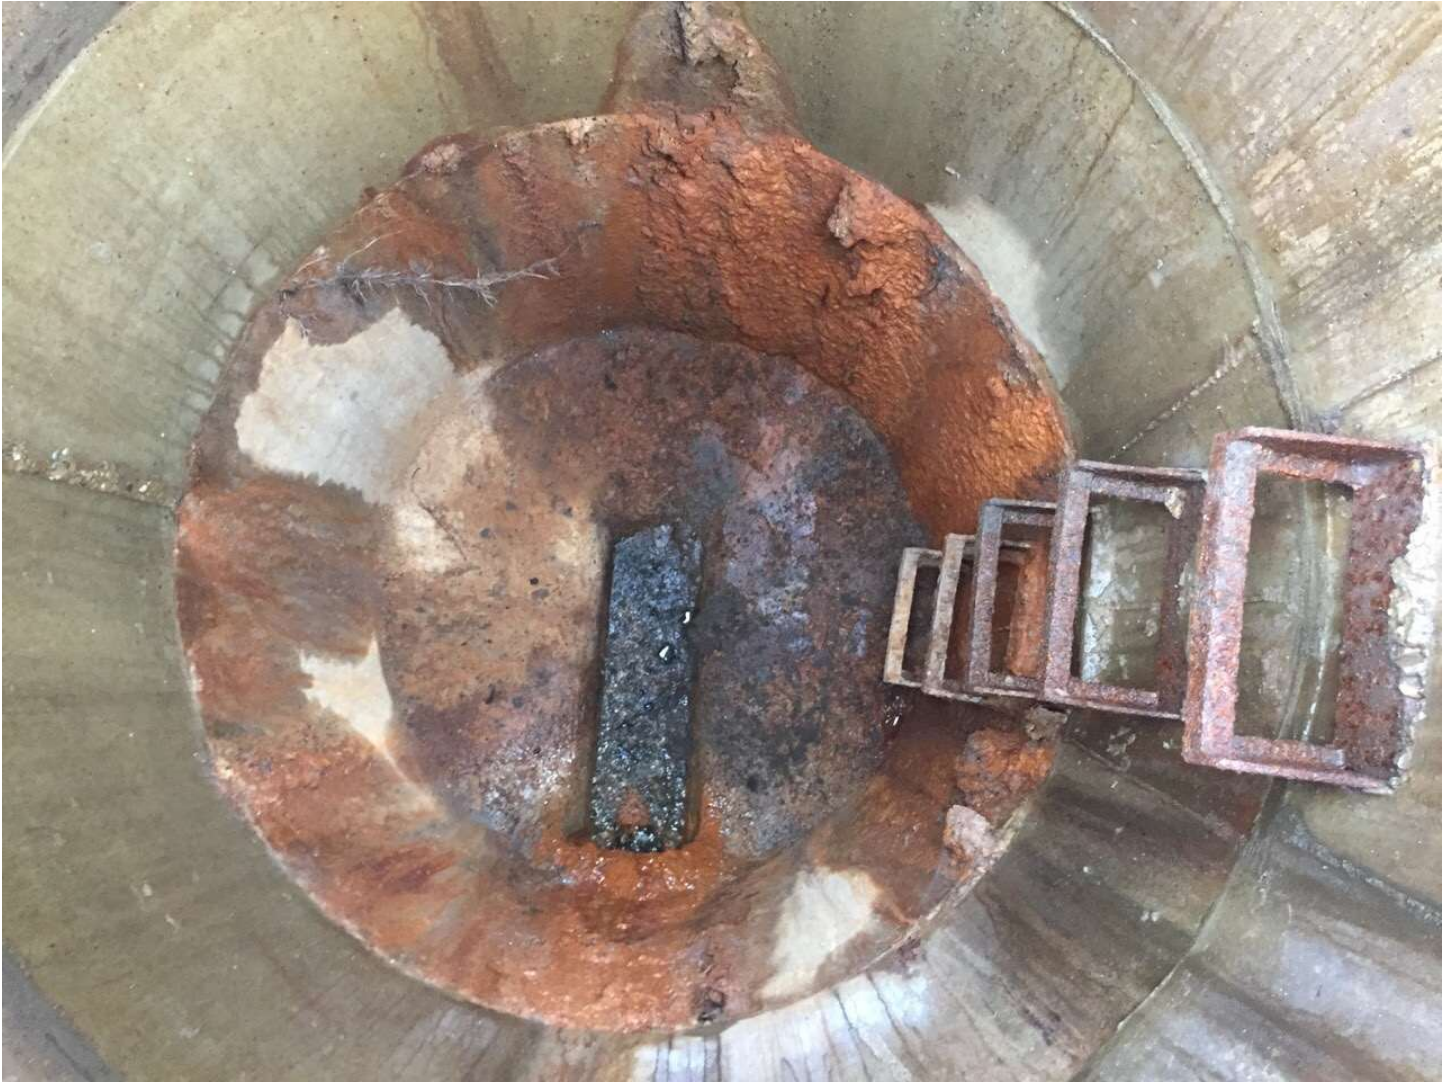
**Diagram 1: Cross-section of manhole**  
 Shows a brick-lined manhole with a depth of 30" and a diameter of 48". The top is covered with a concrete slab.

**Diagram 2: Plan view of manhole**  
 Shows a circular manhole with a dashed line indicating a **SPRINKLER LINE OVER COILER**. A note below the diagram reads: **(F) S-12 conc. 9.25**.
