Manhole Inspection Form

M2-16-36-P5-10E-P6-21-2

Community: Chesterfield

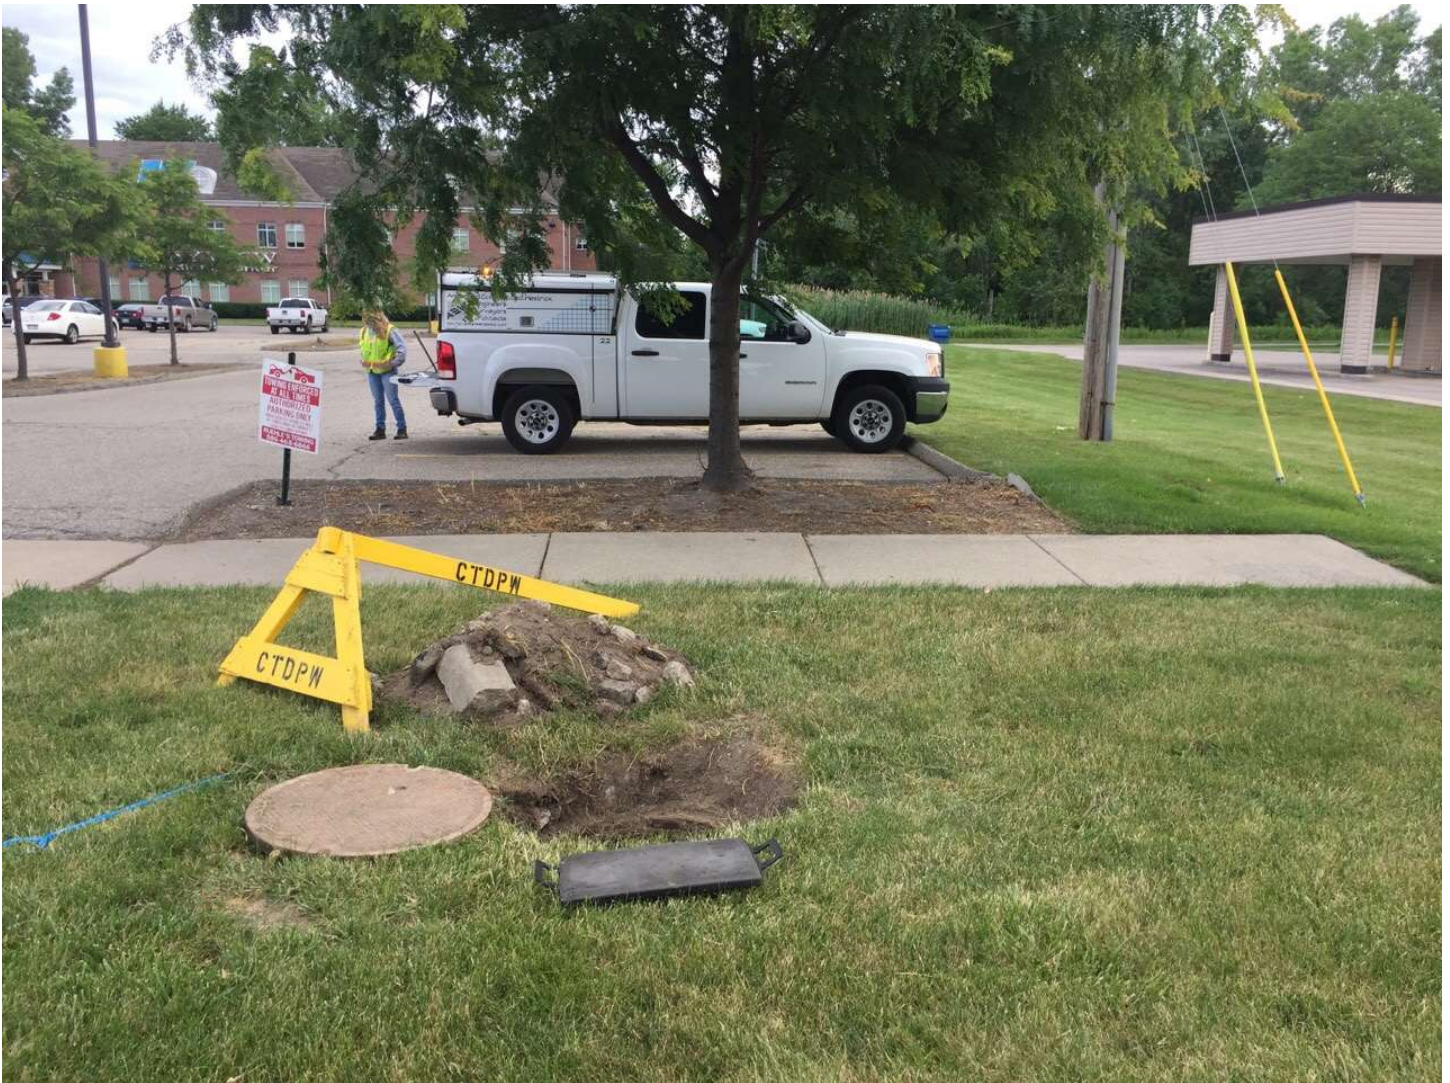
Wall Construction	Precast	Wall Condition	Fair
Wall Inflow	Low	Wall Defect Location	Wall Joint
Wall Defect Location 2	<null>	Wall Defect Location 3	<null>
Wall Defect Location 4	<null>	Wall Defect Location 5	<null>
Bench Construction	Poured	Bench Condition	Good
Bench Inflow	None	Channel Construction	Poured
Channel Condition	Good	Channel Inflow	None
Channel Hydraulics	Fair	Channel Exposure	Fully

Pipe 6 Flow	<null>	Pipe 6 Diameter	<null>
Pipe 6 Direction	<null>	Pipe 6 Depth	<null>
Pipe 6 Material	<null>	Pipe 6 Seal Condition	<null>
Pipe 6 Drop	<null>	Pipe 6 Comments	<null>
Recommendation 1	Seal Wall Joints	Recommendation 2	<null>
Recommendation 3	<null>	Recommendation 4	<null>
Recommendation 5	<null>	Recommendation 6	<null>
