# Manhole Inspection Form

M2-32-P1-32N-P2-5E-1-1A

| Street | Meldrum | Address | 33566 |

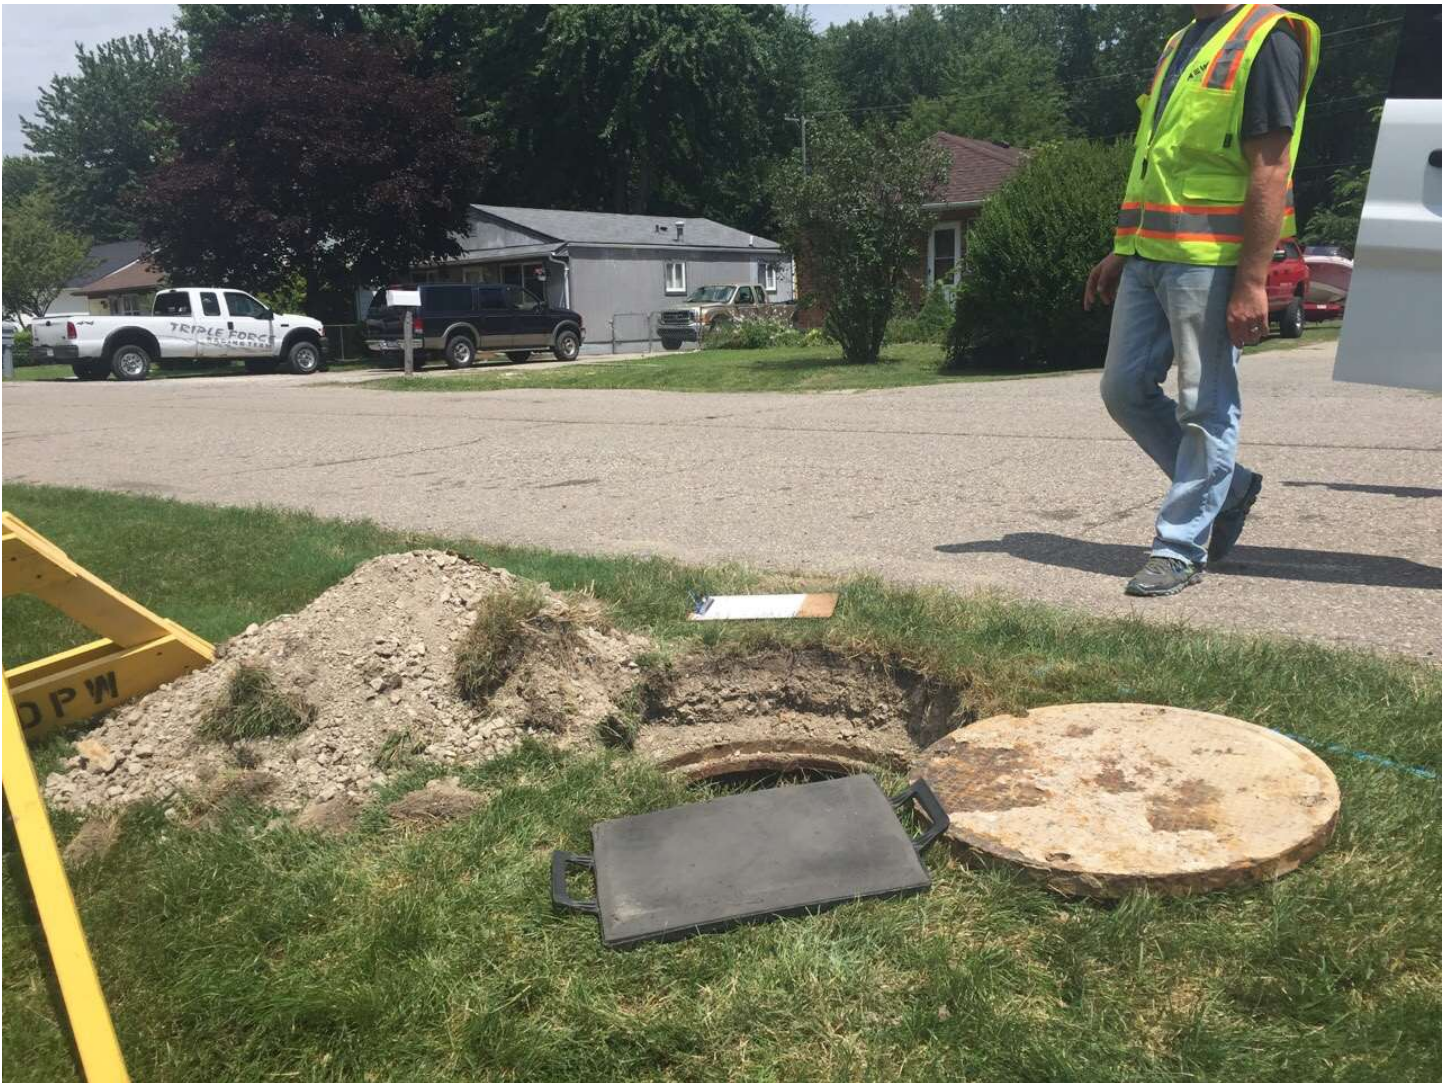
| Cover Gasket | No | Cover Grade | Cover is Below Grade |
| Frame Offset | 0 | Frame Seal Condition | Fair |
| Chimney Condition | Good | Chimney Inflow | Low |

| Recommendation 1 | <null> | Recommendation 2 | Internal Chimney Seal |
