Manhole Inspection Form

M2-32-P1-32N-P2-5E-1-3

Manhole Number: M2-32-P1-32N-P2-5E-1-3
Community: Chesterfield
Inspector Initials: AMC / OAD

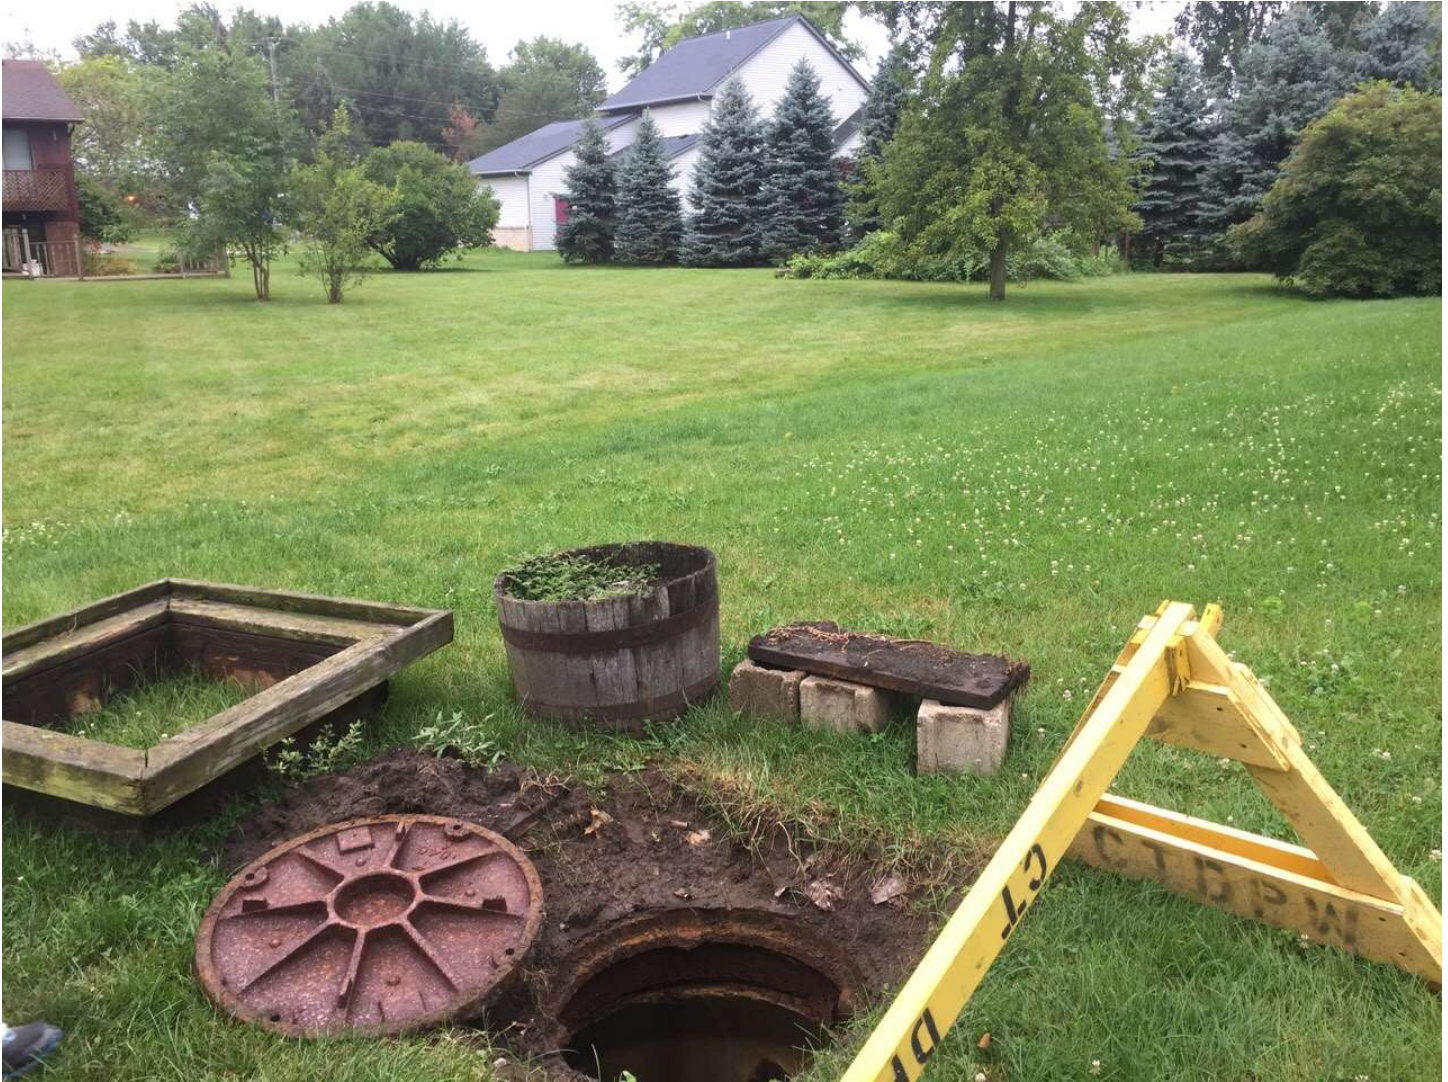
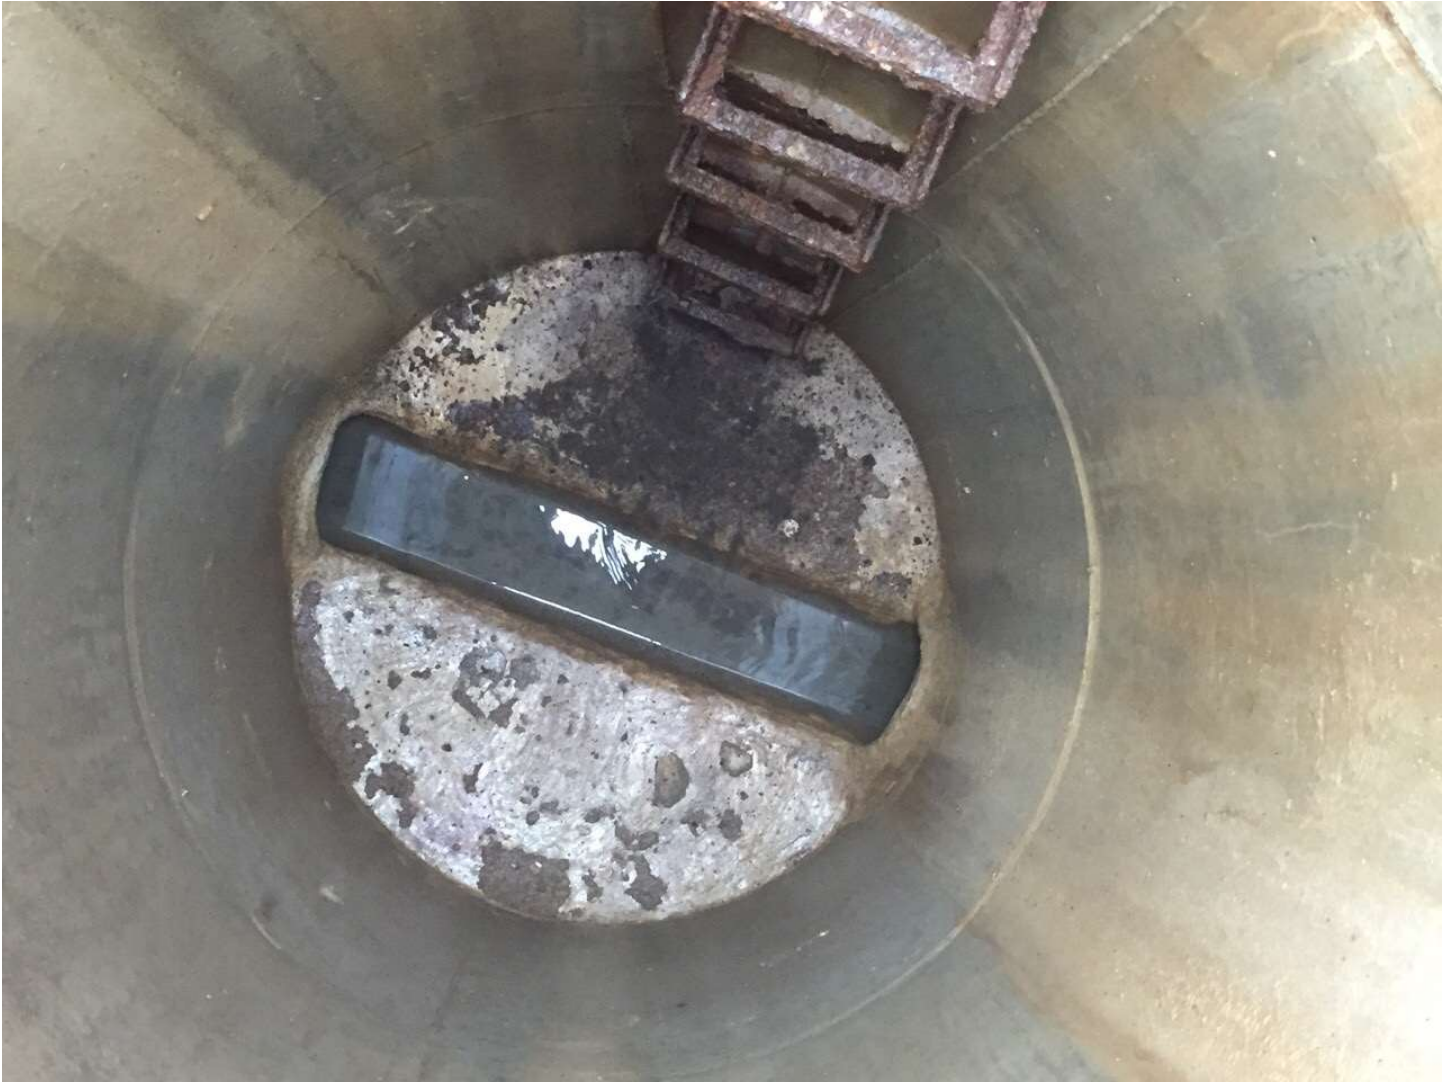
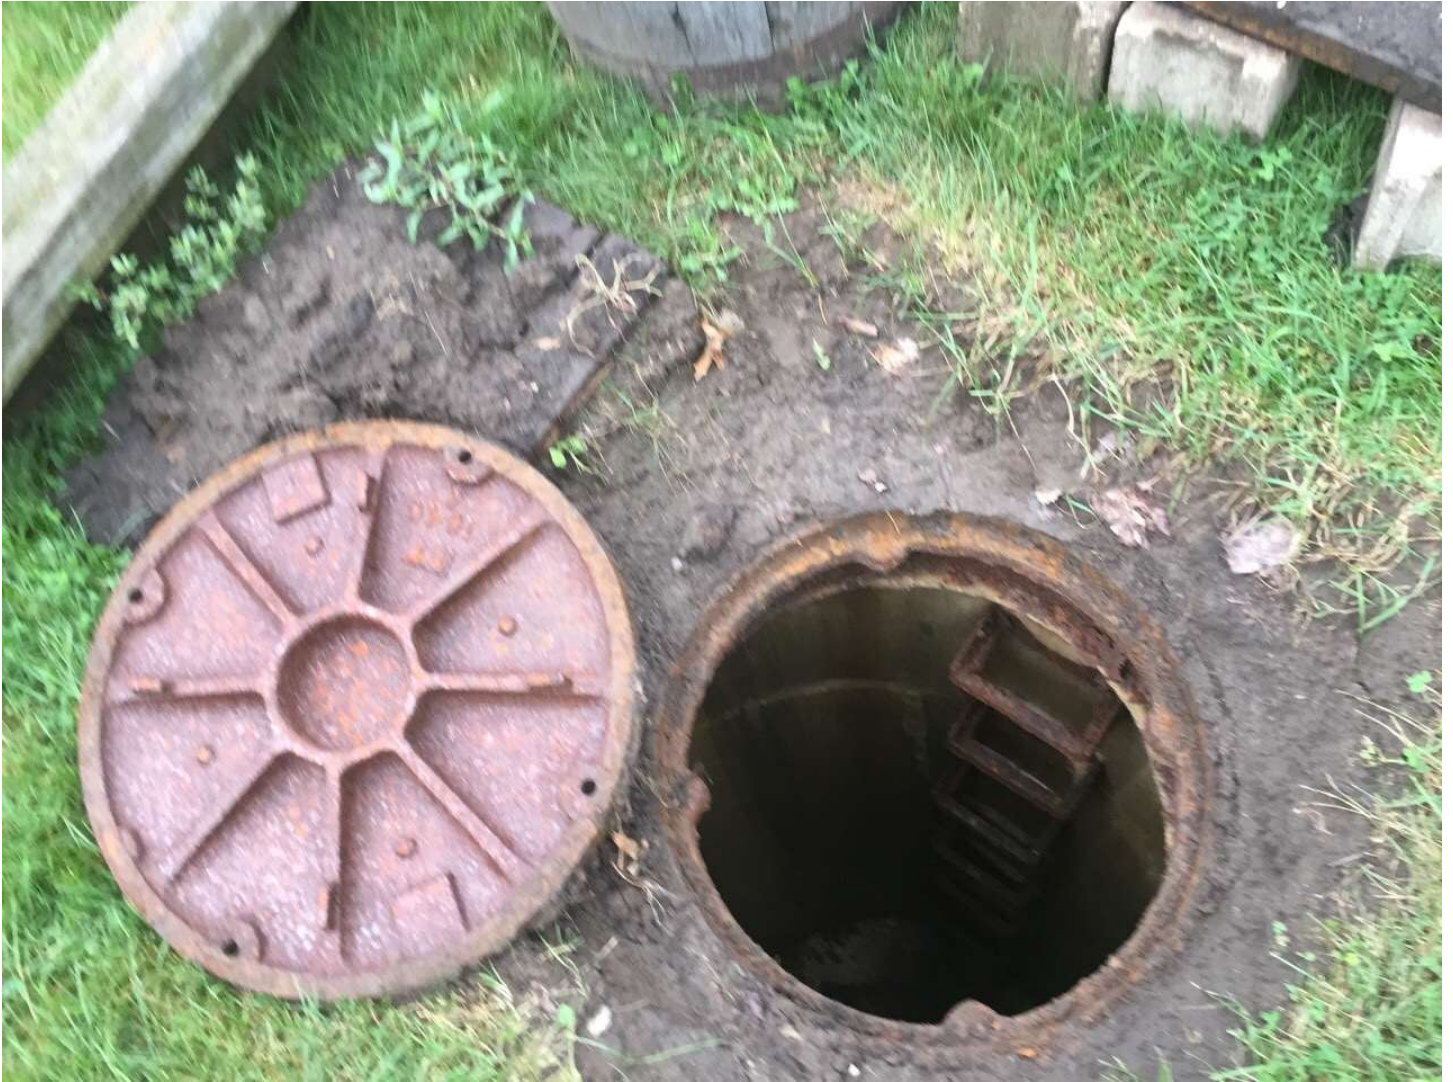
| Cone Construction | Precast | Cone Condition | Fair |
| Cone Inflow | Low | Cone Defect Location | Wall/Cone Joint |

| Manhole Rating | 3 – Failure likely in 10 to 20 years (Fair) | Comments | Pictures taken from south |

| Recommendation 1 | Internal Chimney Seal | Recommendation 2 | Seal Wall Joints |

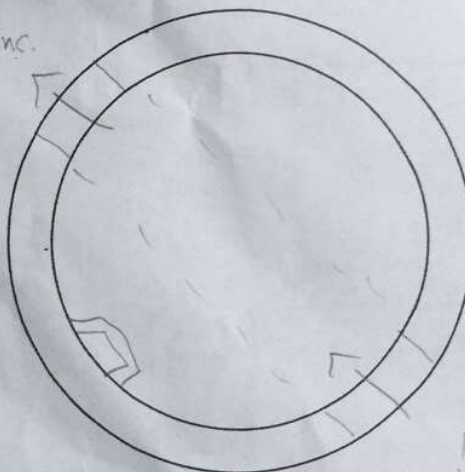
NW
10" Conc.
11.35'
G

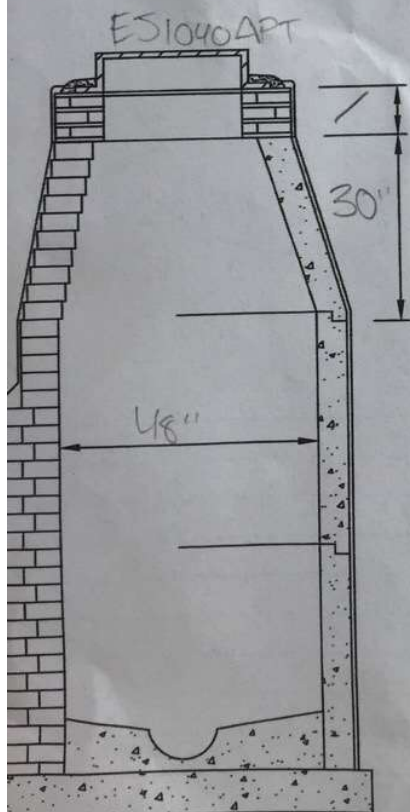
SE
10" Conc.
11.25'
G
