Manhole Inspection Form

M1-5-3-3-13-4-1-2

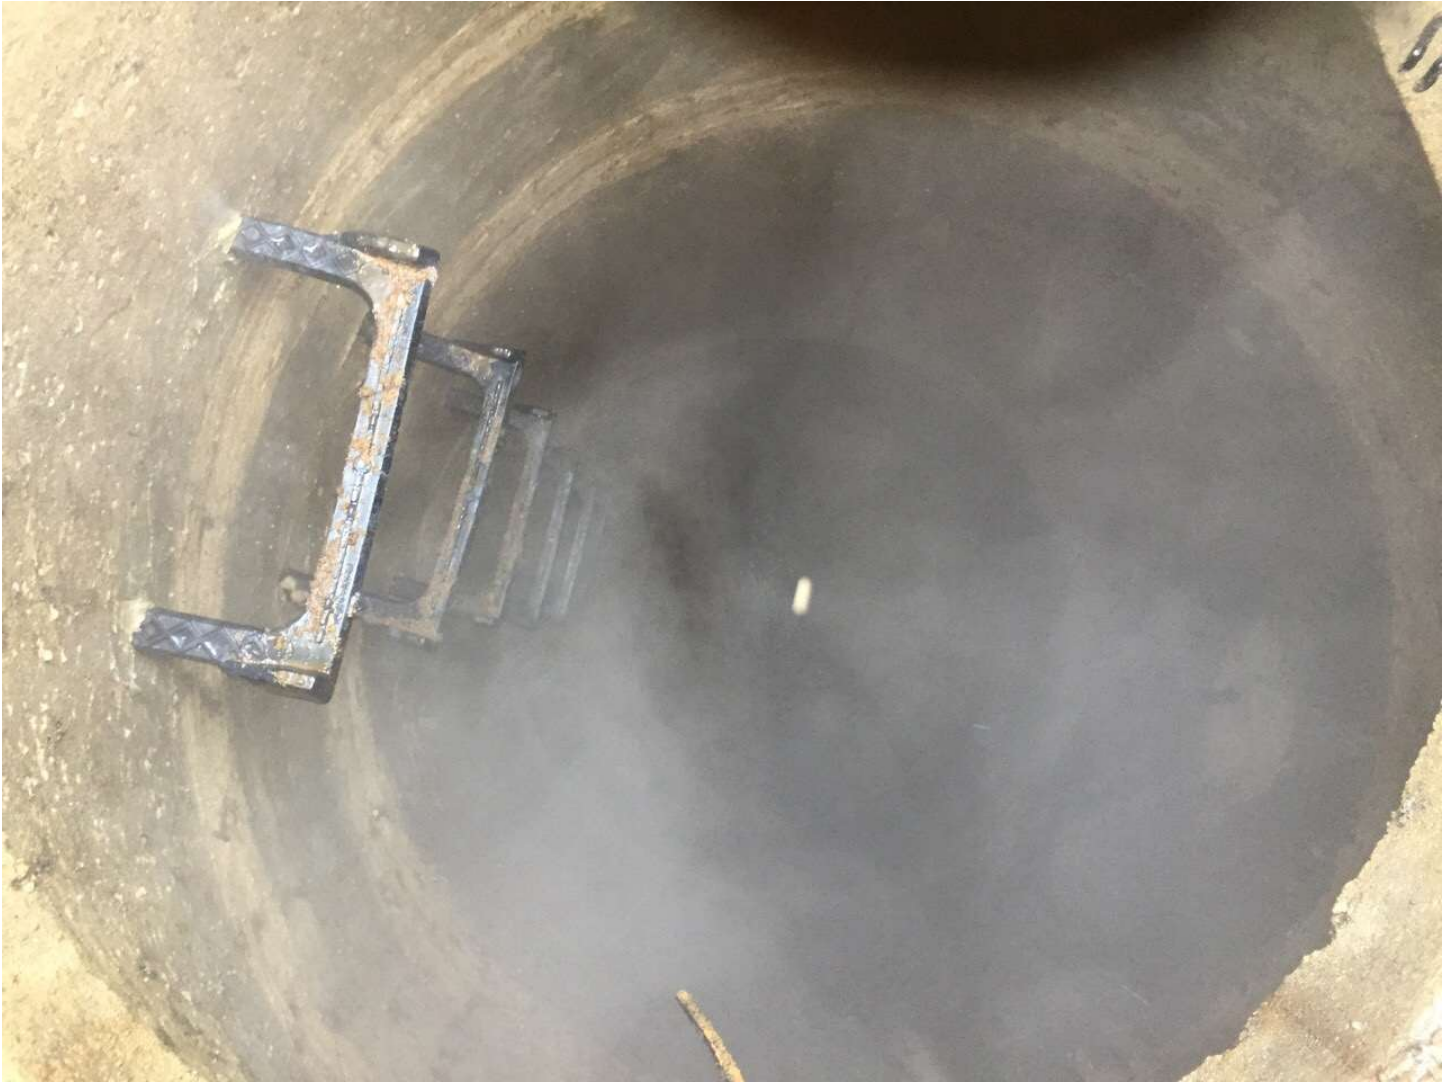
M1-5-3-3-13-4-1-2

Recommendation 7	<null>	Recommendation 8	<null>
Manhole Rating	2 – Failure unlikely in 20 years (Good)	Comments	Buried 6" next to driveway
