Manhole Inspection Form

M2-16-25-5-P4-18-3W-1

Community: Chesterfield

Address: 51020 West Village

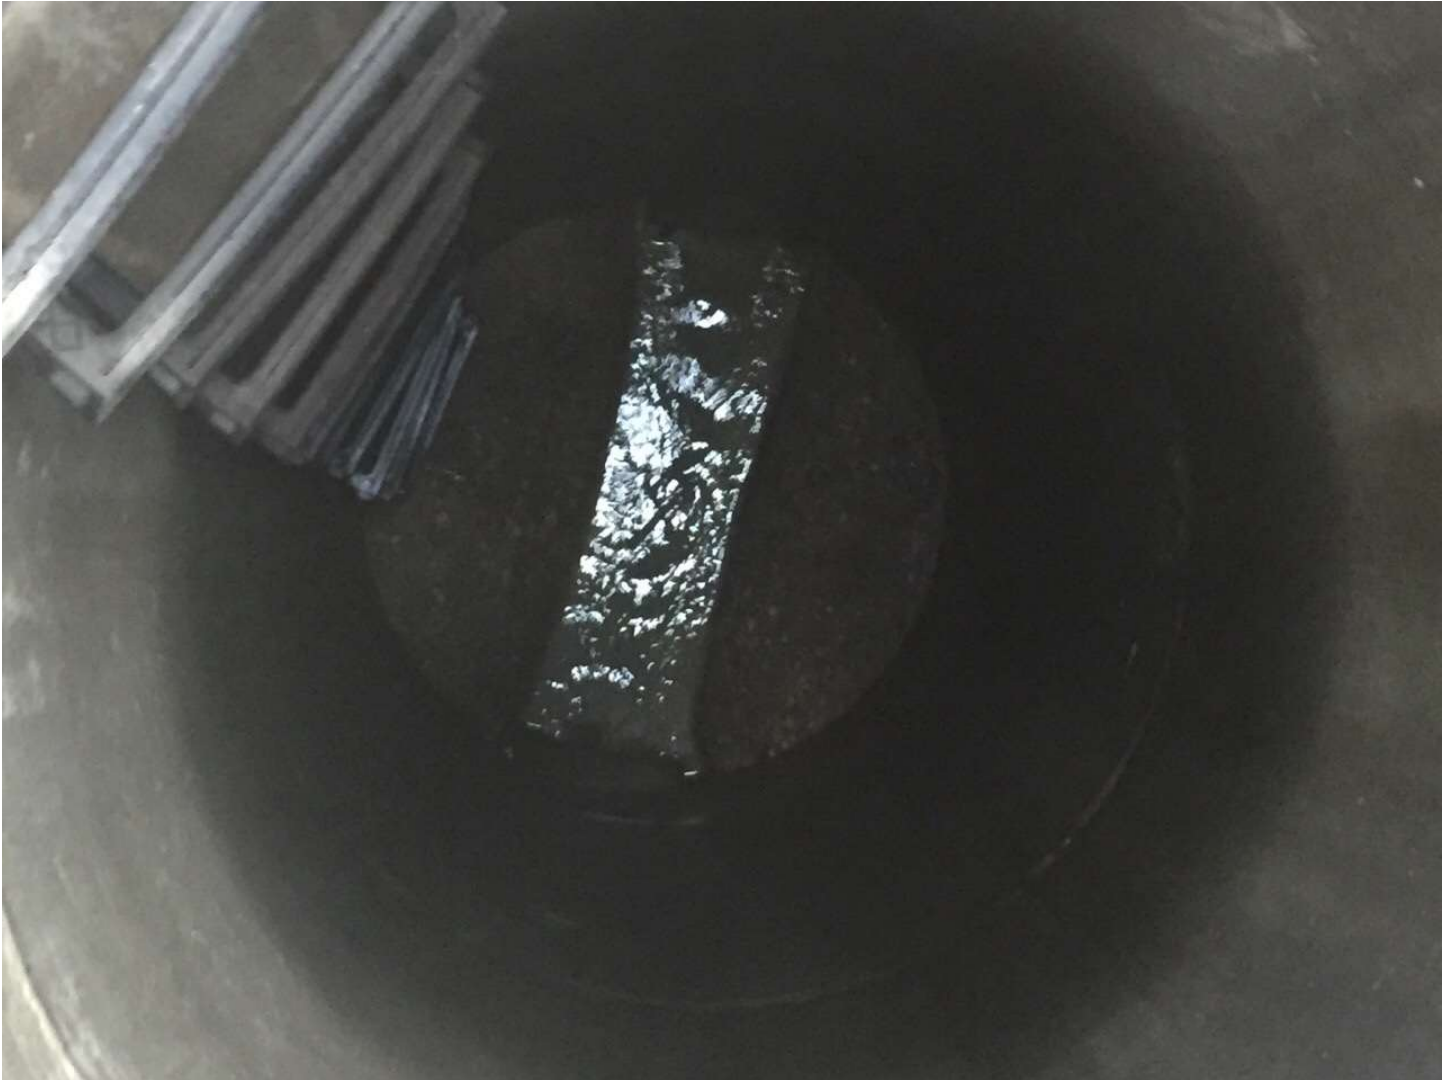
M2-16-25-5-P4-18-3W-1

Cone Inflow	Low	Cone Defect Location	<null>
Wall Construction	Precast	Wall Condition	Fair
Wall Inflow	Low	Wall Defect Location	Wall Joint
Wall Defect Location 2	<null>	Wall Defect Location 3	<null>
Wall Defect Location 4	<null>	Wall Defect Location 5	<null>
Bench Construction	Poured	Bench Condition	Good
Bench Inflow	None	Channel Construction	Poured
Channel Condition	Good	Channel Inflow	None
Channel Hydraulics	Fair	Channel Exposure	Fully

Recommendation 7	<null>	Recommendation 8	<null>
Manhole Rating	3 – Failure likely in 10 to 20 years (Fair)	Comments	Hole in cover. Inspected 8-2-2017

Pipe 6 Flow	<null>	Pipe 6 Diameter	<null>
Pipe 6 Direction	<null>	Pipe 6 Depth	<null>
Pipe 6 Material	<null>	Pipe 6 Seal Condition	<null>
Pipe 6 Drop	<null>	Pipe 6 Comments	<null>
Recommendation 1	Seal Wall Joints	Recommendation 2	<null>
Recommendation 3	<null>	Recommendation 4	<null>
Recommendation 5	<null>	Recommendation 6	<null>
