# Manhole Inspection Form

M2-16-36-P5-10E-P6-7-7-1

Manhole Number: M2-16-36-P5-10E-P6-7-7-1  
 Community: Chesterfield  
 Inspector Initials: RES / KMD

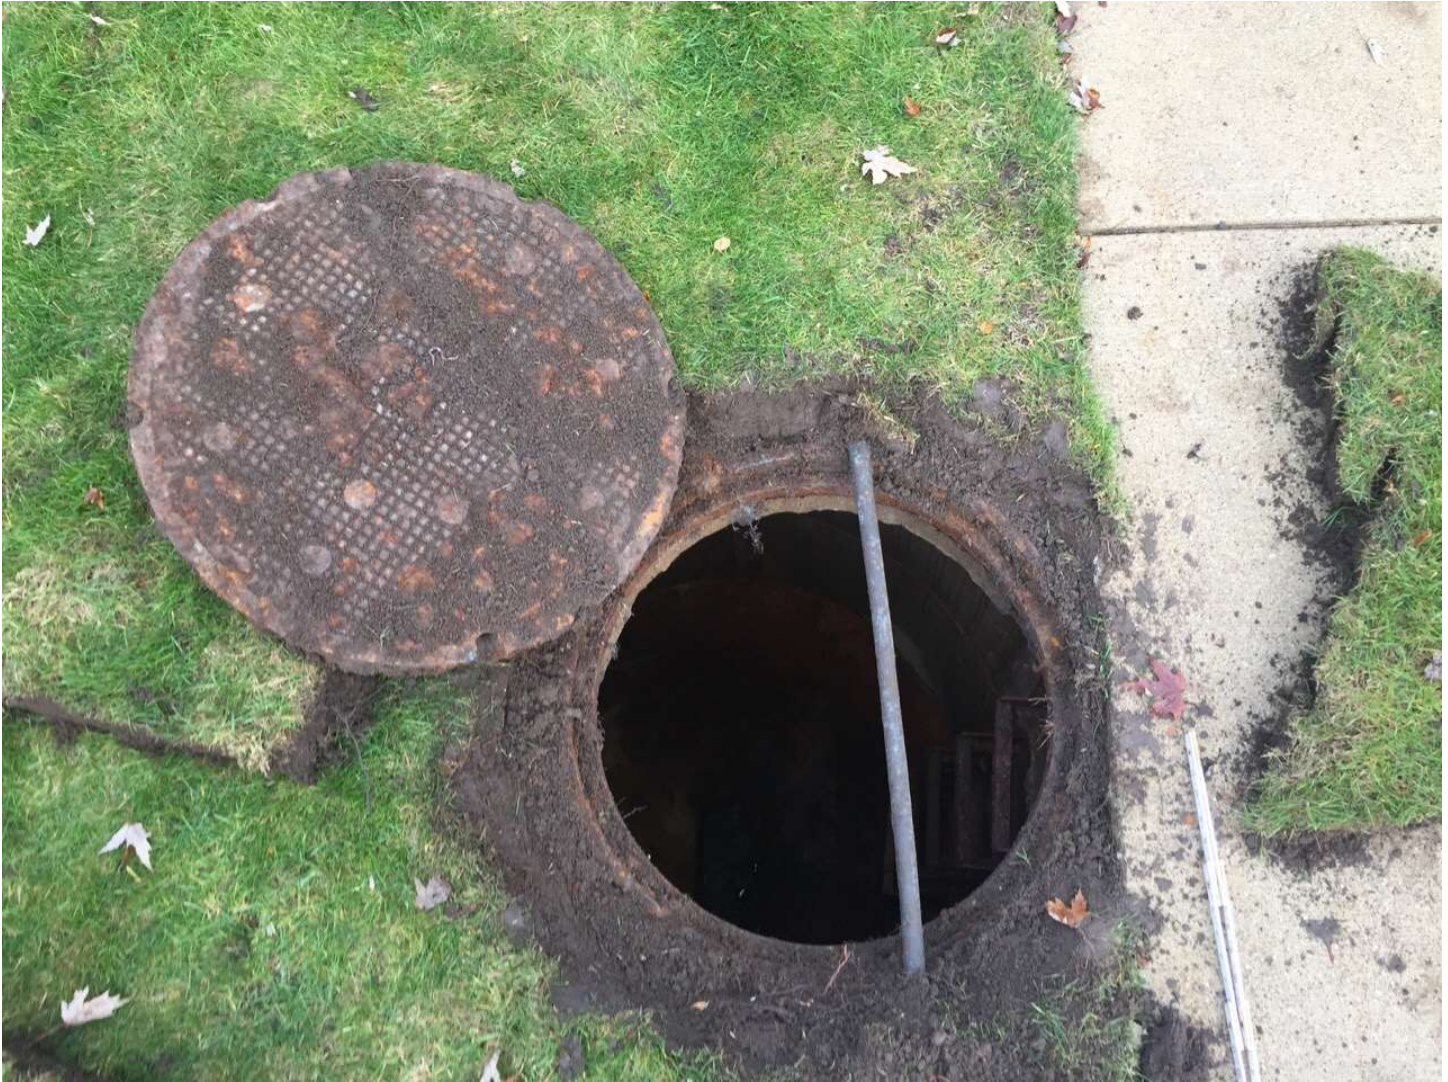
Manhole Number	M2-16-36-P5-10E-P6-7-7-1	Historic Manhole Number	Leeward 2
Year Installed	1969	Structure Type	Sanitary Manhole
Street	Leeward	Address	50628
Elevation	584.358	Weather	Overcast
Temperature	40°	Ground Condition	Dry
Status	At Surface Grade	Location	Yard Front
Pavment Condition	N/A	Traffic	Two Lane Road
Inspector 1	Kmd	Inspector 2	Brs
Cover Type	Ej1040	Number of Cover Holes	Solid Cover
Catch Basin Cover	N/A	Cover Insert	No
Cover Gasket	No	Cover Grade	Cover is At Grade
Grade Dist	0	Cover Fit	Good Fit
Cover Condition	Good	Frame Condition	Good
Frame Offset	<null>	Frame Seal Condition	Good
Frame Seal Inflow	None	Frame Riser	No
Frame Riser Height	<null>	Frame Riser Material	N/A
Manhole Diameter	48	Manhole Depth	9.25
Chimney Depth	<null>	Chimney Construction	None
Chimney Condition	<null>	Chimney Inflow	<null>
Cone Shape	Eccentric	Cone Depth	30
Cone Construction	Precast	Cone Condition	Good
Cone Inflow	Low	Cone Defect Location	Lift Holes

Wall Construction	Precast	Wall Condition	Fair
Wall Inflow	Moderate	Wall Defect Location	Lift Holes
Wall Defect Location 2	Wall Joint	Wall Defect Location 3	<null>
Wall Defect Location 4	<null>	Wall Defect Location 5	<null>
Bench Construction	Poured	Bench Condition	Good
Bench Inflow	None	Channel Construction	Poured
Channel Condition	Good	Channel Inflow	None
Channel Hydraulics	Good	Channel Exposure	Yes

Recommendation 5	<null>	Recommendation 6	<null>
Recommendation 7	<null>	Recommendation 8	<null>
Manhole Rating	3 – Failure likely in 10 to 20 years (Fair)	Comments	Sprinkler line over manhole

Pipe 5 Drop	<null>	Pipe 5 Comments	<null>
Pipe 6 Flow	<null>	Pipe 6 Diameter	<null>
Pipe 6 Direction	<null>	Pipe 6 Depth	<null>
Pipe 6 Material	<null>	Pipe 6 Seal Condition	<null>
Pipe 6 Drop	<null>	Pipe 6 Comments	<null>
Recommendation 1	Seal Wall Joints	Recommendation 2	Seal Lift Holes
Recommendation 3	<null>	Recommendation 4	<null>
