Manhole Inspection Form

M2-16-36-P5-10E-P6-21-2

Community: Chesterfield

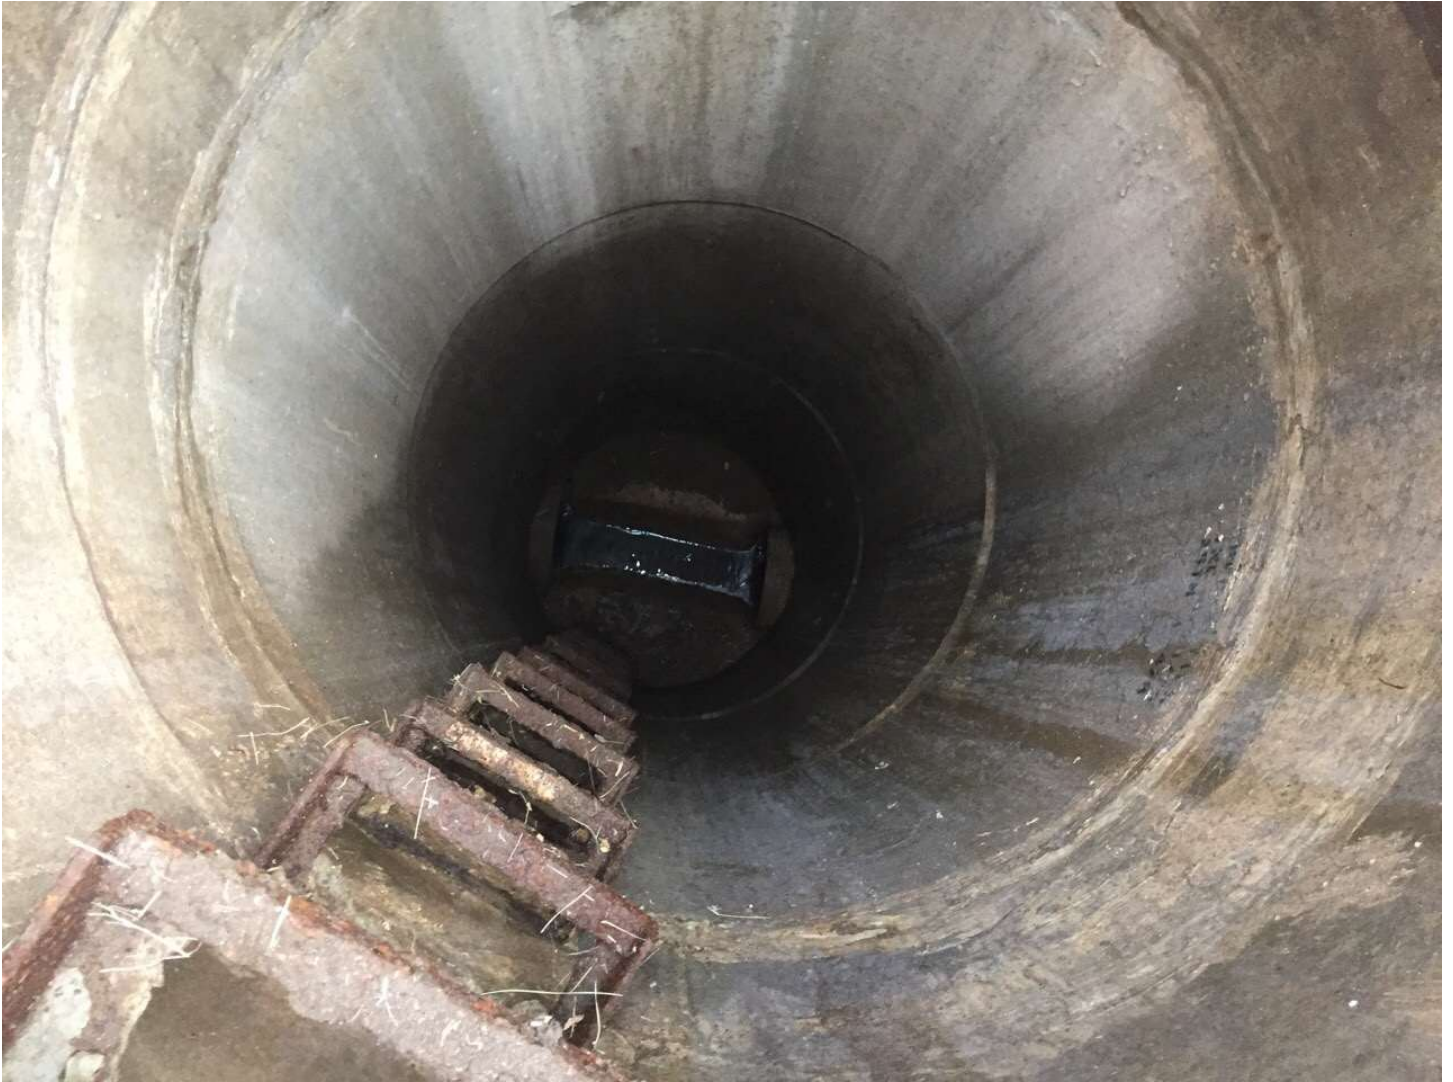
M2-16-36-P5-10E-P6-21-2

Wall Construction	Precast	Wall Condition	Fair
Wall Inflow	Low	Wall Defect Location	Wall Joint
Wall Defect Location 2	<null>	Wall Defect Location 3	<null>
Wall Defect Location 4	<null>	Wall Defect Location 5	<null>
Bench Construction	Poured	Bench Condition	Good
Bench Inflow	None	Channel Construction	Poured
Channel Condition	Good	Channel Inflow	None
Channel Hydraulics	Fair	Channel Exposure	Fully

Recommendation 7	<null>	Recommendation 8	<null>
Manhole Rating	2 – Failure unlikely in 20 years (Good)	Comments	<null>

Pipe 6 Flow	<null>	Pipe 6 Diameter	<null>
Pipe 6 Direction	<null>	Pipe 6 Depth	<null>
Pipe 6 Material	<null>	Pipe 6 Seal Condition	<null>
Pipe 6 Drop	<null>	Pipe 6 Comments	<null>
Recommendation 1	Seal Wall Joints	Recommendation 2	<null>
Recommendation 3	<null>	Recommendation 4	<null>
Recommendation 5	<null>	Recommendation 6	<null>
