# Manhole Inspection Form

M2-16-36-P5-3W-8

Manhole Number	M2-16-36-P5-3W-8	Historic Manhole Number	Peggy 8
Year Installed	1971	Structure Type	Sanitary Manhole
Street	Peggy	Address	50336
Elevation	588.612	Weather	Sunny
Temperature	65°	Ground Condition	Dry
Status	At Surface Grade	Location	Yard Front
Pavment Condition	N/A	Traffic	No Traffic at Location
Inspector 1	Rbc	Inspector 2	Cad
Cover Type	EJ 1040APT	Number of Cover Holes	3 - 5
Catch Basin Cover	N/A	Cover Insert	No
Cover Gasket	Yes	Cover Grade	Cover is Below Grade
Grade Dist	4	Cover Fit	Good Fit
Cover Condition	Good	Frame Condition	Good
Frame Offset	<null>	Frame Seal Condition	Good
Frame Seal Inflow	None	Frame Riser	Yes
Frame Riser Height	8	Frame Riser Material	Concrete
Manhole Diameter	48	Manhole Depth	10.25
Chimney Depth	<null>	Chimney Construction	Precast
Chimney Condition	Good	Chimney Inflow	None
Cone Shape	<null>	Cone Depth	<null>
Cone Construction	Precast	Cone Condition	Fair
Cone Inflow	Low	Cone Defect Location	Wall/Cone Joint

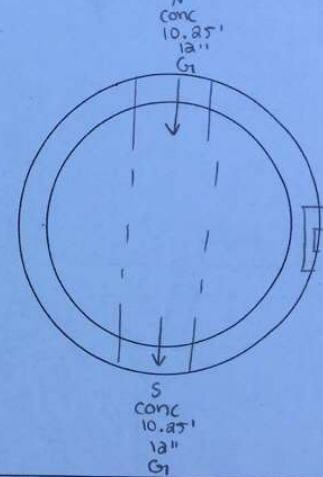
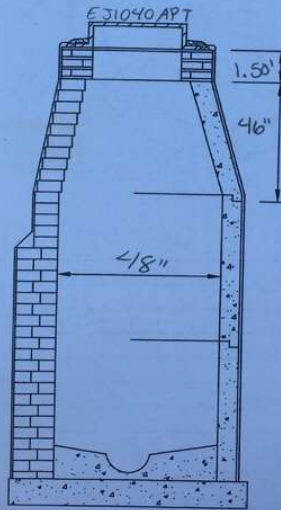
Date: 6-28-17  
Address: 50336 Peggy  
R.T. = 10.25'  
D = 48"  
Map: 47

Manhole Number: M2-16-36-P5-3W-8
